COLORADO DIVISION OF RECLAMATION, MINING AND SAFETY COAL PROGRAM INSPECTION REPORT

| Permit Number: C-1992-081 Mine Name: Hayden Gulch Loadout Operator: Hayden Gulch Terminal, LLC Operator Address: Mr. Roy Karo 37796 Routt County Road 53 P.O. Box 670 Hayden, CO 81639 | County: Routt Operation Type: Loadout Permit Status: Permanent Cessation Ownership: Private |

| Inspection Start Date: February 19, 2013 Inspection Start Time: 11:00 Inspection End Date: February 19, 2013 Inspection End Time: 11:10 | Inspection Type: Aerial Inspection Inspection Reason: Normal I&E Program Weather: Clear | |

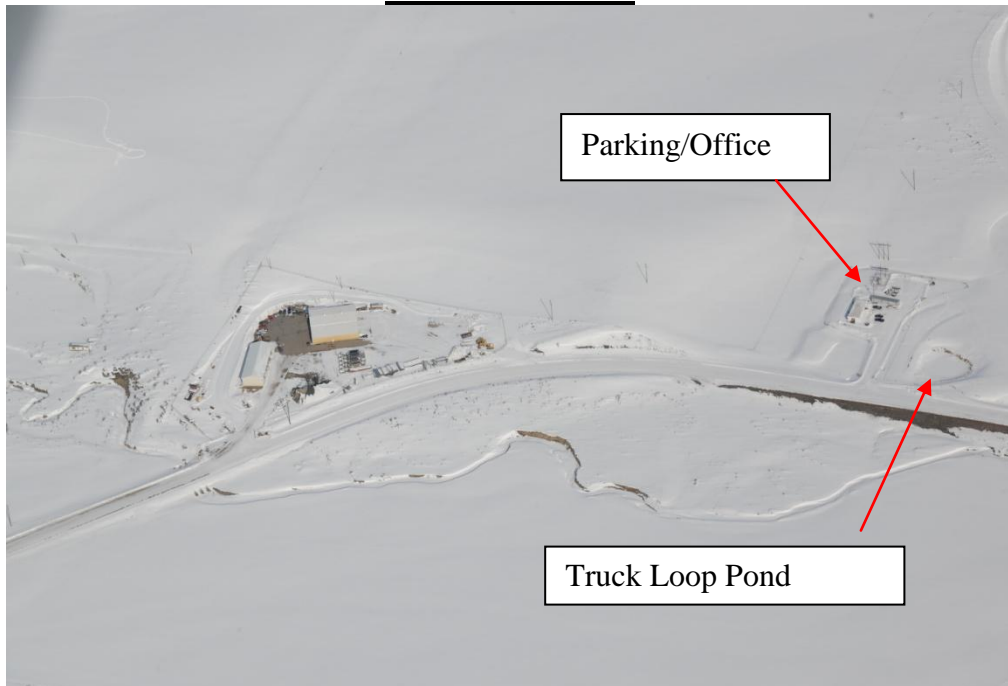
The facilities area has been demolished and the area has been graded. The rail loop was visible in the photographs and no problems were observed. The parking and office trailer area were also observed and no problems were noted.

The Hayden Gulch Loadout haul road was observed, the road appears to have been plowed and maintained.

Hayden Gulch Loadout haul road, parking and office area, truck look pond

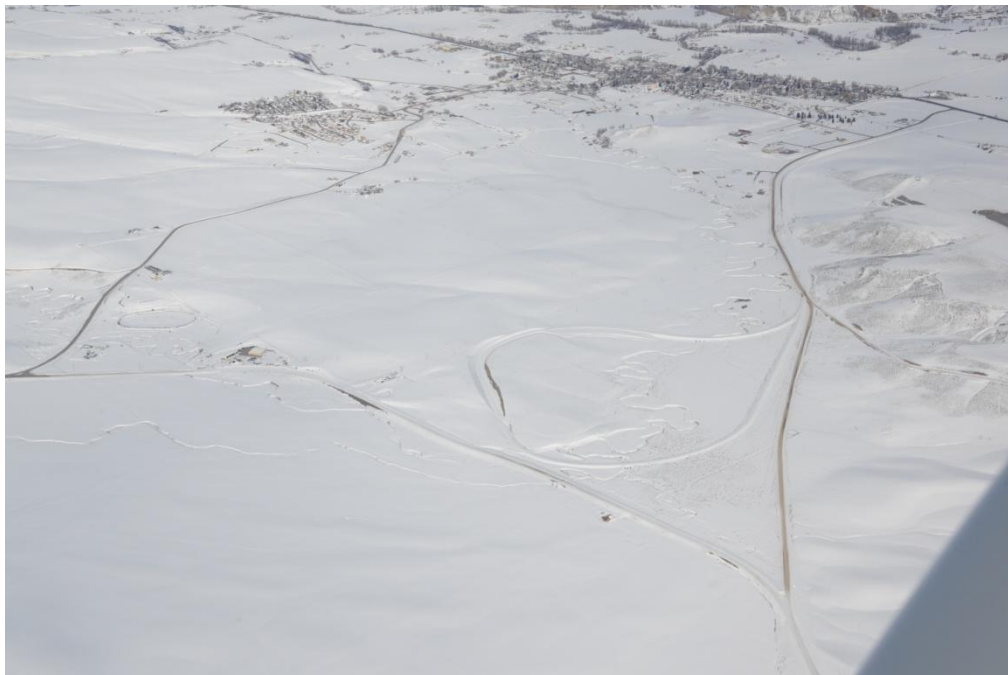
Hayden Gulch Loadout rail loop

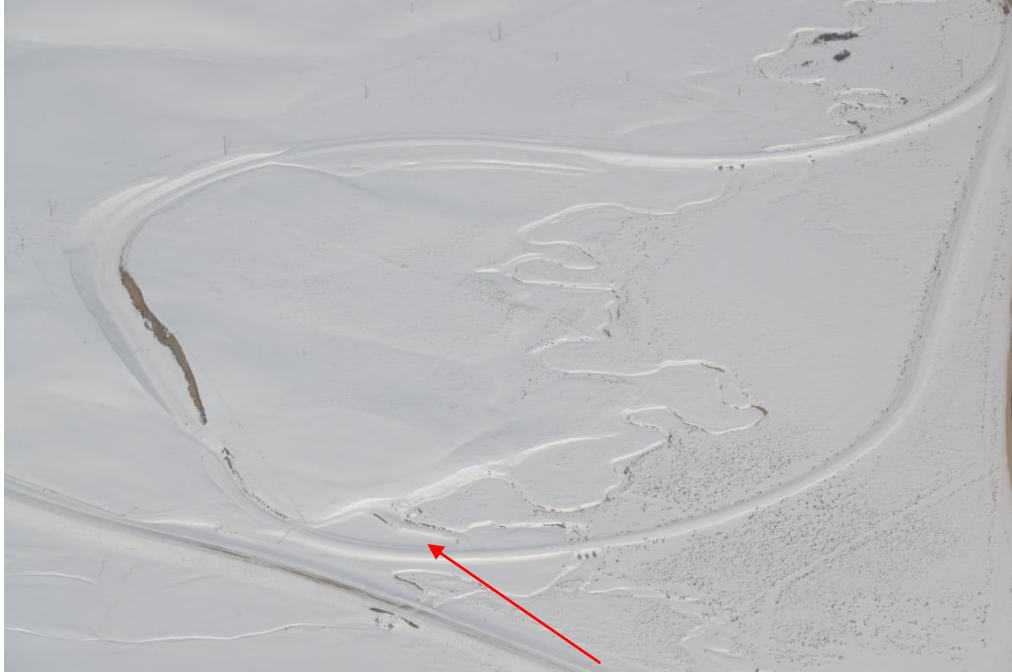
The truck and rail loop ponds were observed. The ponds were covered with snow but appeared stable. It did not appear that the ponds were discharging.

Rail loop and rail loop pond.
