COLORADO DIVISION OF RECLAMATION, MINING AND SAFETY COAL PROGRAM INSPECTION REPORT

Permit Number: C-1981-019 Mine Name: Colowyo Coal Mine Operator: Colowyo Coal Company L.P. Operator Address: Mr. Tony Tennyson 5731 State Highway 13 Meeker, CO 81641	County: Moffat, Rio Blanco Operation Type: Surface Permit Status: Active Ownership: Federal
Operator Representative Present: Tony Tennyson	
Operator Representative Signature: (Field Issuance Only)

Inspection Start Date: February 20, 2013 Inspection Start Time: 08:00 Inspection End Date: Inspection End Time:	Inspection Type: Coal Partial Inspection Inspection Reason: Normal I&E Program Weather: Cloudy
Joint Inspection Agency: None	Joint Inspection Contacts:
Post Inspection Agency: None	Post Inspection Contacts:
Inspector(s): Robert D. Zuber	Inspector's Signature:

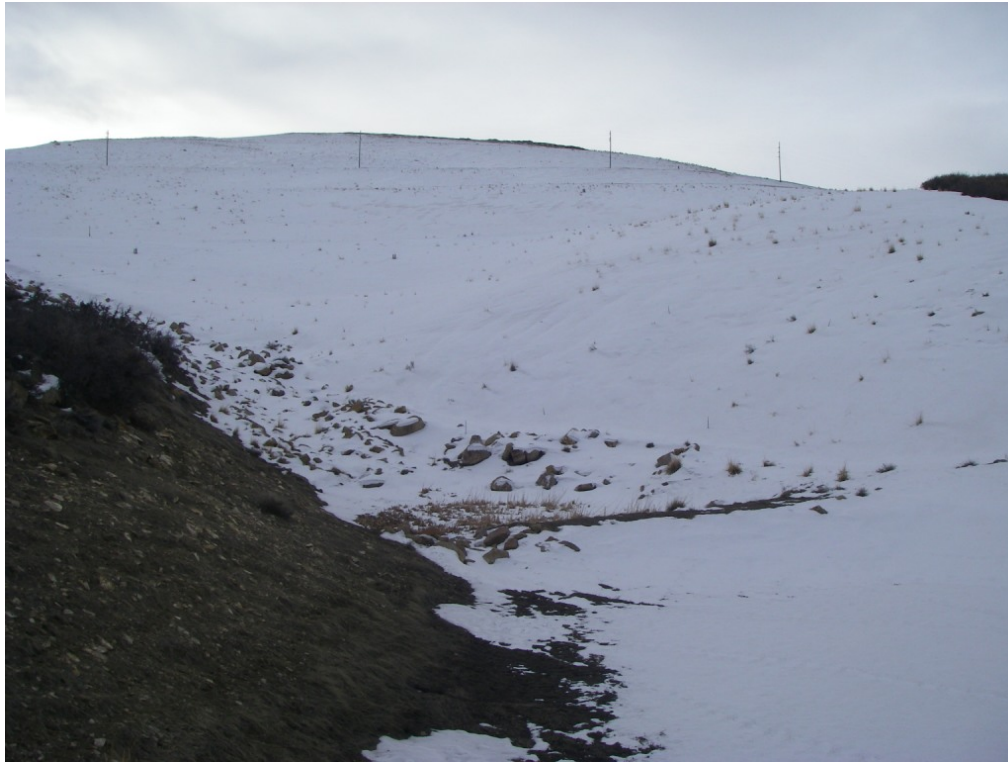
West Pit fill was observed from below, and no problems were seen.

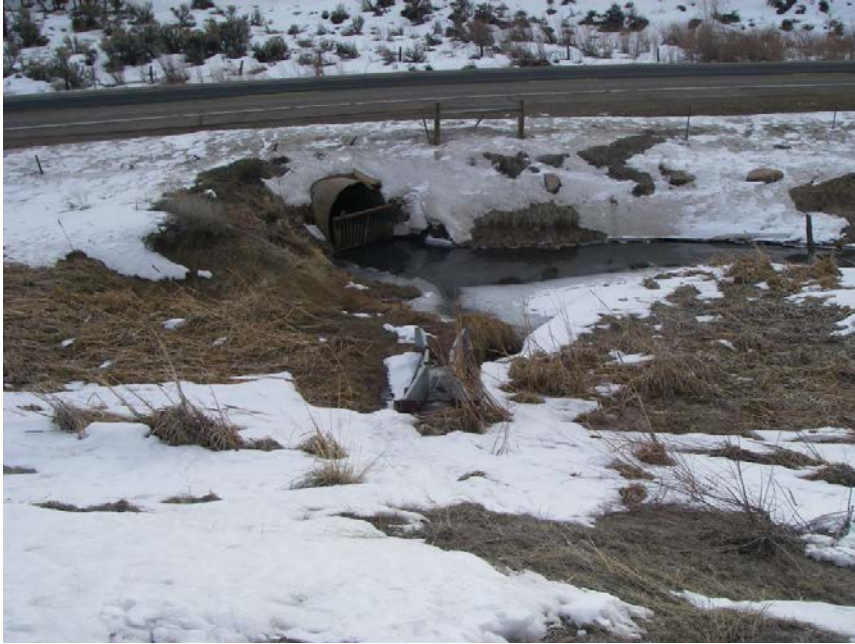
Flow out of Streeter Pond

The following ponds were inspected: West Pit, Prospect, Streeter, Gossard, Stoker Siding. Streeter was discharging at a significant flow rate. The Stoker Siding Pond was discharging a very small amount of water. No sign of pollutants was observed in and near either discharge. The other three observed ponds were not discharging.

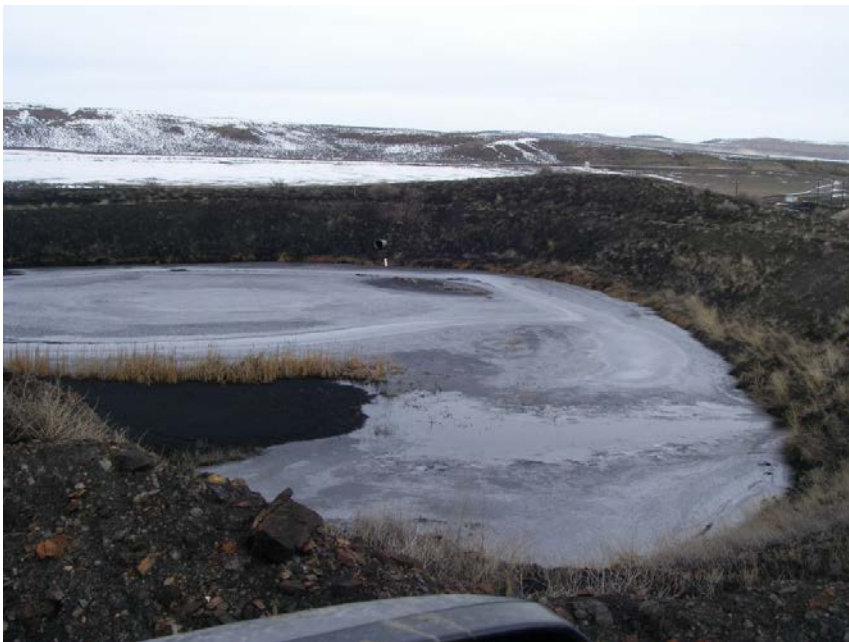
Gossard Pond

No problems were identified with embankments, spillways, or other aspects of the ponds.

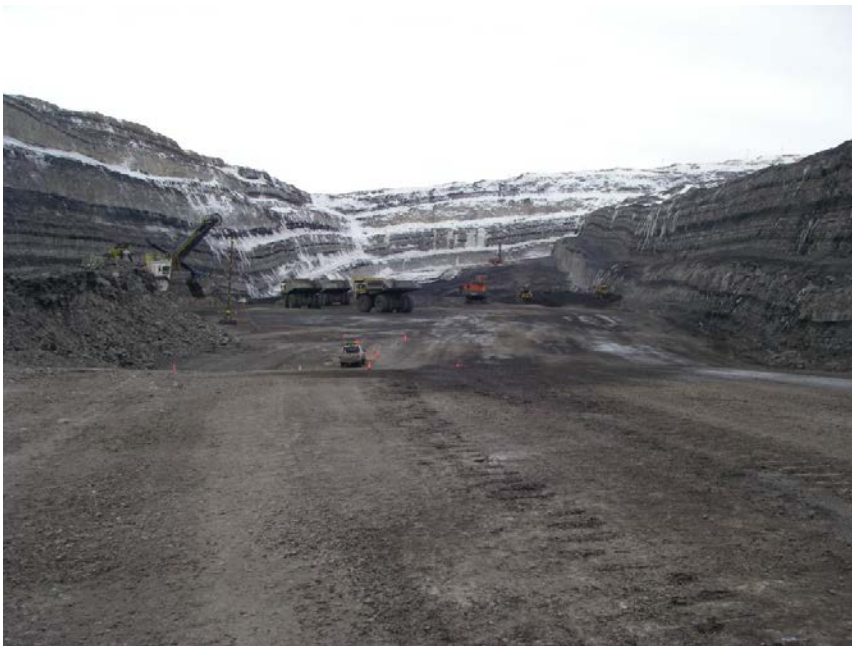
The 115 excavator and the 114 shovel were idle in the South Taylor Pit when observed. A second drill rig was being brought into the pit during the inspection.

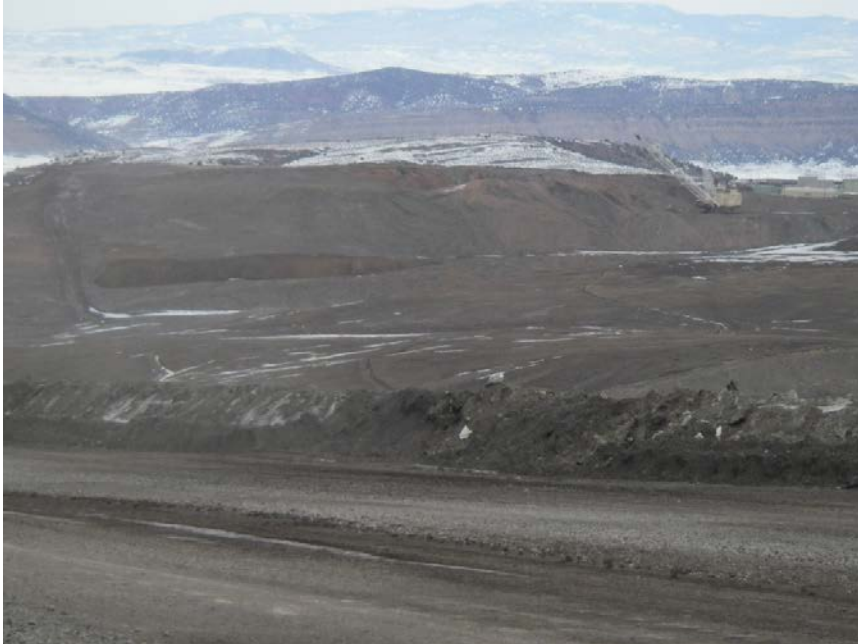
West Pit reclamation

In the West Pit there was little snow on the reclamation. No gullies were seen. Good roughening was observed. Topsoil staged for spreading this year is protected by ring ditches.

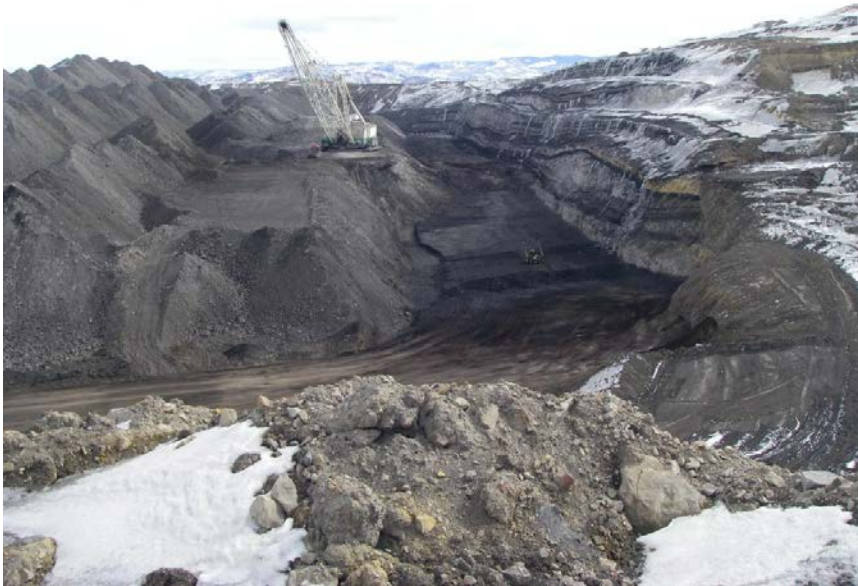
West Pit

In the West Pit, the 102 dragline was idle, but the 103 was seen moving during the inspection.

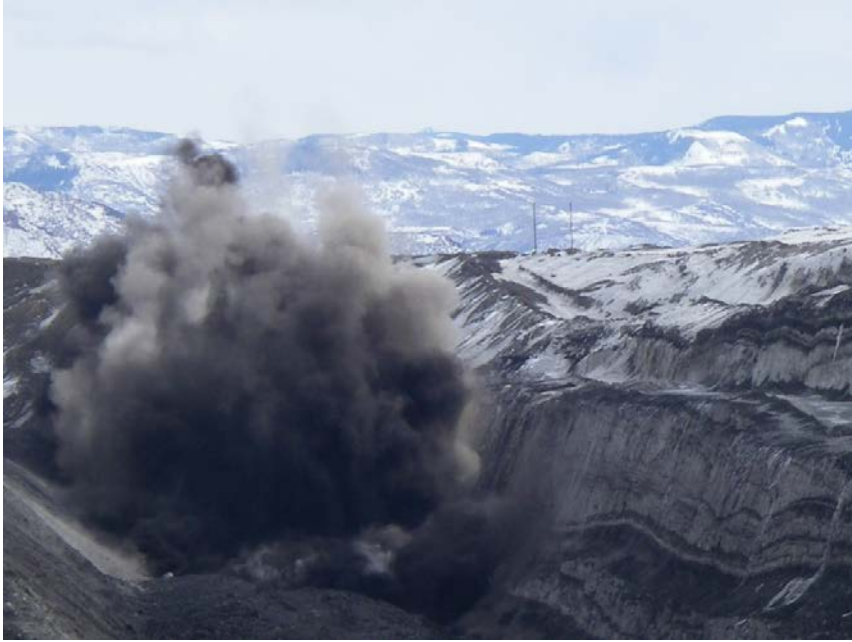
West Pit blast

An overburden shot was observed in the West Pit; no problems were observed.

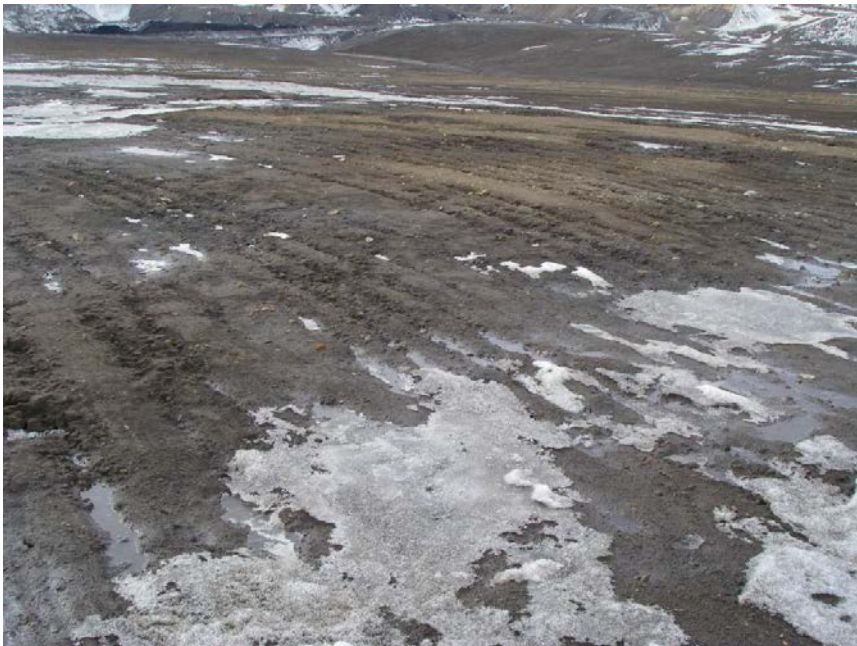
Roughening in West Pit reclamation
