## COLORADO DIVISION OF RECLAMATION, MINING AND SAFETY COAL PROGRAM INSPECTION REPORT

<b>Permit Number:</b> C-1981-019 <b>Mine Name:</b> Colowyo Coal Mine <b>Operator:</b> Colowyo Coal Company L.P. <b>Operator Address:</b> Mr. Tony Tennyson 5731 State Highway 13 Meeker, CO 81641	<b>County:</b> Moffat, Rio Blanco <b>Operation Type:</b> Surface <b>Permit Status:</b> Active <b>Ownership:</b> Federal
	<b>Operator Representative Present:</b>  None
<b>Operator Representative Signature: (Field Issuance Only)</b>

<b>Inspection Start Date:</b> February 19, 2013 <b>Inspection Start Time:</b> 11:30 <b>Inspection End Date:</b> <b>Inspection End Time:</b>	<b>Inspection Type:</b> Aerial Inspection <b>Inspection Reason:</b> Normal I&E Program <b>Weather:</b> Clear
<b>Joint Inspection Agency:</b>  None	<b>Joint Inspection Contacts:</b>  
<b>Post Inspection Agency:</b>  None	<b>Post Inspection Contacts:</b>  
<b>Inspector(s):</b>  Robert D. Zuber	<b>Inspector's Signature:</b>  <i>Robert D. Zuber</i> <b>Signature Date:</b>  2/22/2013

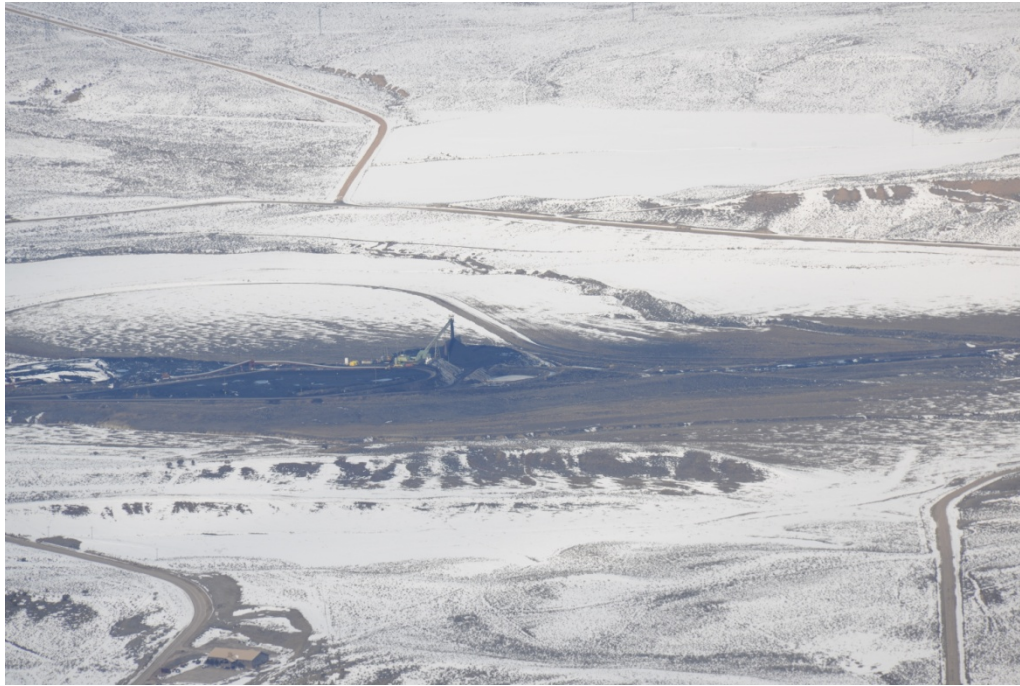
**Gossard Loadout**

No problems were seen at the facility area or the Gossard loadout.

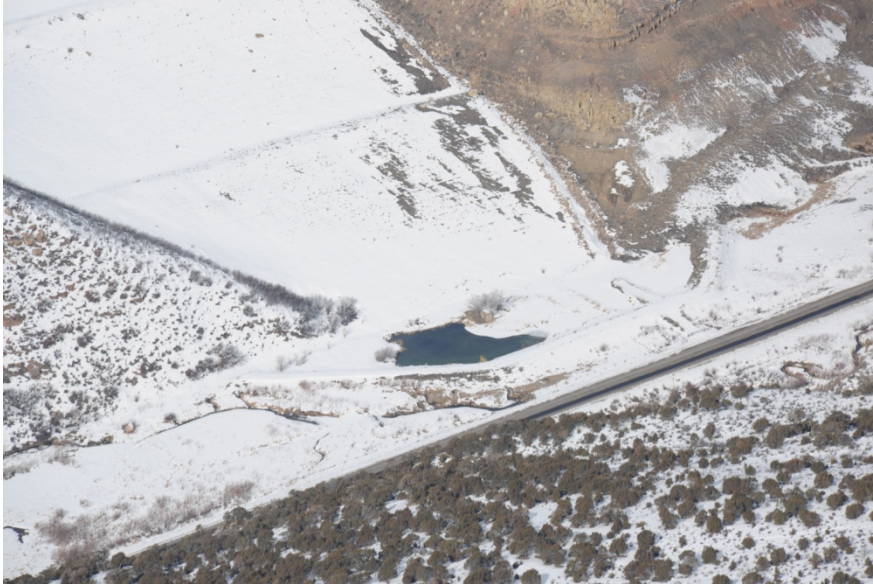
**Streeter Pond**

No problems were observed with pond embankments or channels.

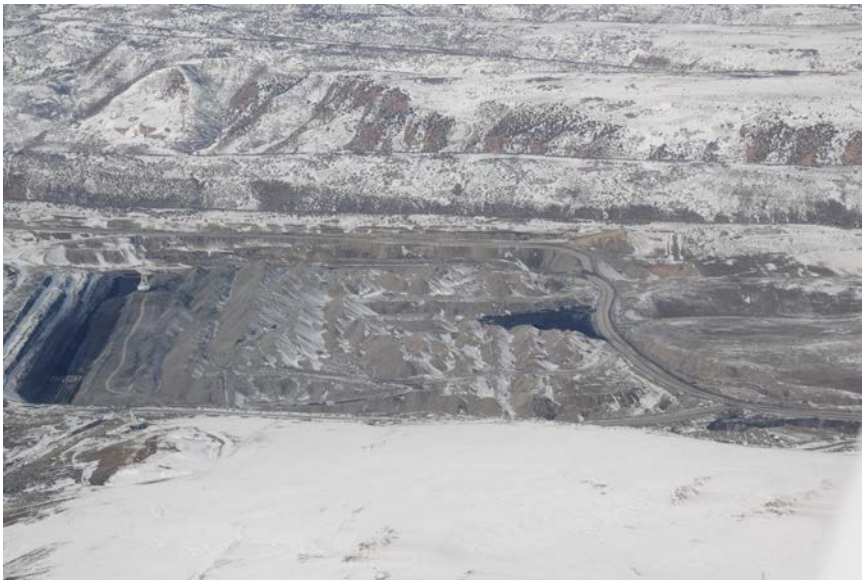
**West Pit, looking west**

The 103 dragline was seen in the West Pit.

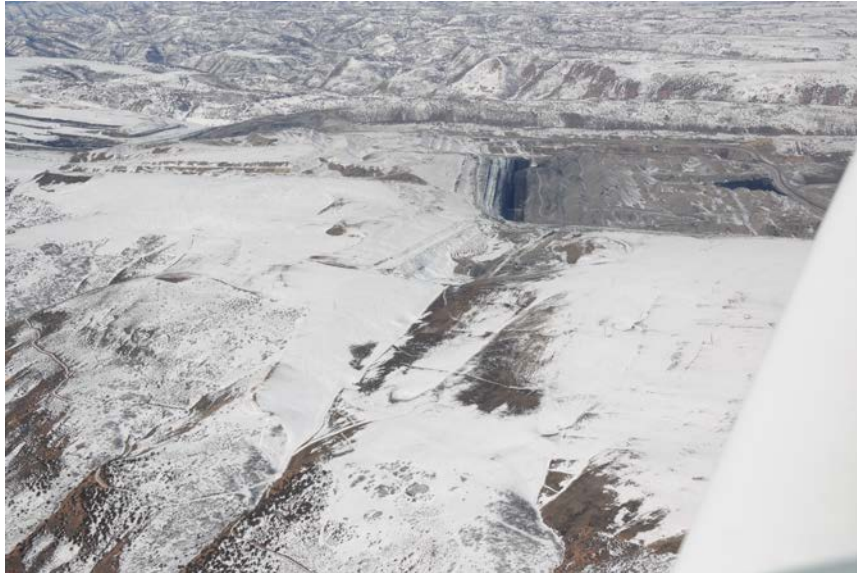
**East Pit reclamation**

No problems were observed in the reclamation areas.
