**COLORADO DIVISION OF RECLAMATION, MINING AND SAFETY
COAL PROGRAM INSPECTION REPORT**

Permit Number: C-1982-057 Mine Name: Seneca II-W Mine Operator: Seneca Coal Company, LLC Operator Address: Mr. Roy Karo 37796 Routt County Road 53 P.O. Box 670 Hayden, CO 81639	County: Routt Operation Type: Surface Permit Status: Permanent Cessation Ownership: Federal
	Operator Representative Present: None
Operator Representative Signature: (Field Issuance Only)

Inspection Start Date: February 19, 2013 Inspection Start Time: 12:14 Inspection End Date: February 19, 2013 Inspection End Time: 12:20	Inspection Type: Aerial Inspection Inspection Reason: Normal I&E Program Weather: Clear
Joint Inspection Agency: None	Joint Inspection Contacts:
Post Inspection Agency: None	Post Inspection Contacts:
Inspector(s): Jared Ebert Harry B. Ranney	Inspector's Signature:

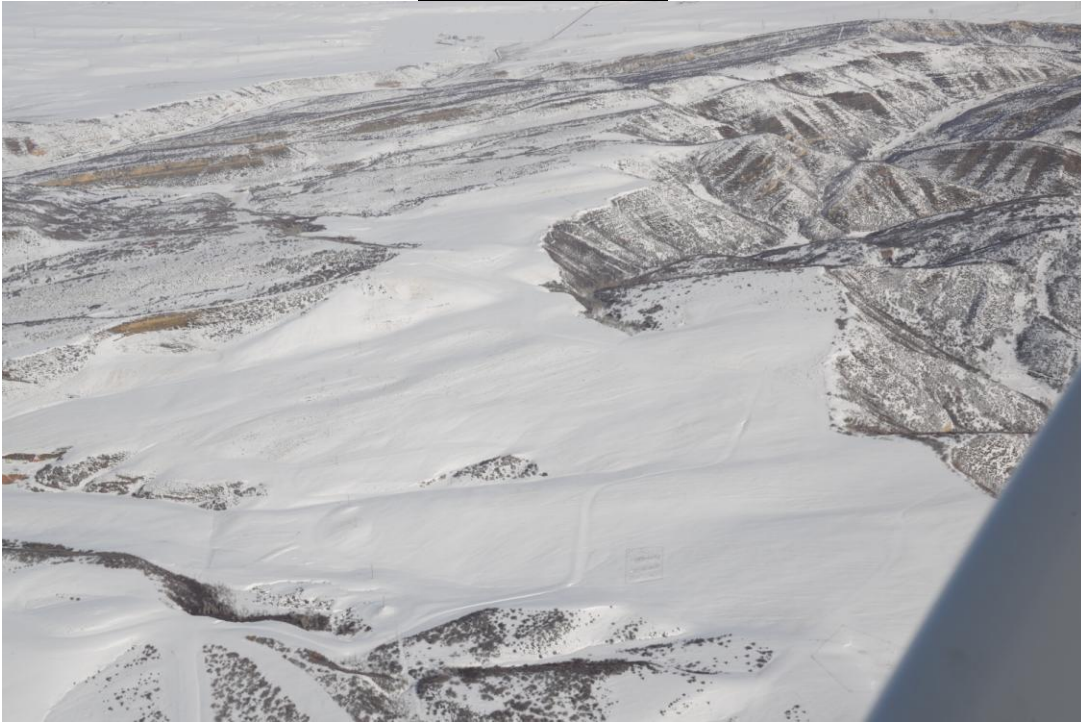
The majority of the reclaimed area is visible in the photographs. The affected land is covered in snow and the stability of the area is difficult to ascertain. 006 Gulch, 005 Gulch, PM-4, PM-3 PM-2 and PM-1 drainage areas are visible, the runoff control structures are in place and snow covered.

North Area, 006 gulch in the front of the photo and the 005 drainage area in the top of the Photo.

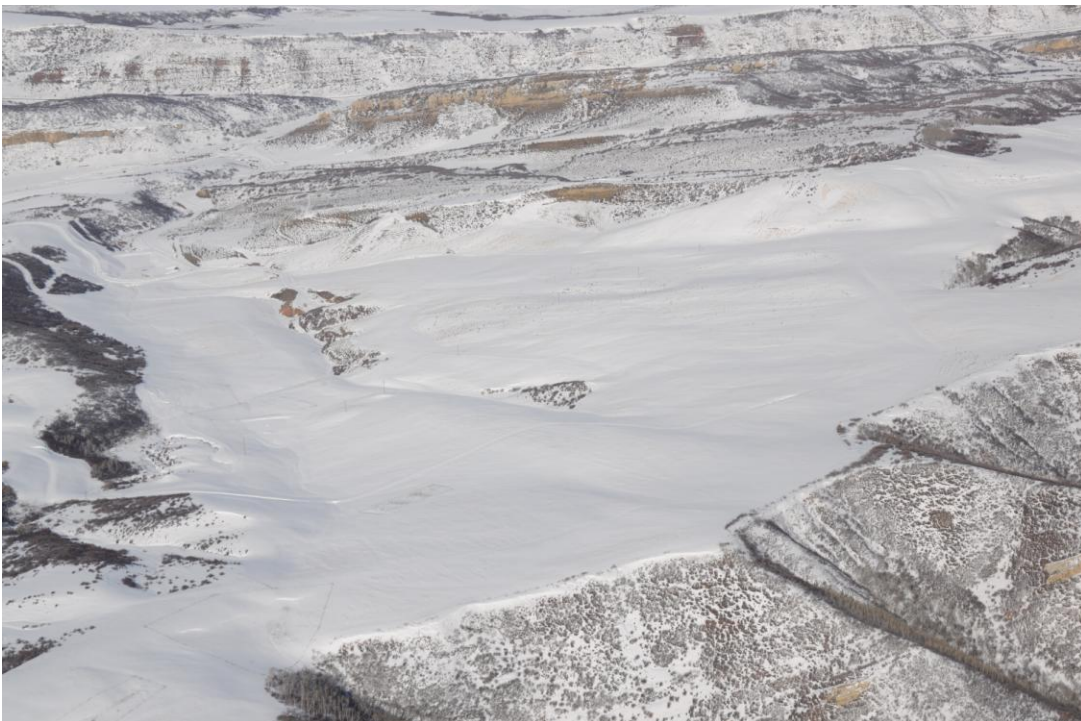
Pond 006, 015, 017 and stock tank T-5, was snow and ice covered. Given the snow conditions it was unclear if the impoundments were discharging water. Overall, the embankment of the impoundments appeared stable.

006 Gulch from the southeast looking northwest. T-5 and Pond 6 visible.

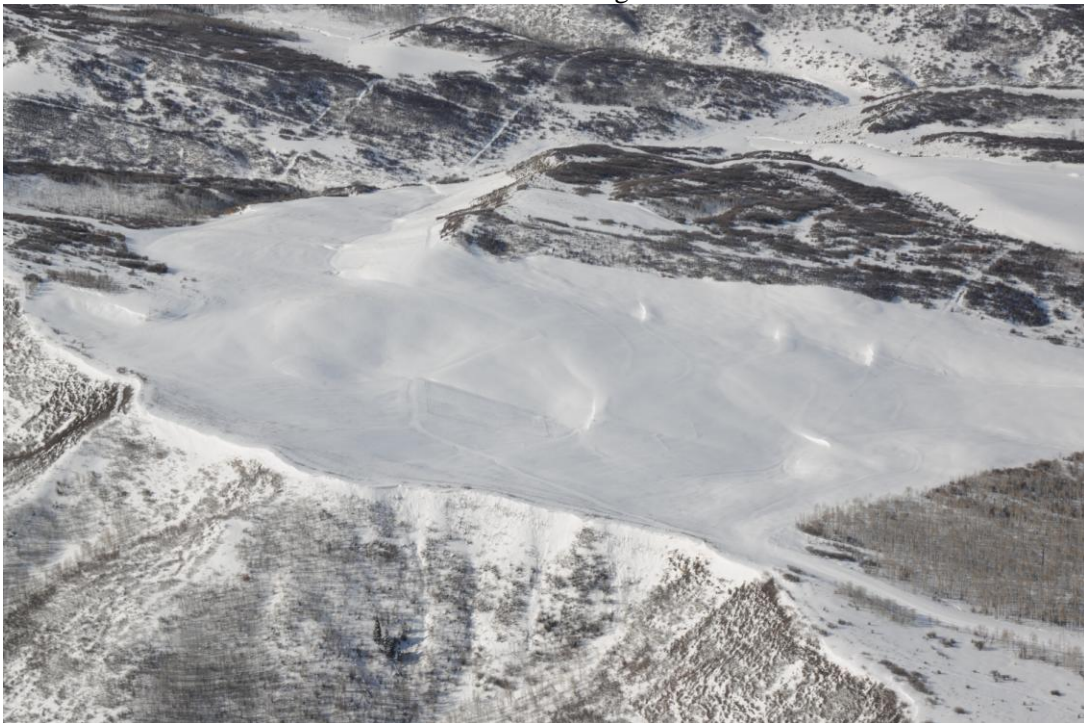
South mining area, PM-2 drainage and runoff control structures.

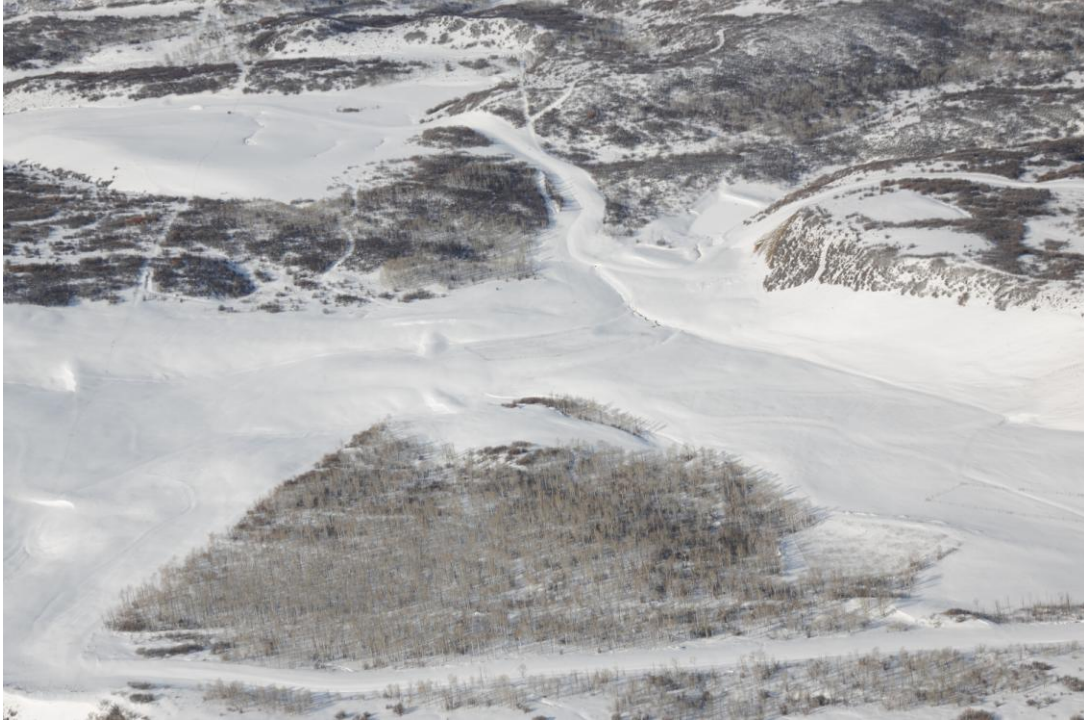
PM-3 and P-2 drainage basin into Pond 015.

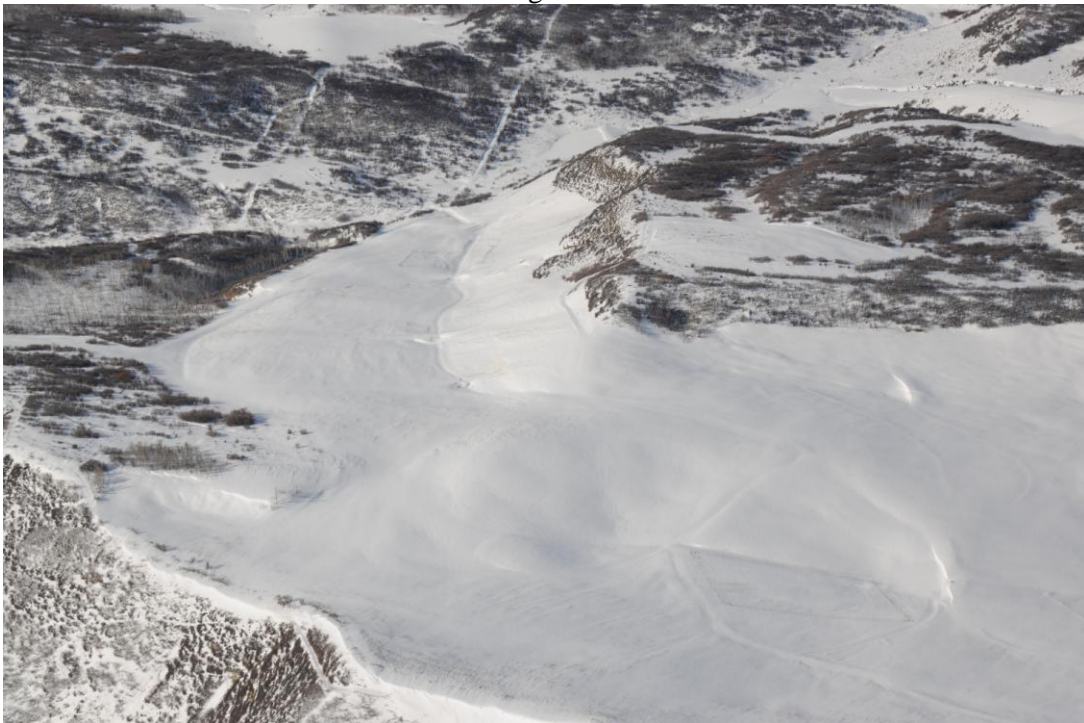
Pm-1 drainage basin into Pond 017.

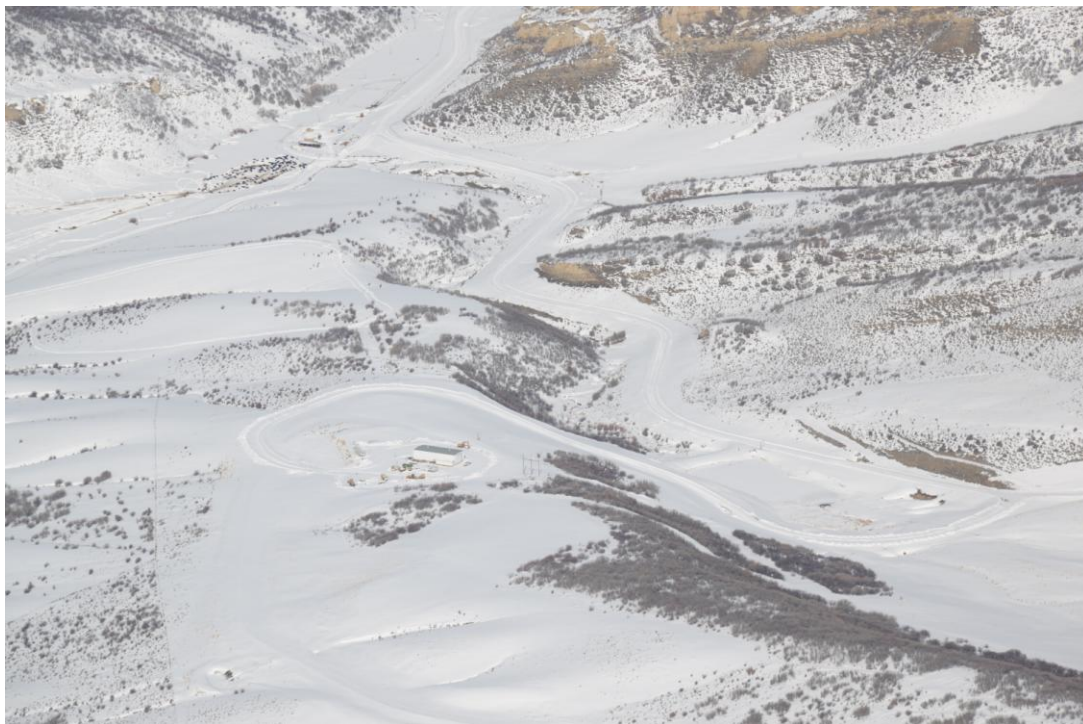
Shop area.

The shop area was observed and no problems were noted.
