**COLORADO DIVISION OF RECLAMATION, MINING AND SAFETY
COAL PROGRAM INSPECTION REPORT**

Permit Number: C-1994-082 Mine Name: Yoast Mine Operator: Seneca Coal Company, LLC Operator Address: Mr. Roy Karo 37796 Routt County Road 53 P.O. Box 670 Hayden, CO 81639	County: Routt Operation Type: Surface Permit Status: Permanent Cessation Ownership: Federal
	Operator Representative Present: None
Operator Representative Signature: (Field Issuance Only)

Inspection Start Date: February 19, 2013 Inspection Start Time: 11:10 Inspection End Date: February 19, 2013 Inspection End Time: 11:20	Inspection Type: Aerial Inspection Inspection Reason: Normal I&E Program Weather: Clear
Joint Inspection Agency: None	Joint Inspection Contacts:
Post Inspection Agency: None	Post Inspection Contacts:
Inspector(s): Jared L. Ebert Harry B. Ranney	Inspector's Signature:

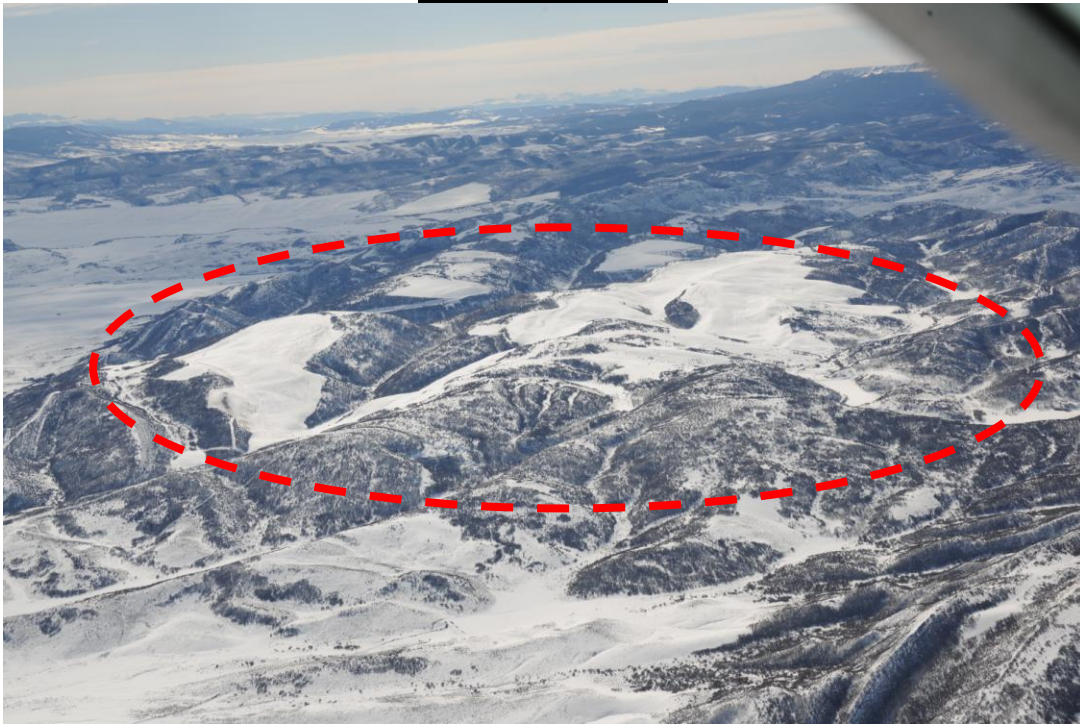
Entire mine site from the west looking east.

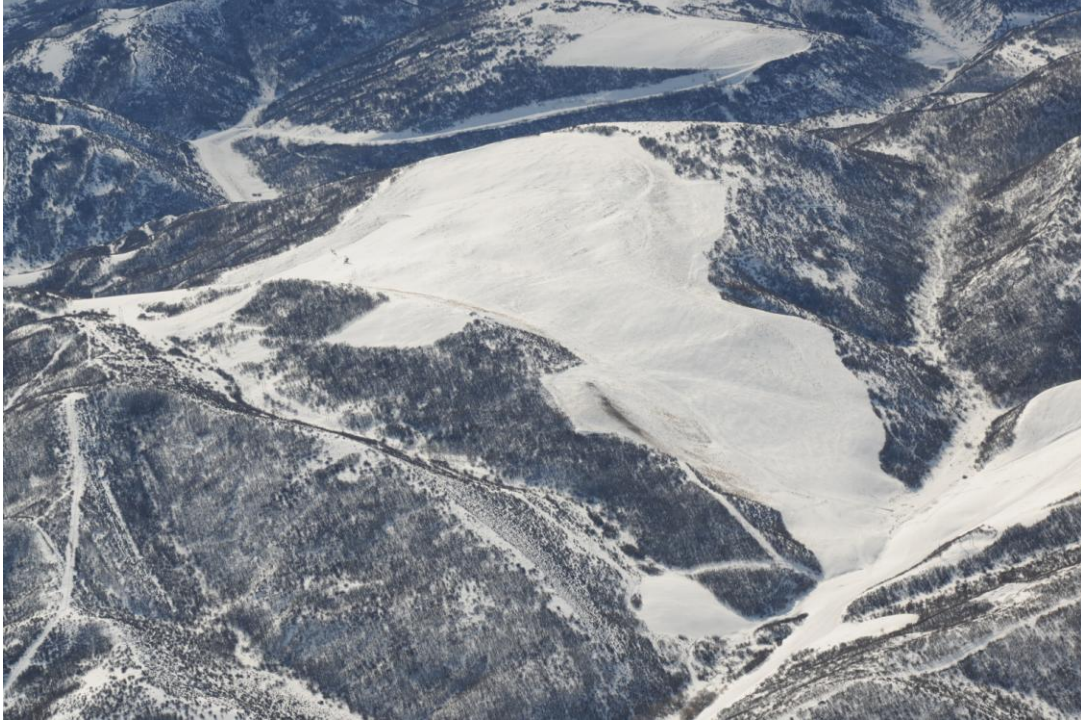
Head Pit

The “head pit” area on the north end of the site was observed, drainages YPM-9, 21, 11 and 13 were visible. These drainages were snow covered and appeared stable. Several runoff control structures were observed and were snow covered.

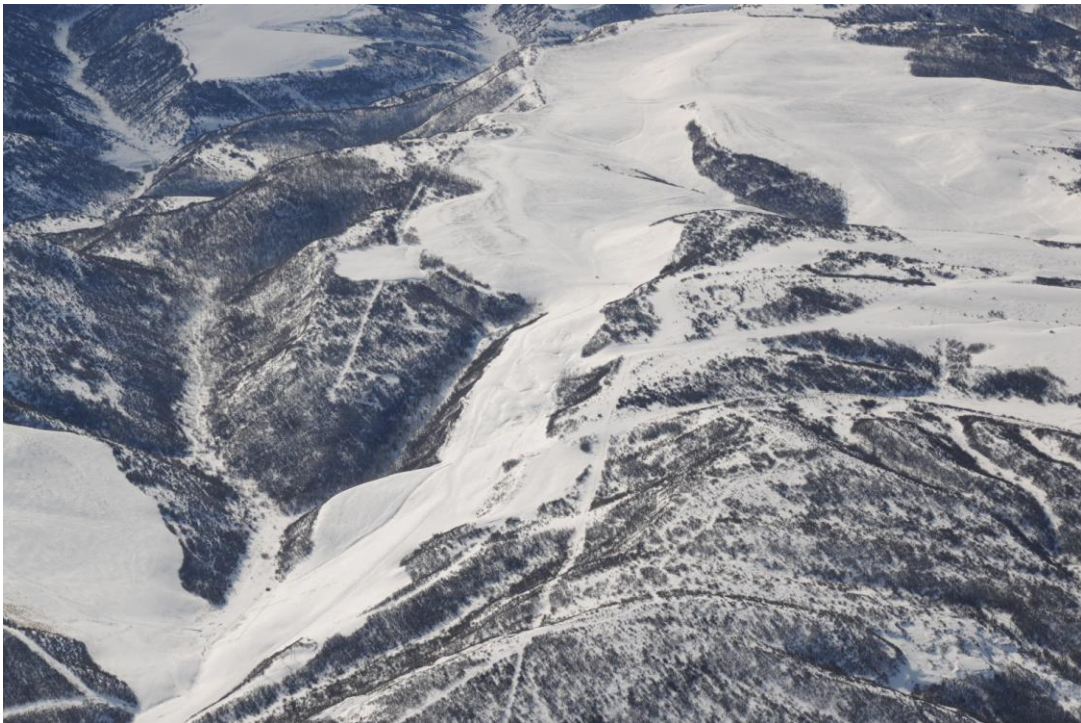
The “neck pit” area was observed; drainages YPM-5, 6 and 7 were visible. These drainages were snow covered and appeared stable.

The southern mine area was observed, the area was snow covered and no problems were noted.

Neck Pit and southern pit area.

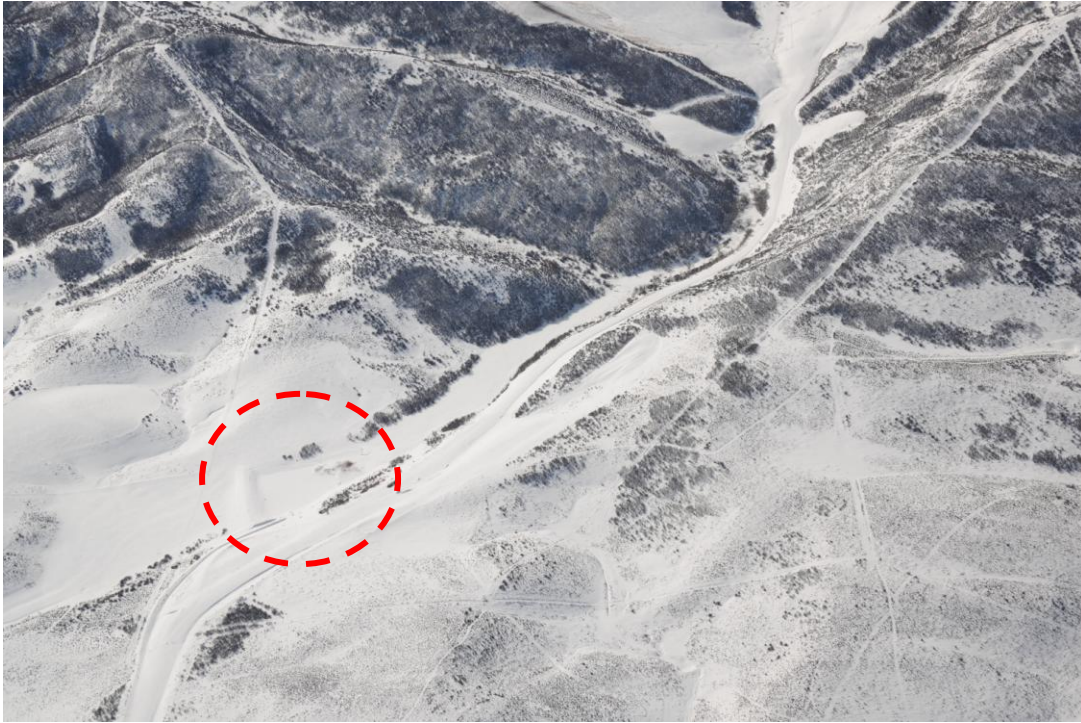
Pond 010 and 011A were snow and ice covered, it was difficult to determine if the ponds were discharging. The embankments were snow covered but it appeared stable.

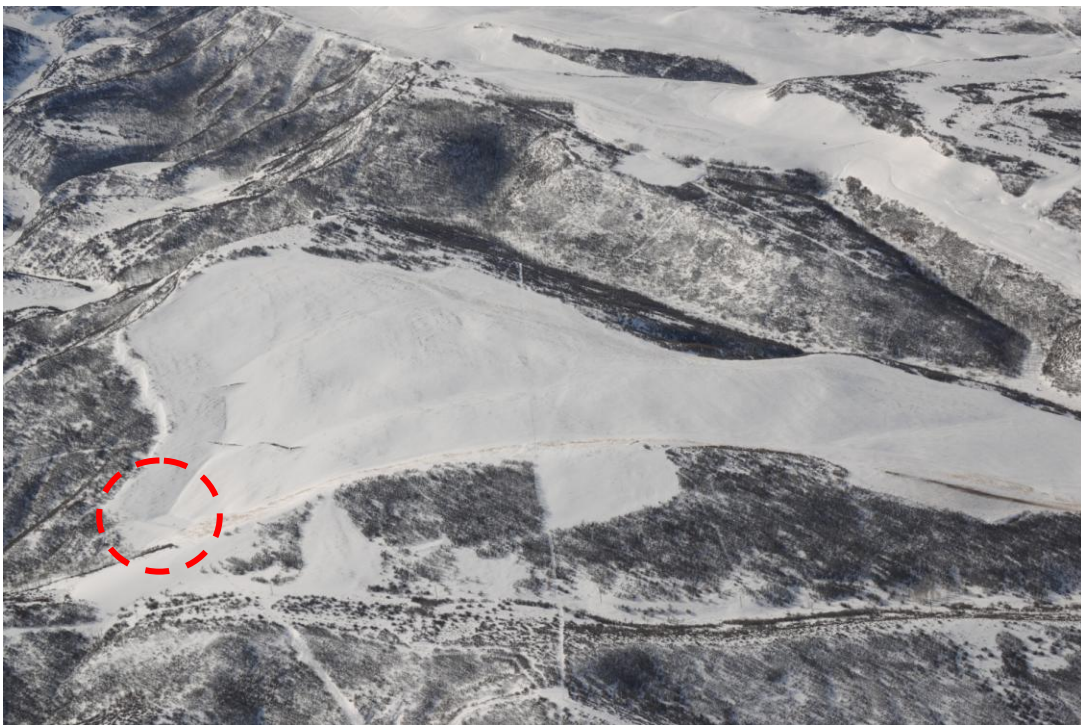
Head Pit area, Pond 011A visible
