COLORADO DIVISION OF RECLAMATION, MINING AND SAFETY COAL PROGRAM INSPECTION REPORT

Permit Number: C-1980-007 Mine Name: West Elk Mine Operator: Mountain Coal Company, LLC Operator Address: Ms Kathleen G Welt P.O. Box 591 Somerset, CO 81434	County: Delta, Gunnison Operation Type: Underground Permit Status: Active Ownership: Federal
Operator Representative Present: Jessica Loveland	
Operator Representative Signature: (Field Issuance Only) N/A – Report Issued from Denver Office

Inspection Start Date: February 14, 2013 Inspection Start Time: 08:00 Inspection End Date: February 14, 2013 Inspection End Time: 13:00	Inspection Type: Coal Partial Inspection Inspection Reason: Normal I&E Program Weather: Snowing
Joint Inspection Agency: None	Joint Inspection Contacts: None
Post Inspection Agency: None	Post Inspection Contacts: None
Inspector(s): James R. Stark	Inspector's Signature:

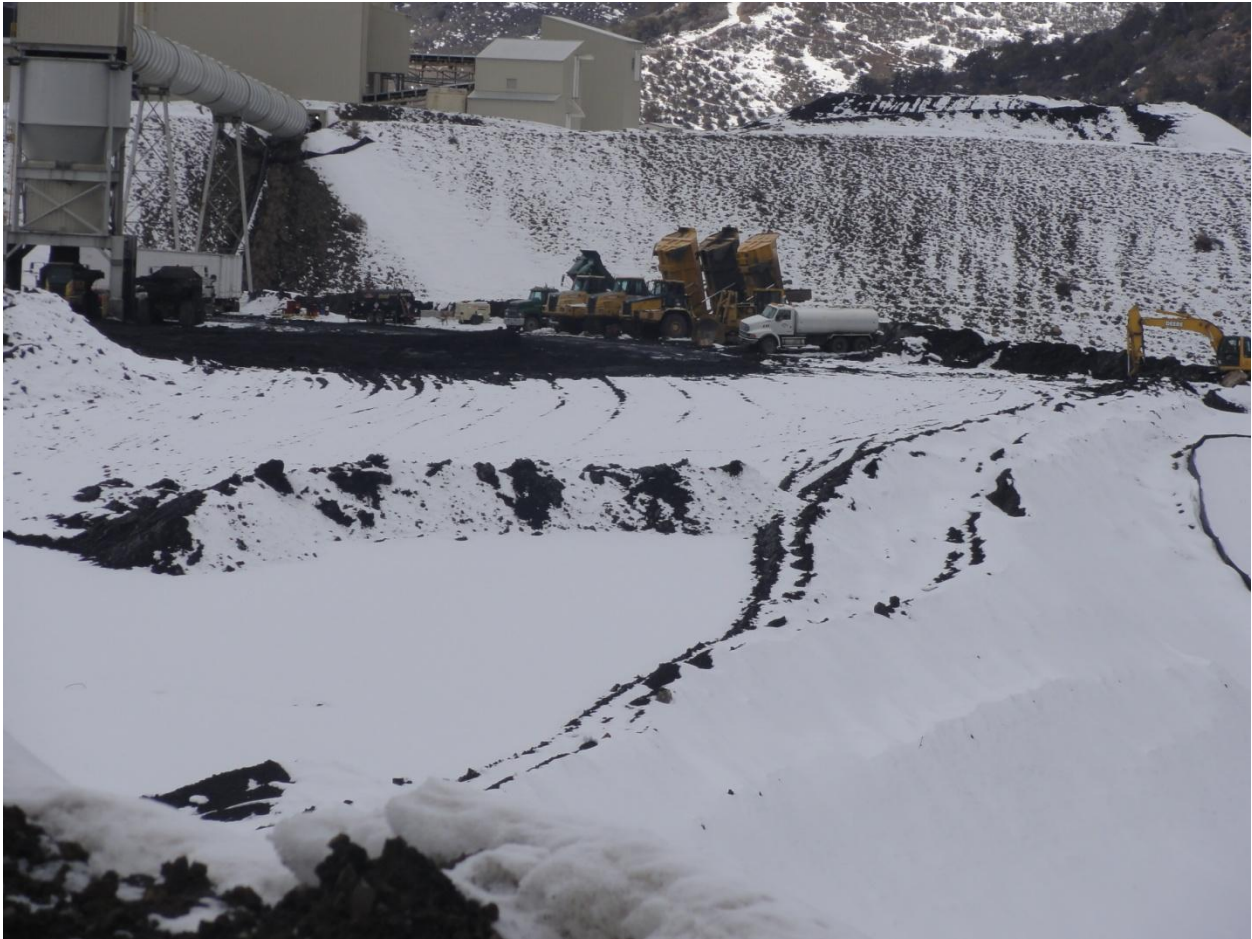
- The LRP was covered with snow but appeared to remain stable at the time of the inspection. There were no erosional problems noted on the LRP.
- The RPE was well graded and stable at the time of the inspection. The pile appeared to have positive drainage as there was no water pooled on the surface of the pile. The pile was not active at the time of the inspection. There were several excavators and articulated trucks parked on the pile.

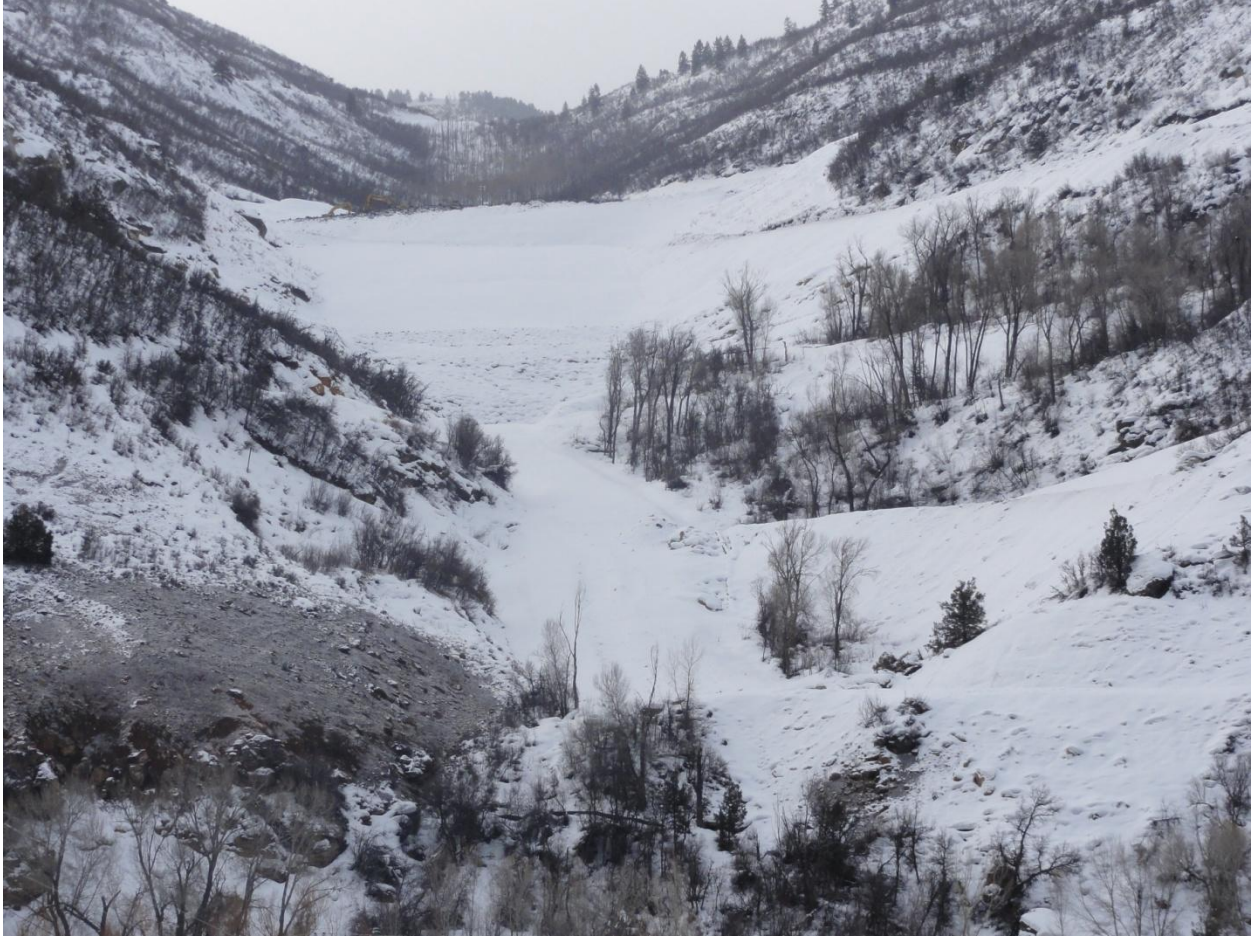
- The operator was actively hauling, dumping and spreading refuse on the RPEE at the time of the inspection. They are still working on the third lift of the pile. The pile was a bit muddy and sloppy due to melting snow but appeared to be stable and have positive drainage, with no visible water pooling on the surface of the pile. There was a large pile of colluvial material in the center of the lift that was being worked into the refuse and compacted. Stability designs allow for refuse to be placed on the colluvial material but some of this material needs to be removed to allow for the pile to have its required capacity. While most of this material is being moved to the subsoil stockpiles, some of it is being worked into the refuse. Current refuse pile compaction testing shows that the minimum 90% compaction requirement is being met even with the inclusion of this colluvial material.

RPEE rock buttress and colluvial fill – taken from across Colorado Highway 133

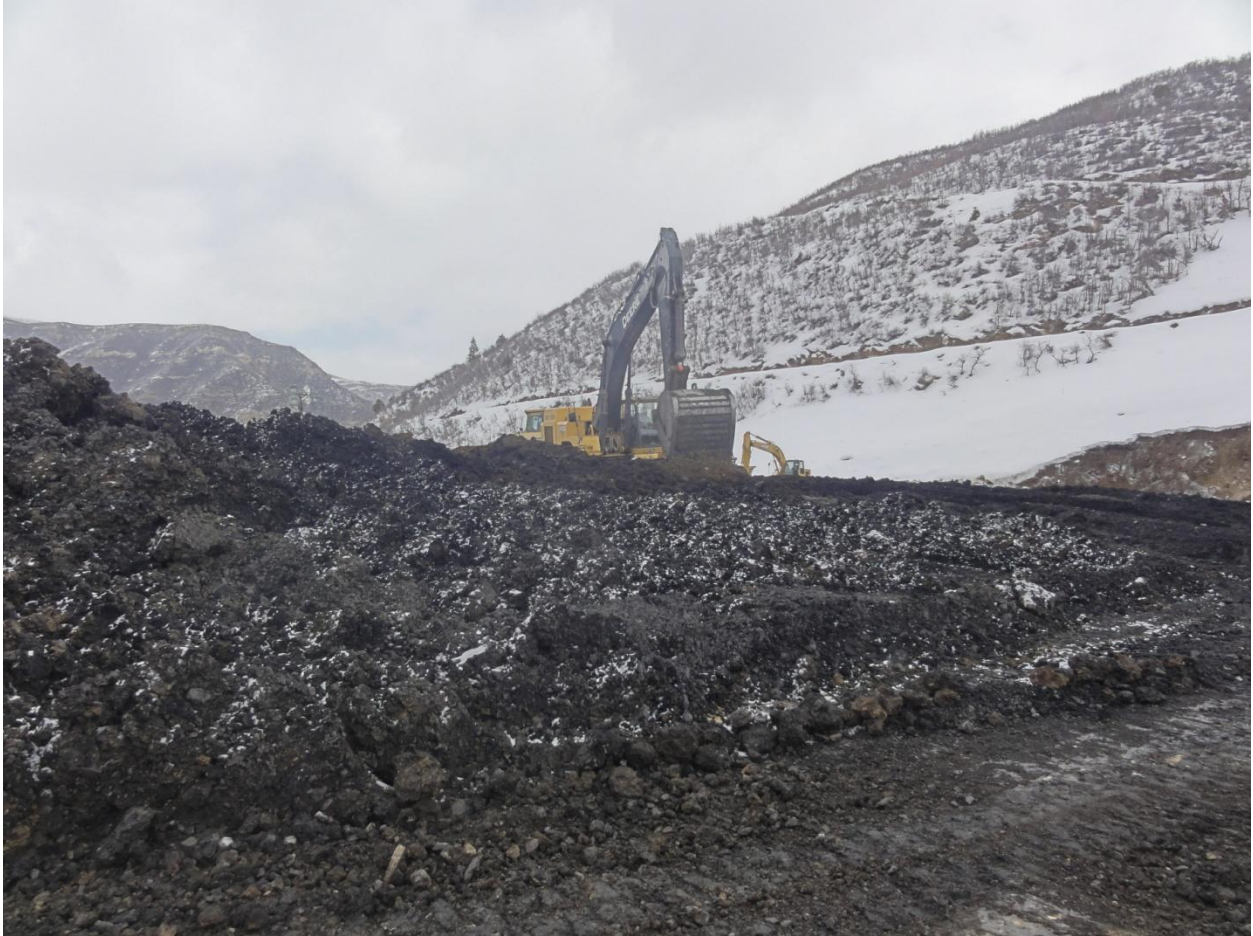
Active lift of RPEE – with colluvial material pile in foreground

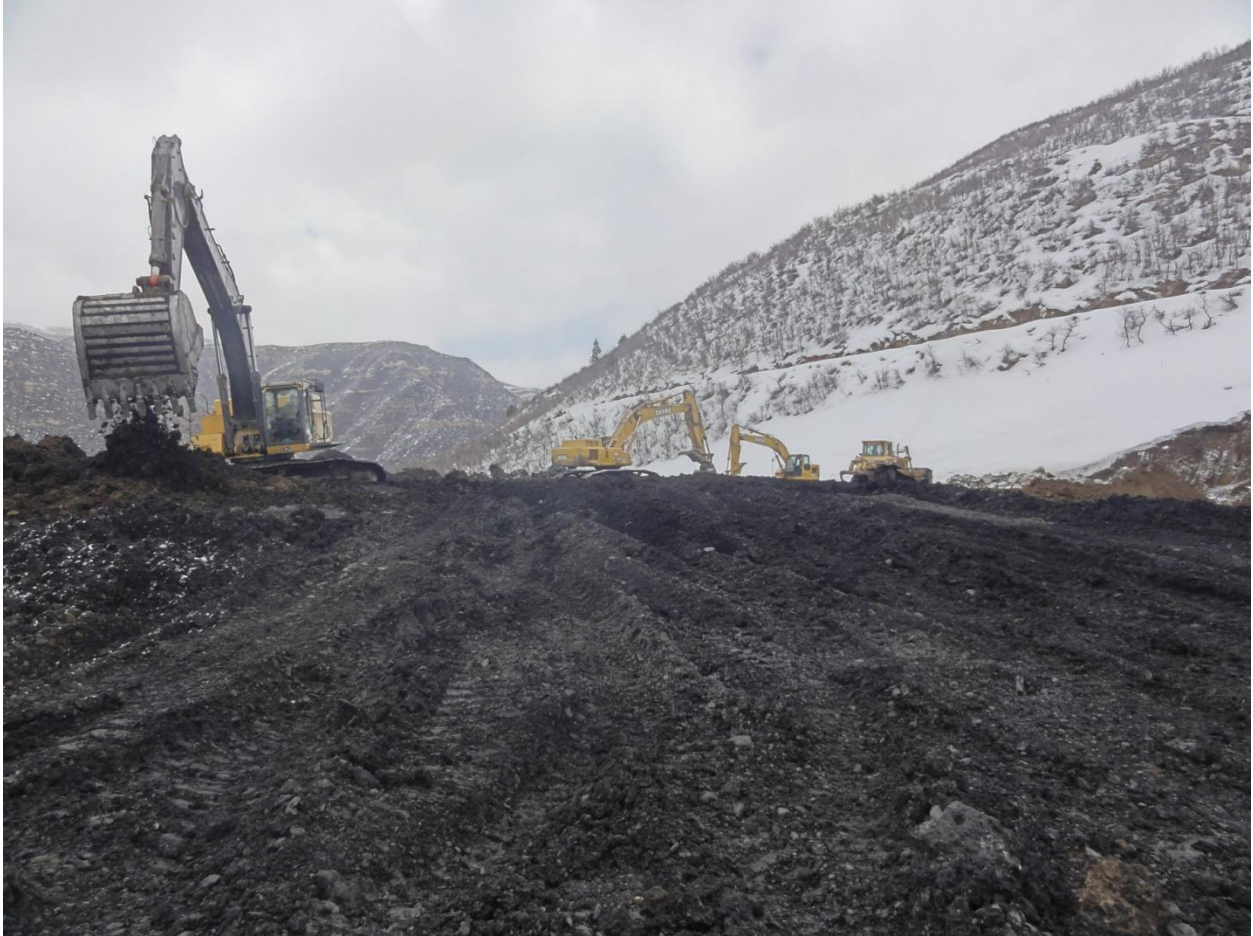
RPEE active lift

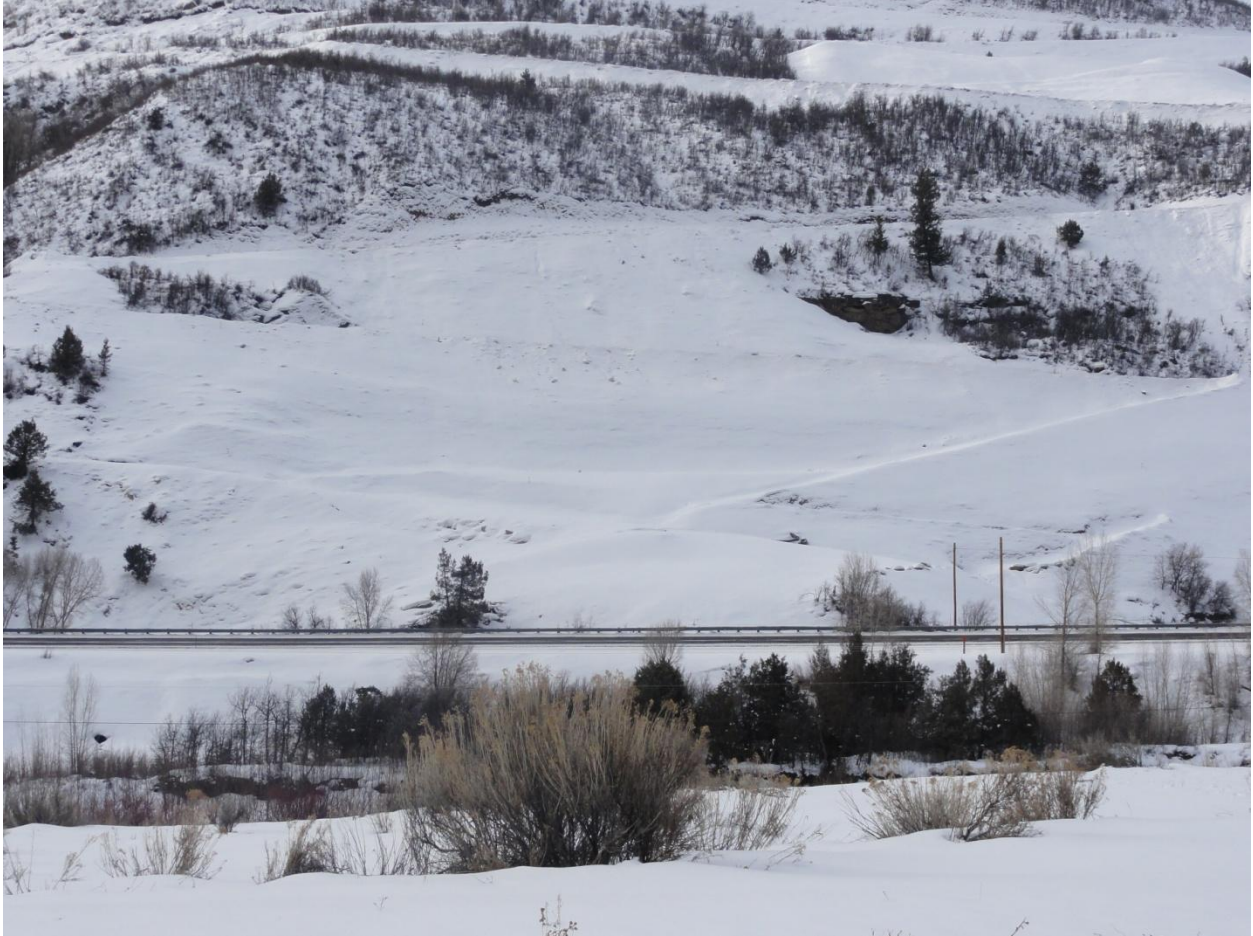
- The HR-1 slide remediation area was covered with snow but appeared to remain stable at the time of the inspection. There was no sliding or movement observed. West Elk has installed a series of mirrors on the slide area and continues to actively monitor the area.

HR-1 slide area – taken from across Colorado Highway 133

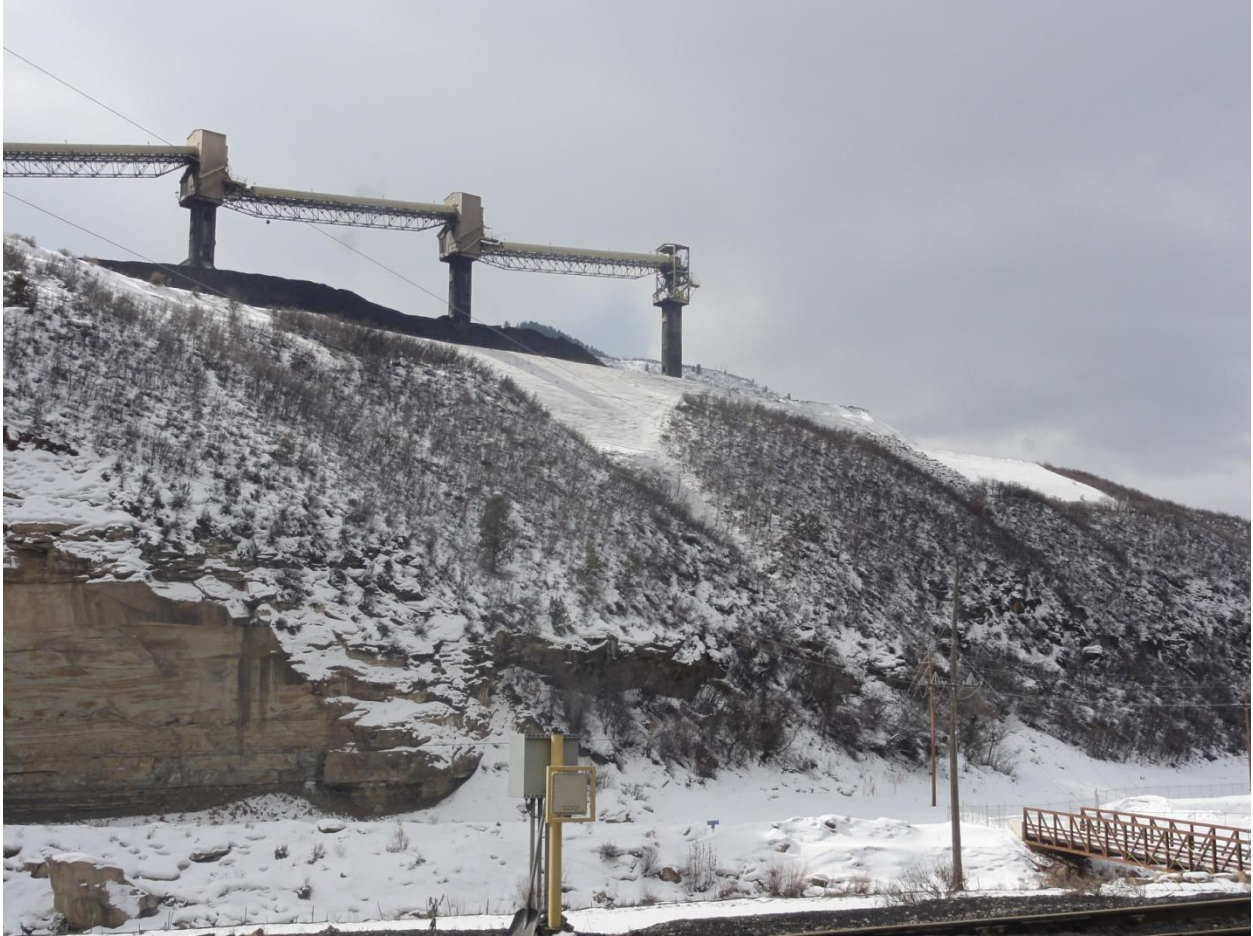
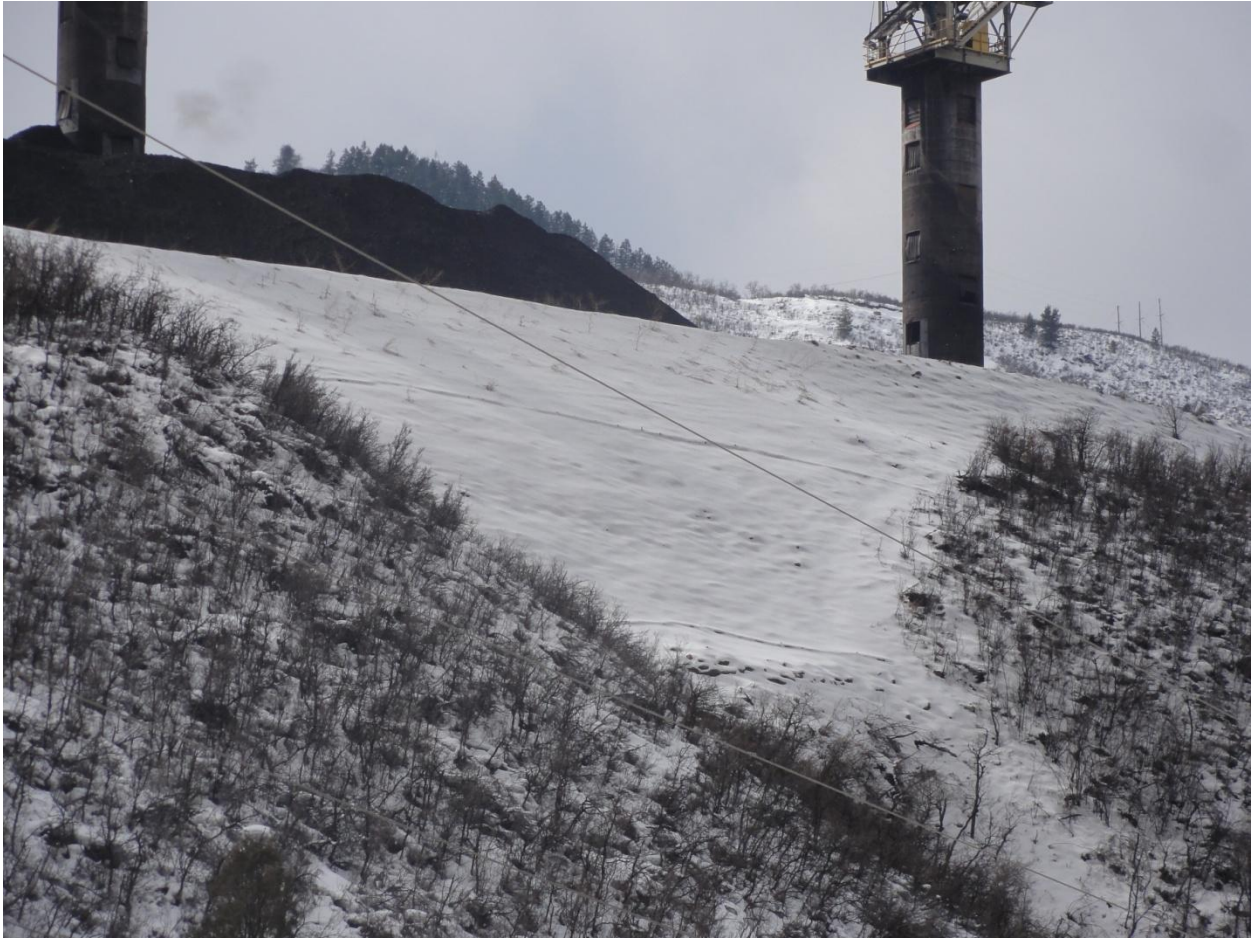
SLIDES and DAMAGE (cont.) - The ST-02 slide area was observed from across Colorado Highway 133 (at the loadout). The area appeared to be stable, with no sliding or movement observed.

ST-02 slide area – taken from loadout
