COLORADO DIVISION OF RECLAMATION, MINING AND SAFETY COAL PROGRAM INSPECTION REPORT

Permit Number: C-1983-059 Mine Name: Terror Creek Loadout Operator: Terror Creek LLC Operator Address: Mr James A Kiger P.O. Box 535 3737 Highway 133 Somerset, CO 81434	County: Delta Operation Type: Loadout Permit Status: Active Ownership: Private
	Operator Representative Present: Jim Kiger
Operator Representative Signature: (Field Issuance Only) N/A – Report Issued from Denver Office

Inspection Start Date: February 14, 2013 Inspection Start Time: 13:15 Inspection End Date: February 14, 2013 Inspection End Time: 15:00	Inspection Type: Coal Partial Inspection Inspection Reason: Normal I&E Program Weather: Cloudy
Joint Inspection Agency: None	Joint Inspection Contacts: None
Post Inspection Agency: None	Post Inspection Contacts: None
Inspector(s): James R. Stark	Inspector's Signature:

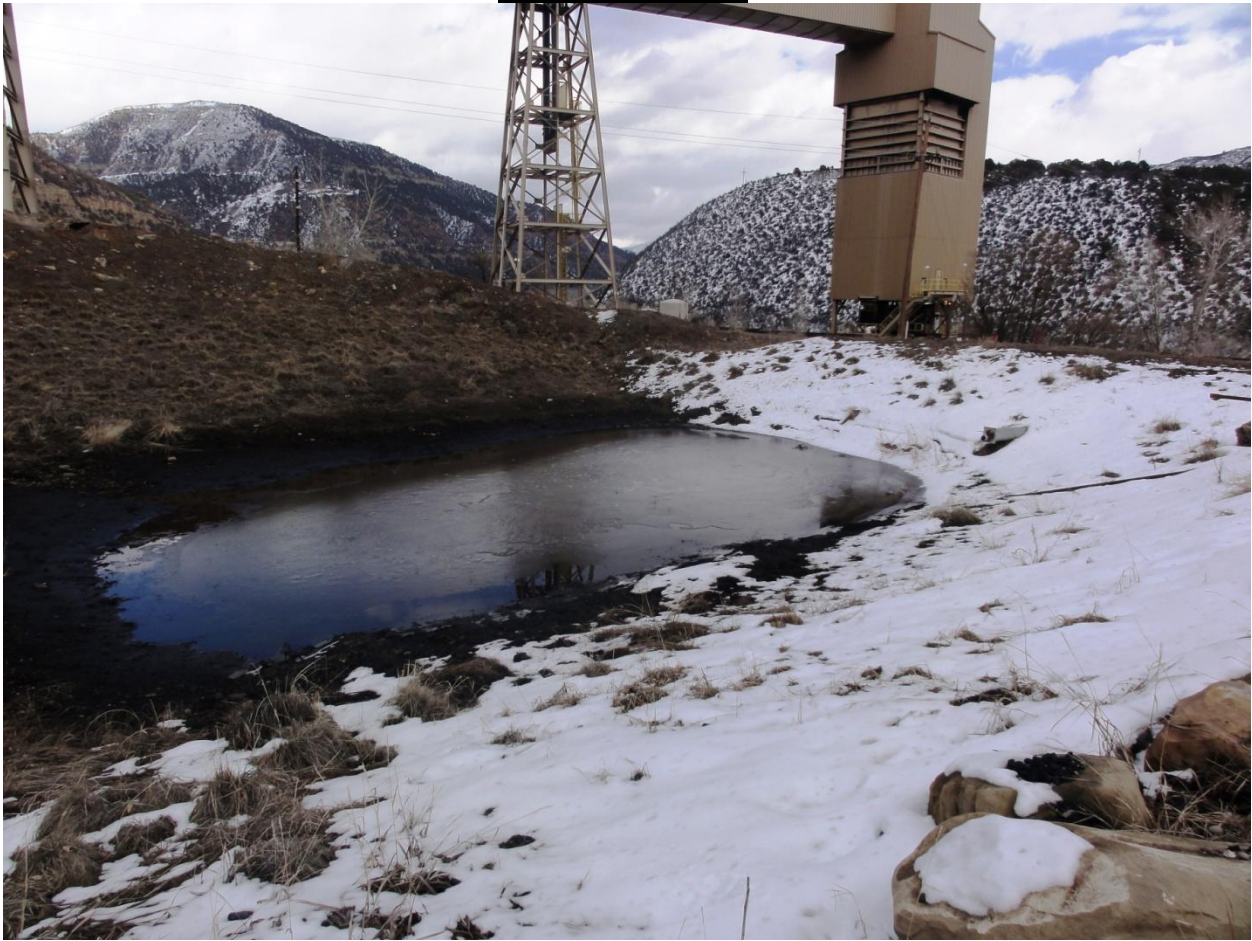
Sediment Pond

- The sediment pond contained a small amount of water and was not discharging at the time of the inspection. The pond embankment was partially covered with snow but was well vegetated and stable. No erosional problems were noted on the pond embankment.

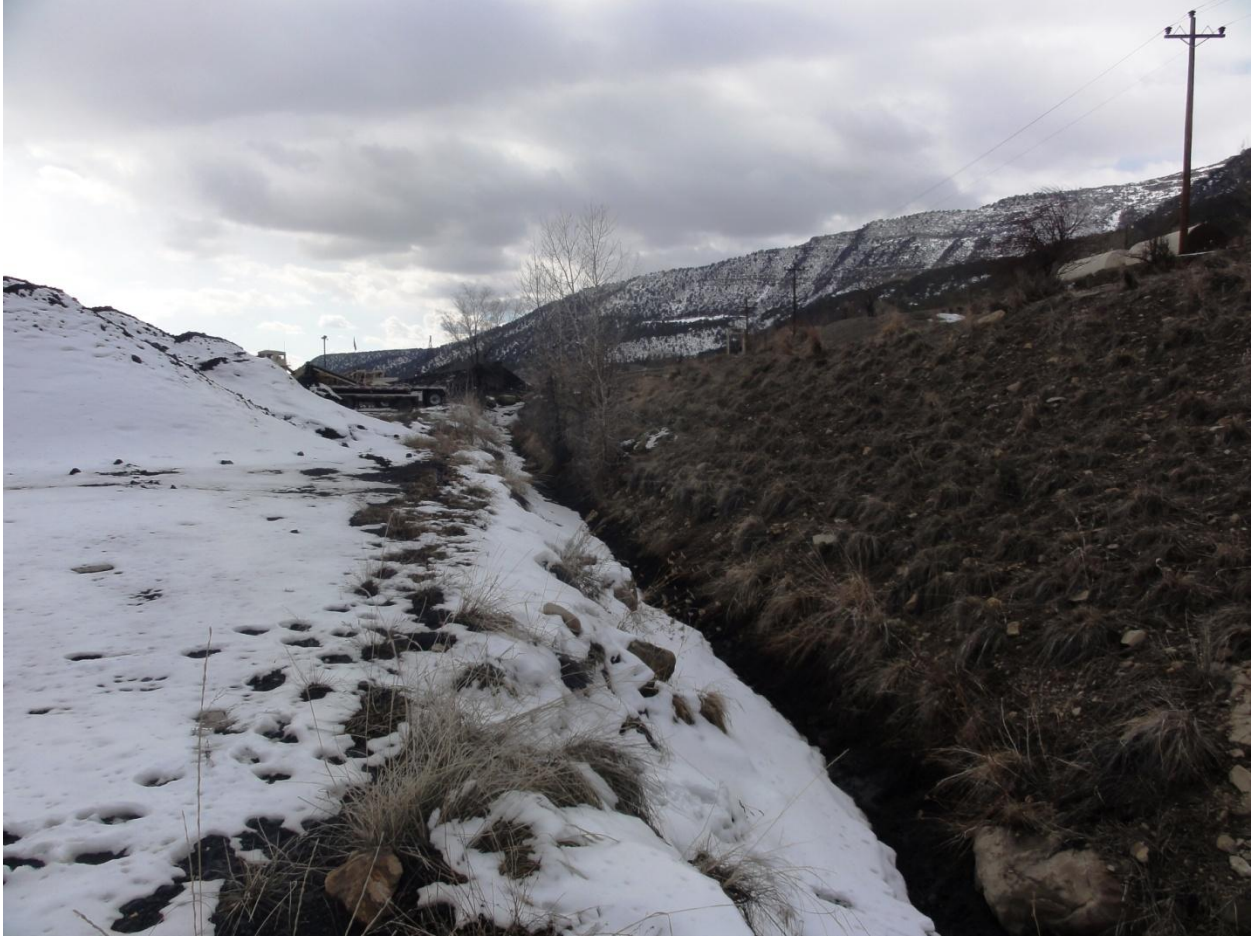
Roadside ditch – looking from sediment pond towards haul road

- The roadside ditch that flows into the sediment pond contained a small amount of standing water but was not flowing at the time of the inspection. The ditch was clean and stable and no erosional problems were noted.

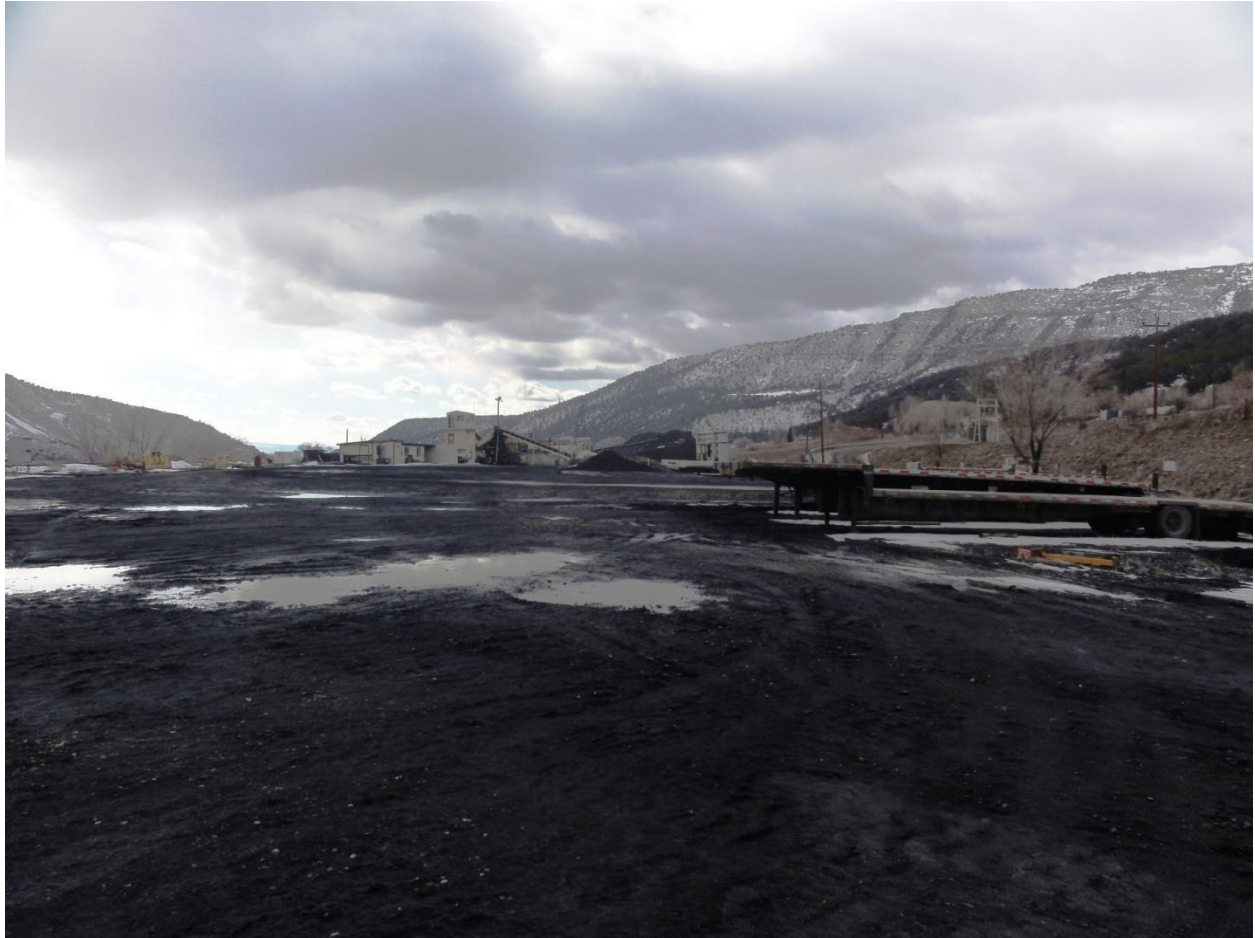
Facilities area, coal processing facility and coal stockpiles

- The entire facilities area was wet and muddy from the melting snow. The area was still stable and in good condition.
- The fuel island area was in good condition at the time of the inspection. There was no sign of any spilled fuel.
- The loadout structure was stable at the time of the inspection.
- The coal crushing and stacking facility was operational at the time of the inspection. The large stockpile of raw coal that was by the truck dump is basically gone. The lump, stoker and coal fines piles were all fairly large.

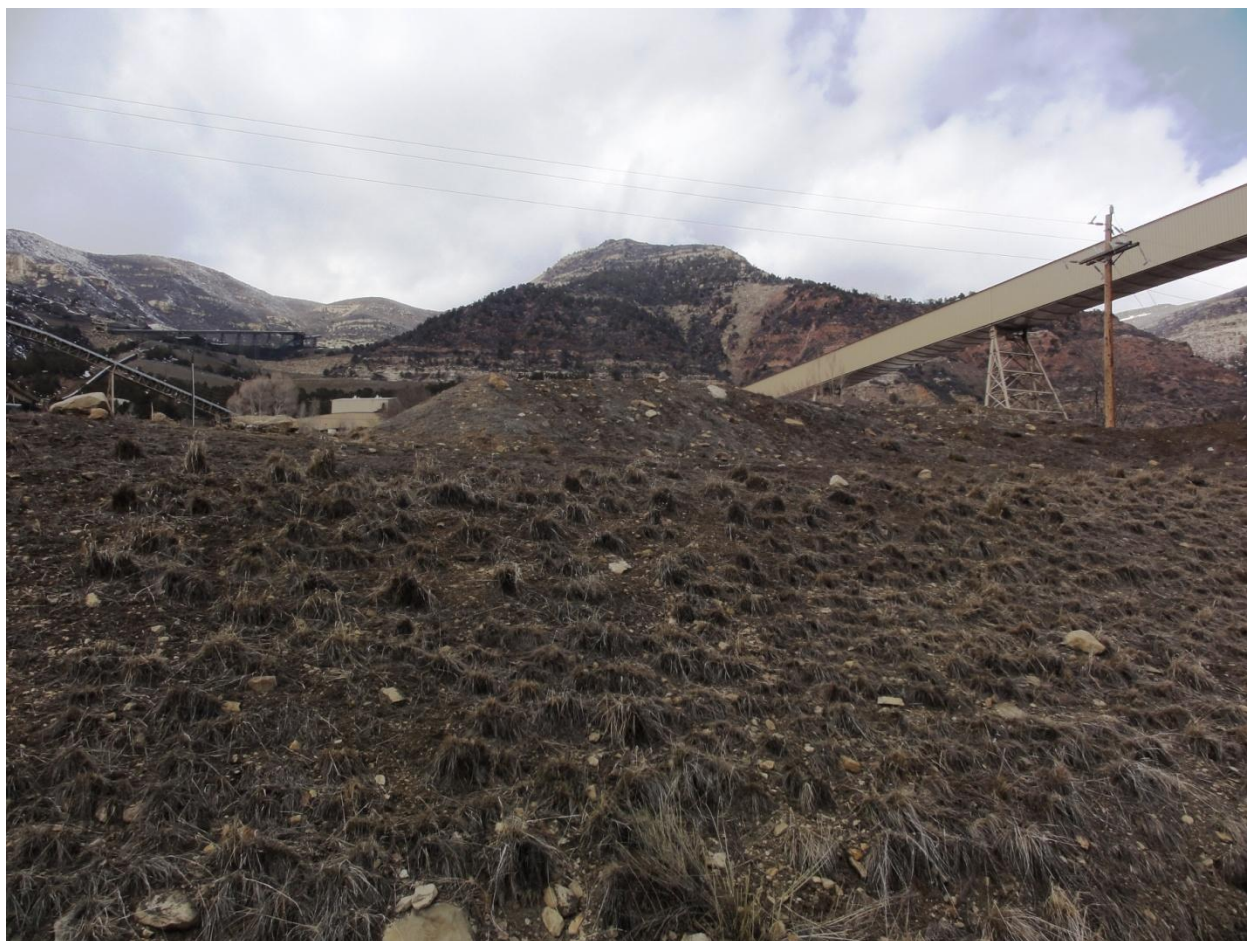
Topsoil stockpile by sediment pond

- The topsoil stockpile by the sediment pond was well vegetated and stable and no erosional problems were noted at the time of the inspection. Last fall Jim Kiger sprayed the top part of the pile with Round-Up to try to kill the cheatgrass infestation. We will see if this worked during the spring or early summer. If not, a more rigorous weed spraying plan will need to be instituted.
