**COLORADO DIVISION OF RECLAMATION, MINING AND SAFETY
COAL PROGRAM INSPECTION REPORT**

Permit Number: C-1991-078 Mine Name: Hamilton Mine Operator: Honeywood Coal Company Operator Address: Mr. Johnny Rich 2120 Crestmoor Road Suite 3020 Nashville, TN 37215	County: Montrose Operation Type: Surface Permit Status: Permanent Cessation Ownership: Private
	Operator Representative Present: None
Operator Representative Signature: (Field Issuance Only)

Inspection Start Date: February 19, 2013 Inspection Start Time: 13:55 Inspection End Date: February 19, 2013 Inspection End Time: 14:00	Inspection Type: Aerial Inspection Inspection Reason: Normal I&E Program Weather: Clear
Joint Inspection Agency: None	Joint Inspection Contacts:
Post Inspection Agency: None	Post Inspection Contacts:
Inspector(s): Jared L. Ebert Harry B. Ranney	Inspector's Signature:

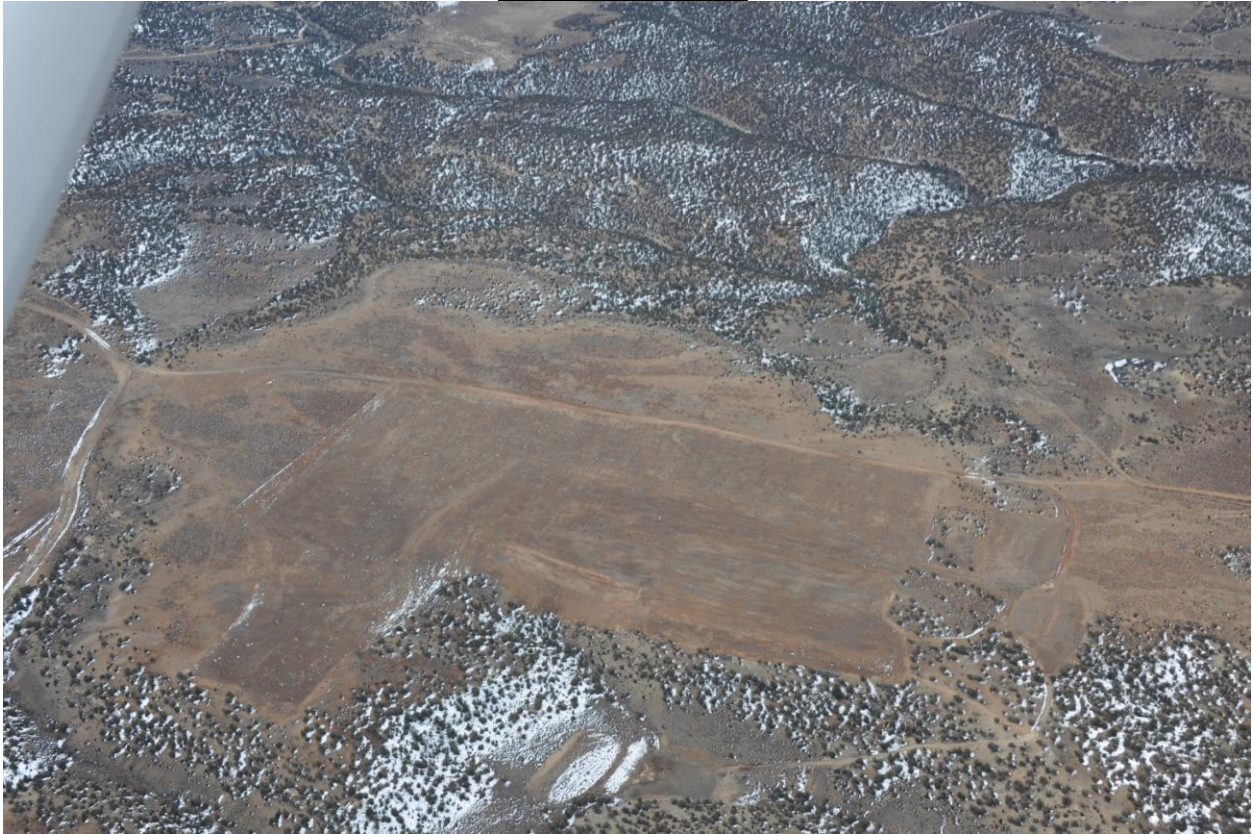
Pond B appeared dry and the embankment stable.

Mine Area No. 1 was visible in the aerial photographs. Overall the reclaimed affected land appears to blend into the surrounding area. The Division did not observe large bare spots or erosion features. The area appears stable.

The Topsoil Stockpile No. 1 area and the former Pond A area are also visible, not problems were noted. Similar to Mine Area No. 1, these areas blend into the surround area and they appear stable.

Mine Area No. 1, Topsoil Stockpile No. 1 and Pond A area. Pond B is also visible.

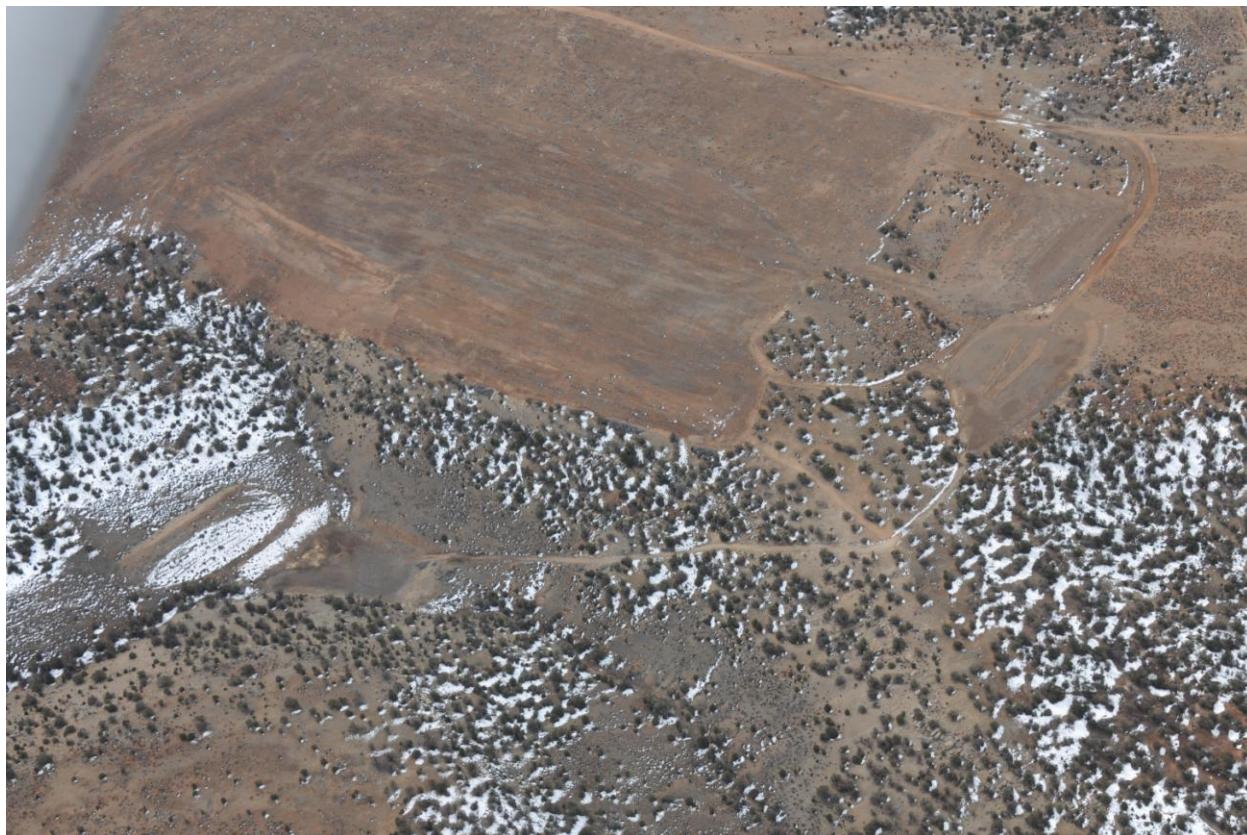
Topsoil Stockpile No. 1 and Pond A area. Pond B is also visible.
