COLORADO DIVISION OF RECLAMATION, MINING AND SAFETY COAL PROGRAM INSPECTION REPORT

| Permit Number: C-1981-022 Mine Name: Elk Creek Mine Operator: Oxbow Mining, LLC Operator Address: Mr. Jim Kiger P.O. Box 535 3737 Highway 133 Somerset, CO 81434 | County: Delta, Gunnison Operation Type: Underground Permit Status: Active Ownership: Federal |

| Inspection Start Date: February 20, 2013 Inspection Start Time: 08:00 Inspection End Date: February 20, 2013 Inspection End Time: 10:30 | | Inspection Type: Coal Partial Inspection Inspection Reason: Normal I&E Program Weather: Cloudy | |

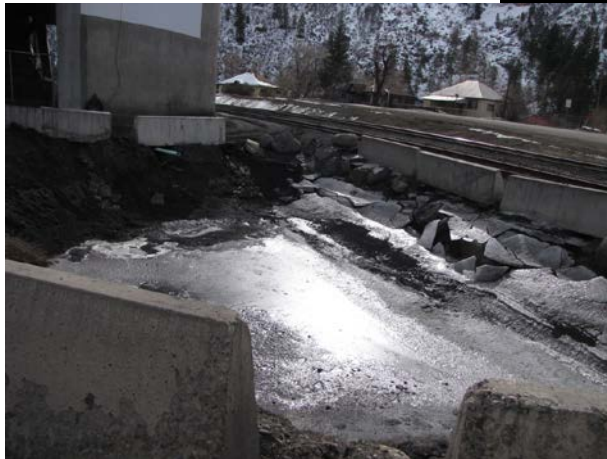
Ponds A1, B and D contained water and none were discharging (photo 1). The banks appeared to be stable. Ponds C and E were inaccessible due to poor road conditions and snow. The East Yard Pond had some

Photo 1 – Pond A1

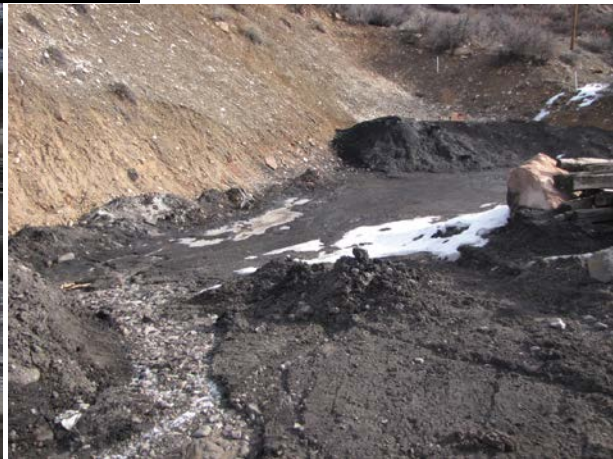
stacked snow but did not contain water (photo 2). The sediment trap west of the bath house contained some water but was clear of sediment (photo 3).

Photo 2 – East Yard Pond

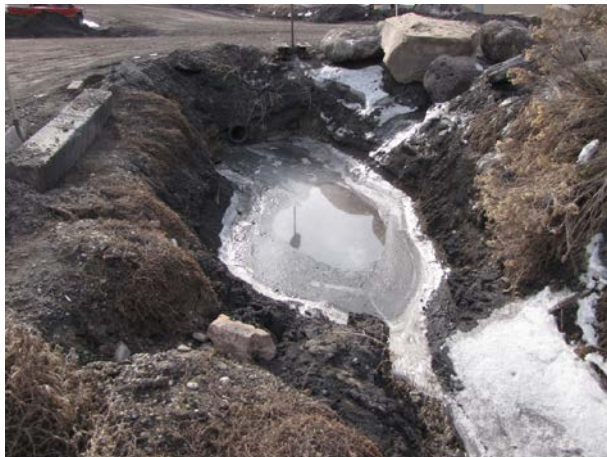
Photo 3 – Sediment Trap East of Bath House

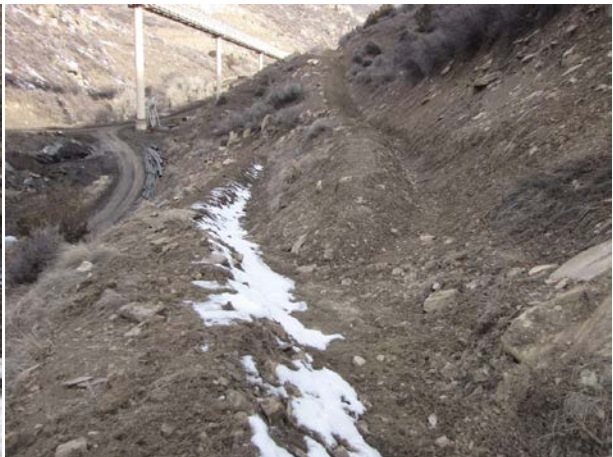
The clean water diversion ditch above and east of Pond D was clean and well defined (photo 4).

Photo 4 – Clean Water Diversion Above Pond D

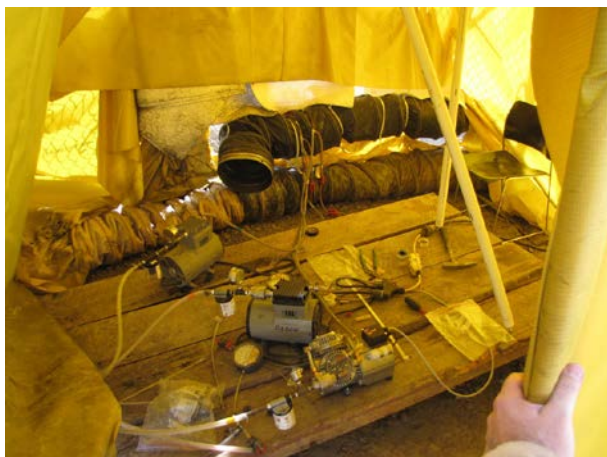
The underground mine atmosphere was being monitored by MSHA. The monitoring equipment at the Bear Creek Fansite consisted of air pumps in a heated tent (photo 5), diesel fuel tank, diesel heater, generator (photo 6) and tubing/hoses running from the monitoring tent down the airshaft (photo 7). The Elk Creek Fansite had the monitoring tubing/hoses set up but not the additional equipment (photo 8).

Photo 5 – Heated Tent with Air Pumps

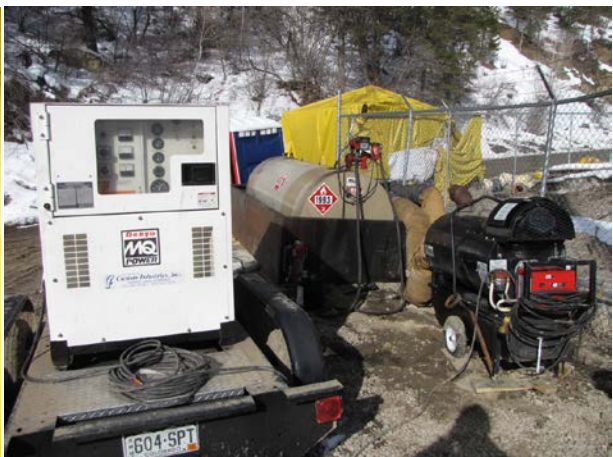
Photo 6 – Generator, Diesel Tank & Heater

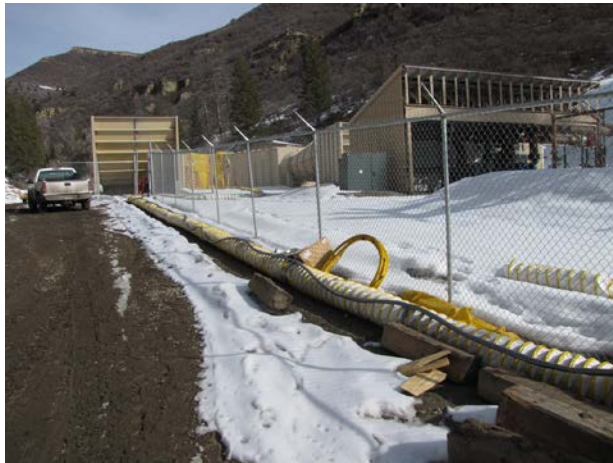
Photo 7–Monitoring Tubes - Bear Creek Fansite Photo 8–Monitoring Tubes - Elk Creek Fansite

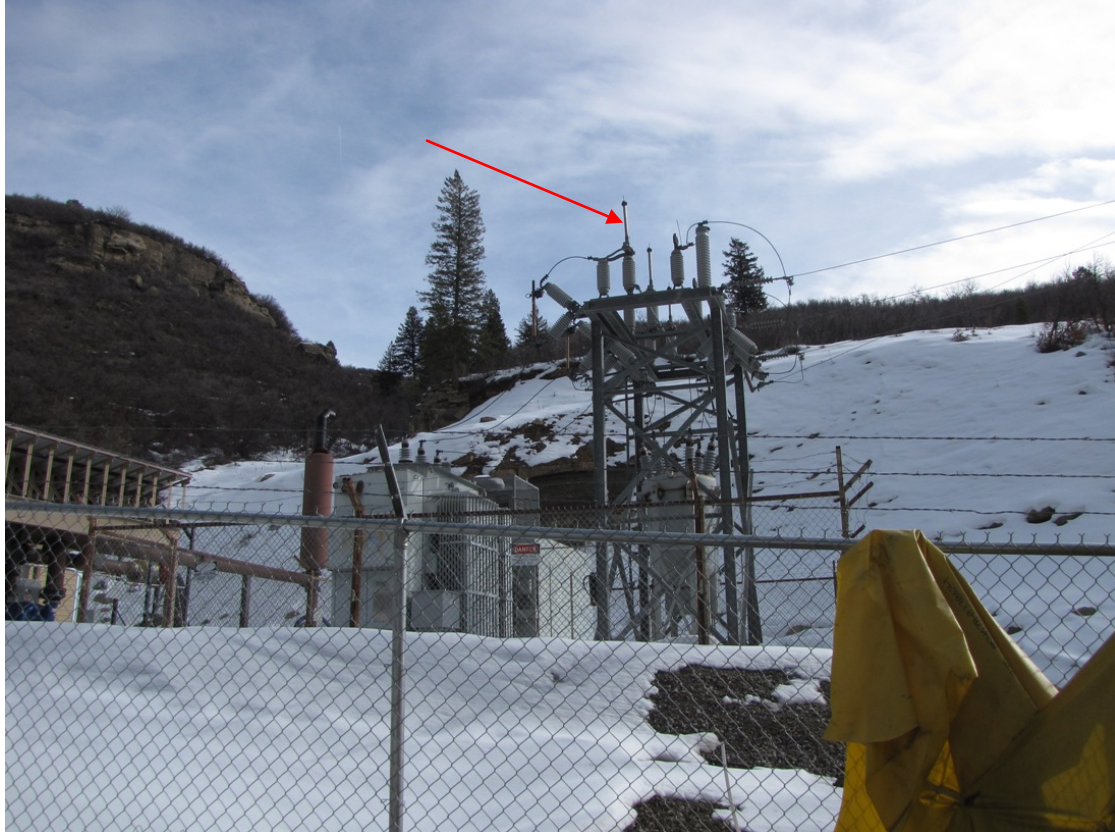
It appeared that the switches on the Bear Creek fansite substation were open, disconnecting the power source to the site (photo 9). The fan was not running during the inspection.

Photo 9 – Open Switches at the Bear Creek Sub-Station
