COLORADO DIVISION OF RECLAMATION, MINING AND SAFETY COAL PROGRAM INSPECTION REPORT

Permit Number: C-1981-038 Mine Name: Bowie No. 1 Mine Operator: Bowie Resources, LLC Operator Address: Mr. Basil Bear P.O. Box 1488 Paonia, CO 81428	County: Delta Operation Type: Underground Permit Status: Permanent Cessation Ownership: Federal
Operator Representative Present:	
Operator Representative Signature: (Field Issuance Only)

Inspection Start Date: February 20, 2013 Inspection Start Time: 14:30 Inspection End Date: February 20, 2013 Inspection End Time: 15:30	Inspection Type: Coal Partial Inspection Inspection Reason: Normal I&E Program Weather: Snowing
Joint Inspection Agency: None	Joint Inspection Contacts:
Post Inspection Agency: None	Post Inspection Contacts:
Inspector(s): Brock F. Bowles	Inspector's Signature:

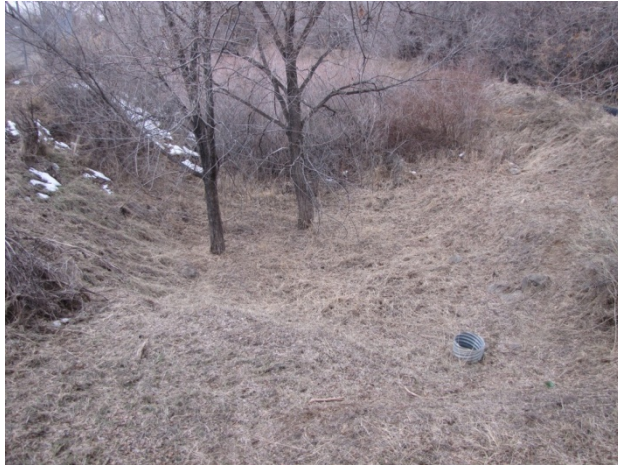
Photo 1 – Loadout Sediment Pond

The sedimentation pond at the loadout did not contain water. It appeared that the grass was recently cut on the east end of the pond (photo 1).

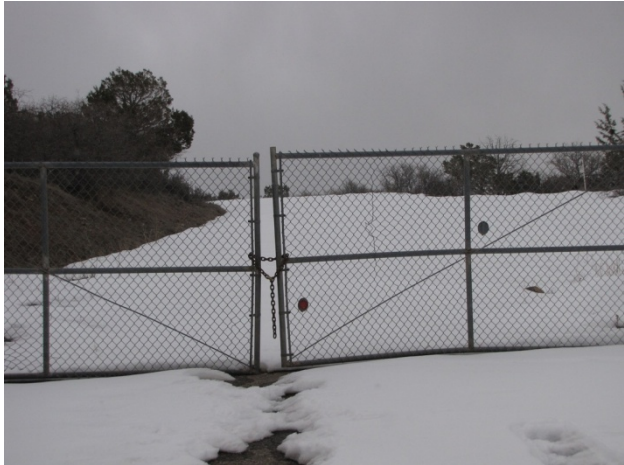
Photo 2 – East Mine Entrance

The entrance road to the East Mine was inaccessible due to snow (photo 2). The access road to the West Mine was not plowed (photo 3). The ROM Area was snow covered (photo 4). The roads in the loadout area were passable.
