COLORADO DIVISION OF RECLAMATION, MINING AND SAFETY COAL PROGRAM INSPECTION REPORT

Permit Number: C-1981-046 Mine Name: Sunlight Mine Operator: Garfield Energy Corporation Operator Address: X X, CO 11111	County: Garfield Operation Type: Underground Permit Status: Revoked Ownership: Private Operator Representative Present: None
Operator Representative Signature: (Field Issuance Only)

Inspection Start Date: February 19, 2013 Inspection Start Time: 13:30 Inspection End Date: February 19, 2013 Inspection End Time: 14:30		Inspection Type: Coal Complete Inspection Inspection Reason: Normal I&E Program Weather: Clear	
Joint Inspection Agency: None		Joint Inspection Contacts: 	
Post Inspection Agency: None		Post Inspection Contacts: 	
Inspector(s): Brock F. Bowles	Inspector's Signature:

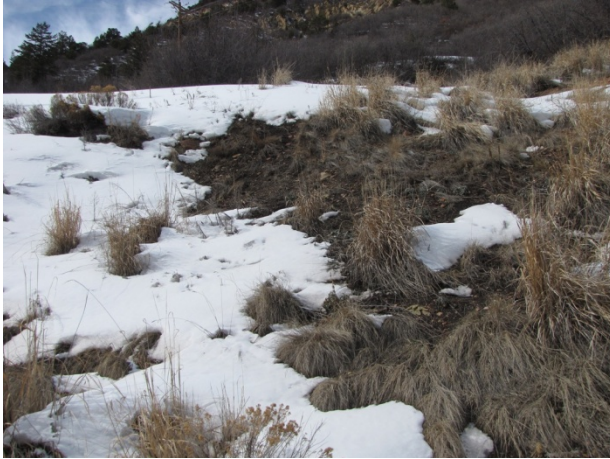
Photo 1 – Portal Area Backfill

The backfilled portal area was mostly snow covered but did not have signs of slumping or cracking (photo 1).

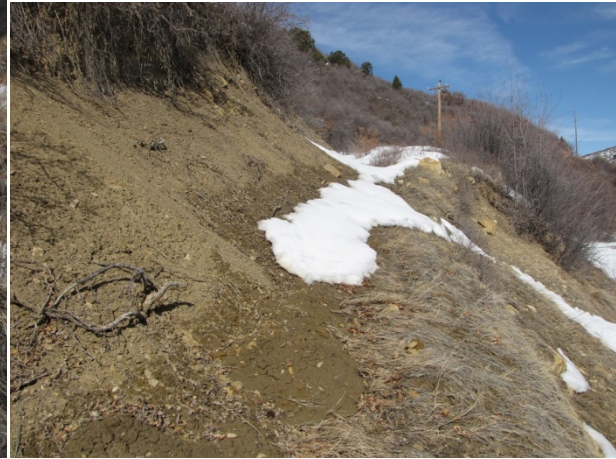
Photo 2 – Upper Clean Water Diversion Ditch

The upper bench clean water diversion ditch was filled with snow (photo 2).
