**COLORADO DIVISION OF RECLAMATION, MINING AND SAFETY**  
**MINERALS PROGRAM INSPECTION REPORT**  
**PHONE: (303) 866-3567**

<b>MINE NAME:</b> Otter Creek Pit	<b>MINE/PROSPECTING ID#:</b> M-2012-050	<b>MINERAL:</b> Gravel and sand	<b>COUNTY:</b> Mesa
<b>INSPECTION TYPE:</b> Preoperation Inspection	<b>INSPECTOR(S):</b> Travis H. Marshall	<b>INSP. DATE:</b> February 6, 2013	<b>INSP. TIME:</b> 14:00
<b>OPERATOR:</b> United Companies of Mesa County	<b>OPERATOR REPRESENTATIVE:</b> Jason Burkey and Brett Kerr	<b>TYPE OF OPERATION:</b> 112c - Construction Regular Operation

<b>REASON FOR INSPECTION:</b> Pre-operation Inspection	<b>BOND CALCULATION TYPE:</b> None	<b>BOND AMOUNT:</b> N/A
<b>DATE OF COMPLAINT:</b> NA	<b>POST INSP. CONTACTS:</b> None	<b>JOINT INSP. AGENCY:</b> None
<b>WEATHER:</b> Clear	<b>INSPECTOR'S SIGNATURE:</b>

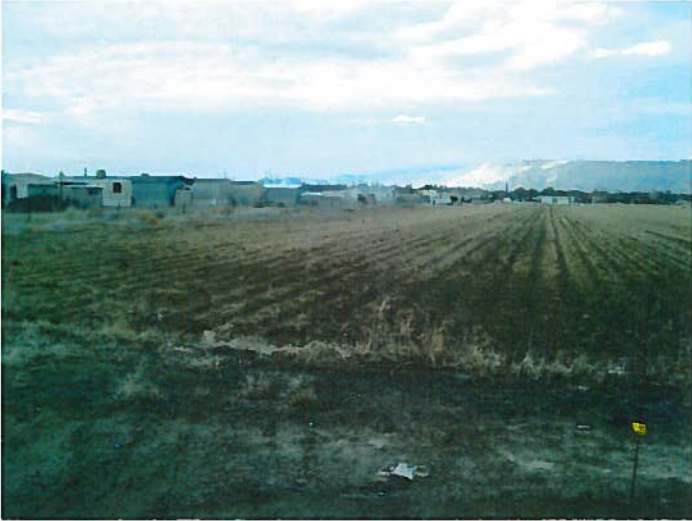
Looking north at irrigated pasture adjacent to 32 1/2 Road.

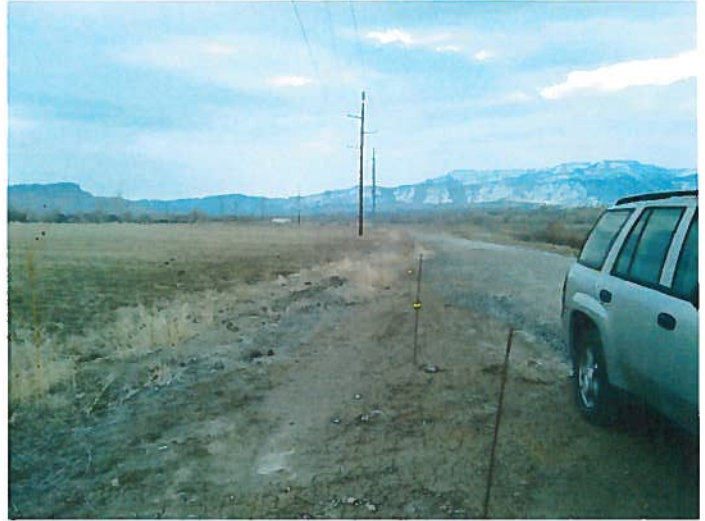
Looking east along southern permit boundary.

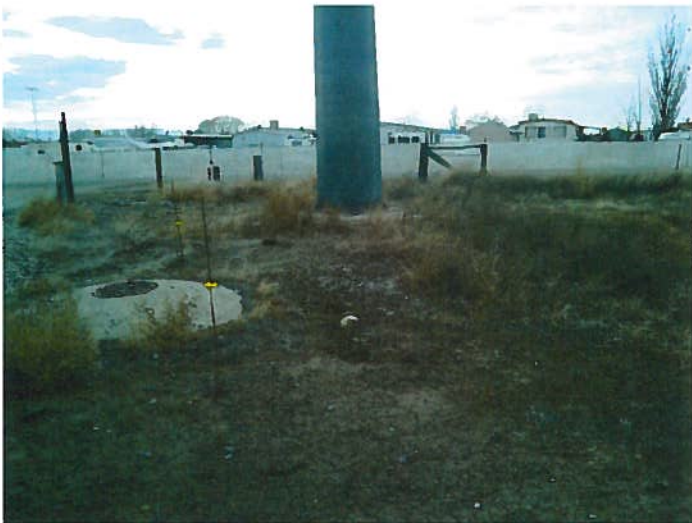
Power pole located at southwest corner of permit area.

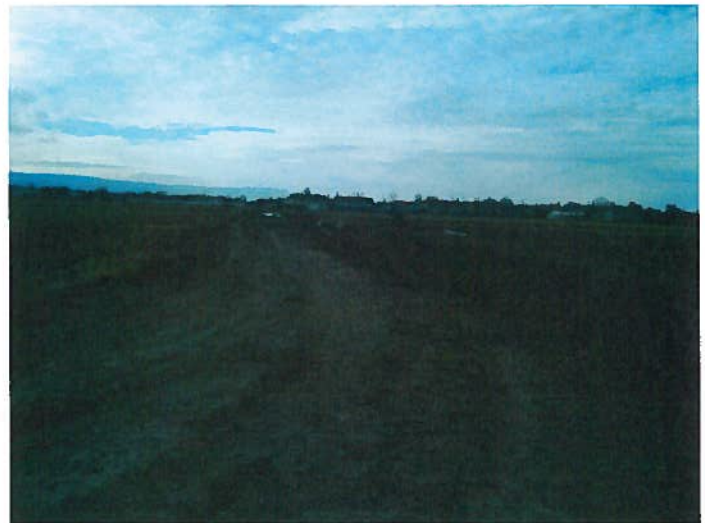
There are two major irrigation drainages adjacent to and within the proposed permit area. The Oberding Drainage is located within the permit area and the 33 Road Drainage is located along the eastern and southern outside of the proposed permit boundary. The Oberding Drainage will be removed as mining progresses and will not be reconstructed.

Oberding Drainage looking west.

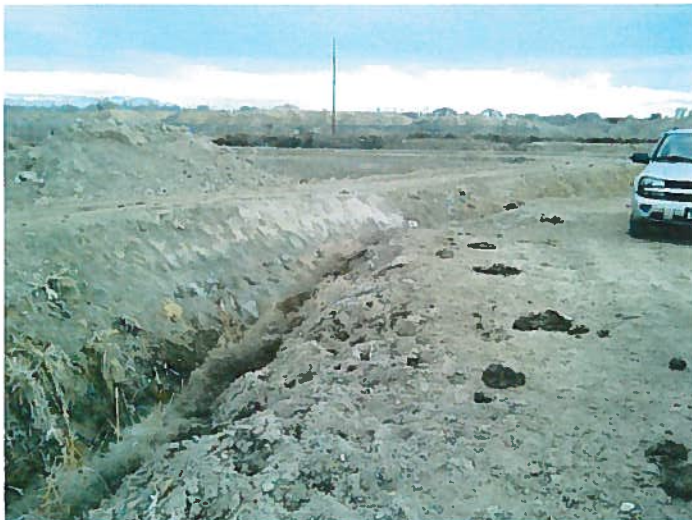
Oberding Drainage looking southeast.

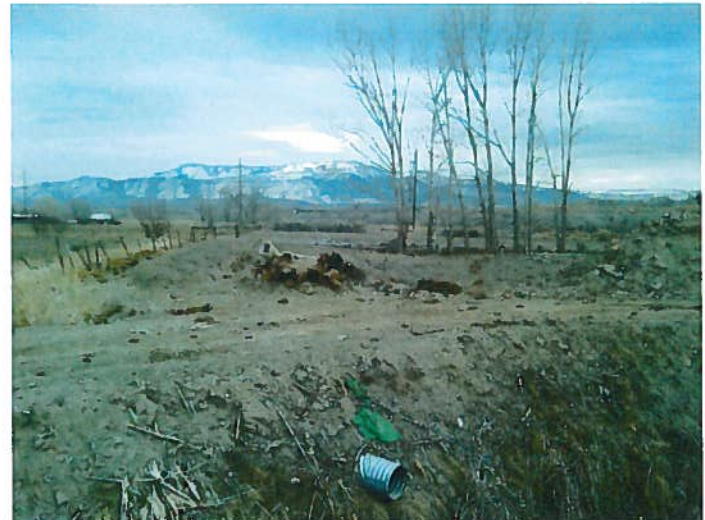
Looking east at proposed stockpile area.

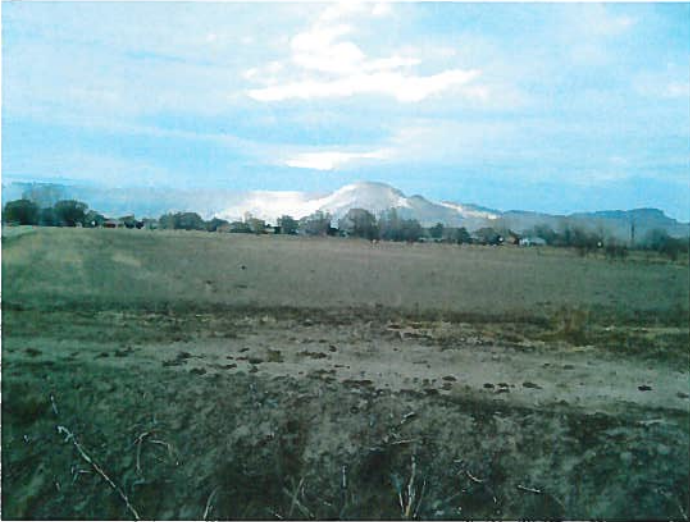
Looking north at pasture adjacent to eastern permit boundary.

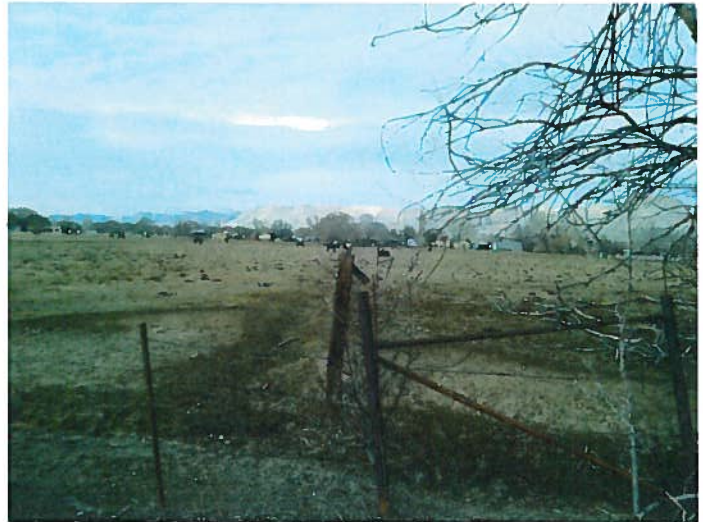
Looking north at pasture in the middle of the permit area.
