COLORADO DIVISION OF RECLAMATION, MINING AND SAFETY COAL PROGRAM INSPECTION REPORT

Permit Number: C-1981-018 Mine Name: Deserado Mine Operator: Blue Mountain Energy, Inc Operator Address: Mr Scott Wanstedt 3607 County Road 65 Rangely, CO 81648	County: Rio Blanco Operation Type: Underground Permit Status: Active Ownership: Federal
Operator Representative Present: Scott Wanstedt	
Operator Representative Signature: (Field Issuance Only)

Inspection Start Date: February 20, 2013 Inspection Start Time: 09:00 Inspection End Date: February 20, 2013 Inspection End Time: 14:00	Inspection Type: Coal Partial Inspection Inspection Reason: Normal I&E Program Weather: Cloudy	
Joint Inspection Agency: None	Joint Inspection Contacts:	
Post Inspection Agency: None	Post Inspection Contacts:	
Inspector(s): Leigh D. Simmons Daniel I. Hernandez	Inspector's Signature:

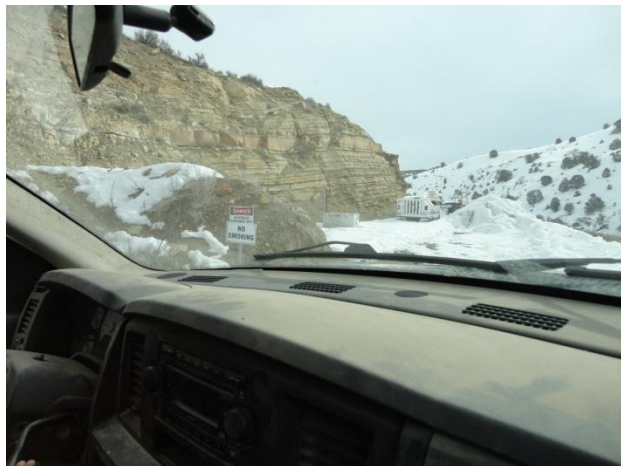
The explosives area was well signed and protected by an earth berm (see photo 1).

Photo 1: Explosives area

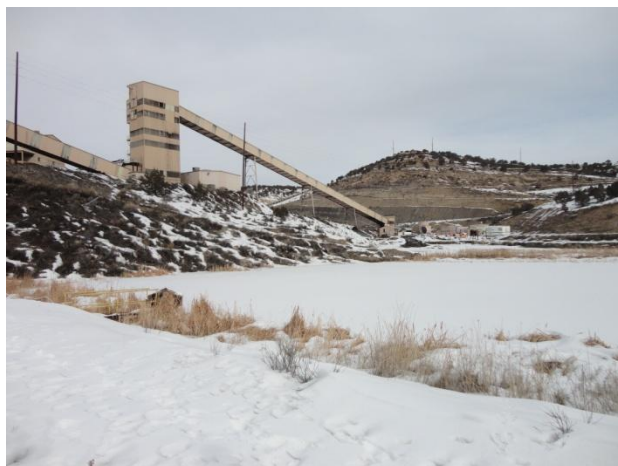
Pond DP1 is the ultimate collection point for all run-off from the facilities area and its discharge point has a NPDES/CDPS permit. The surface of the pond was frozen, and the discharge point of the primary spillway was buried beneath the snow and ice next to the large clean water culvert. The embankment appeared to be sound. Mr Wanstedt said that the pond would usually discharge 0-2 months per year. He said that there may have been one exceedence of a water quality limit, more than 10 years ago. The criteria in the permit for most metals are “report only” (see photos 2 & 3).

Photo 2: Pond DP1

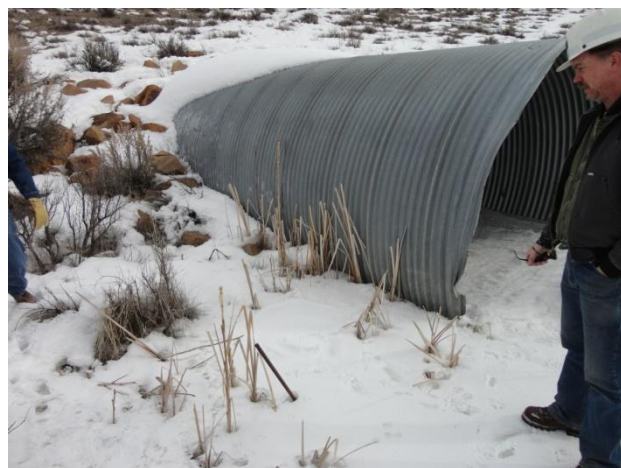
Photo 3: Buried discharge point of pond DP1

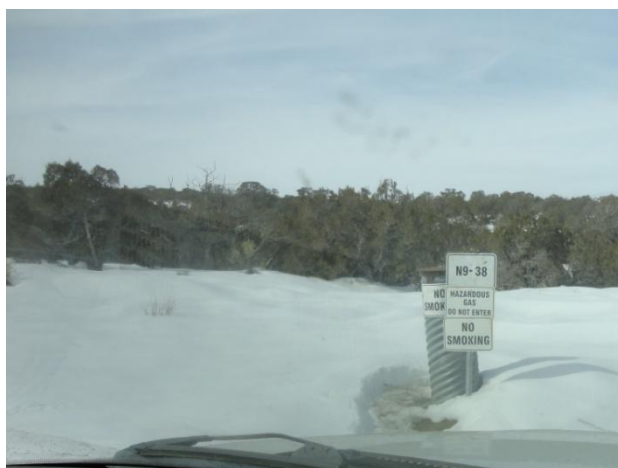
The mine operates under positive ventilation pressure; a single fan at the portal blows air into the mine workings which are vented through two vent shafts and one return shaft (the distinction between which was not clear). A benefit of this design is that the operator is able to pressurize the gob with N₂ (or another inert gas), to reduce the chance of a fire. Nitrogen injection boreholes allow N₂ to be injected through 3” hdpe pipe at 100psi, until the panel is sealed. The borehole N9-38 was inspected; no gas was being injected, but the borehole could also be used for sampling (see photo 4).

Photo 4: Nitrogen injection hole, N9-38

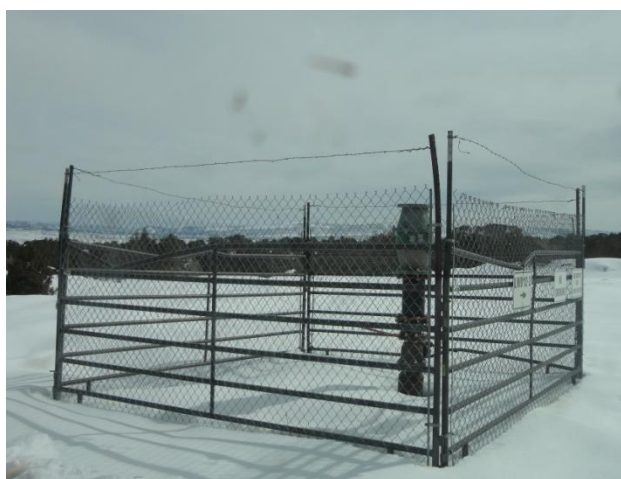
Another ventilation strategy employed at the Deserado Mine is the use of de-gas boreholes (see photo 5). These are drilled ahead of the longwall to 20-30’ of the coal seam. They are opened after the longwall has passed, and allow methane to vent to the atmosphere. After a panel has been mined and sealed, the boreholes are sealed and reclaimed. Mr Wanstedt said that Blue Mountain Energy hopes to eliminate the requirement for de-gas boreholes from their MSHA permit in the future since they (BME) feel that temporary halts in production to allow methane dispersal would be more economic, and sufficient. At the time of the inspection, data streams in the operations room showed 0.1% CH₄ at the longwall face (for reference, equipment must be de-energised at CH₄>2%, and the explosive range is 5-15%).

Photo 5: De-gas borehole, LWB 12-2

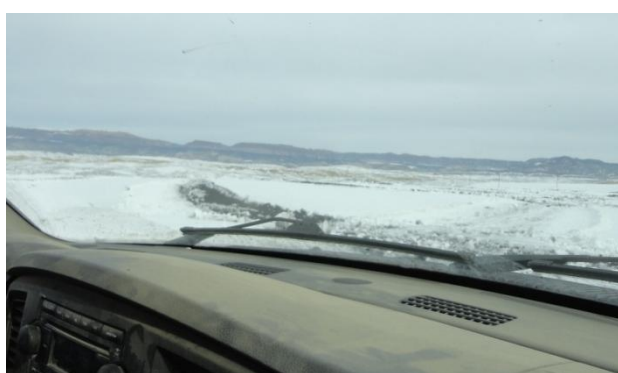
All coal moves through the site by conveyor, from the longwall face, all the way to the rail loadout 4 ½ miles away, but process waste from the wash plant is transported in loads of 40-95 tons, by truck, to the refuse pile (see photo 8). The refuse pile was snowcovered, with some tracks plowed in the snow on the surface to accelerate the spring melt (see photo 6). At the time of the inspection, waste from the wash plant was being deposited in a temporary storage pile at the refuse pile.

Photo 6: Refuse pile

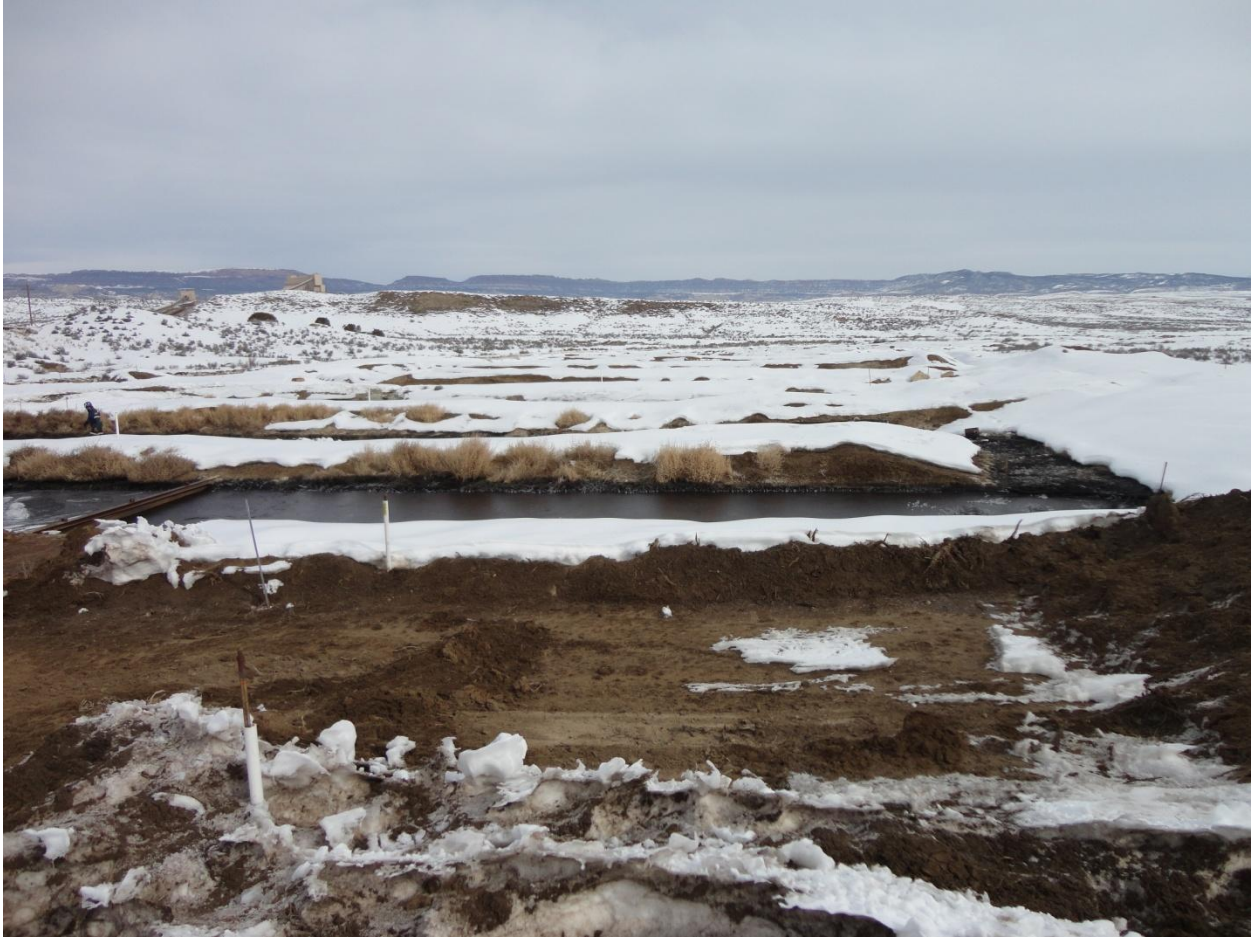
The mine was being de-watered at a rate of ~25 gallons per minute. Although several cells of the mine dewatering pond system were fairly full, the system had yet to discharge. The first cell held a lot of sediment, but was functioning as designed (see photo 7).

Photo 7: System of mine dewatering ponds, with “wetlands” area below

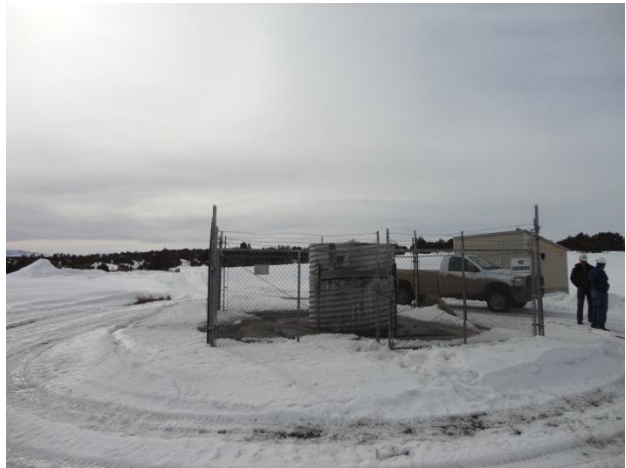
Photo 9: Vent shaft
