**COLORADO DIVISION OF RECLAMATION, MINING AND SAFETY  
COAL PROGRAM INSPECTION REPORT**

<b>Permit Number:</b> C-1981-025 <b>Mine Name:</b> North Thompson Creek Mine <b>Operator:</b> MINREC, Inc. <b>Operator Address:</b> Mr. James E Stover 2352 N 7th St, Ste B Grand Junction, CO 81501	<b>County:</b> Garfield <b>Operation Type:</b> Underground <b>Permit Status:</b> Inactive <b>Ownership:</b> Federal
	<b>Operator Representative Present:</b>  None
<b>Operator Representative Signature: (Field Issuance Only)</b>

<b>Inspection Start Date:</b> February 19, 2013 <b>Inspection Start Time:</b> 15:00 <b>Inspection End Date:</b> February 19, 2013 <b>Inspection End Time:</b> 16:00	<b>Inspection Type:</b> Coal Complete Inspection <b>Inspection Reason:</b> Normal I&E Program <b>Weather:</b> Cloudy
<b>Joint Inspection Agency:</b>  None	<b>Joint Inspection Contacts:</b>  
<b>Post Inspection Agency:</b>  None	<b>Post Inspection Contacts:</b>  
<b>Inspector(s):</b>  Brock F. Bowles	<b>Inspector's Signature:</b>

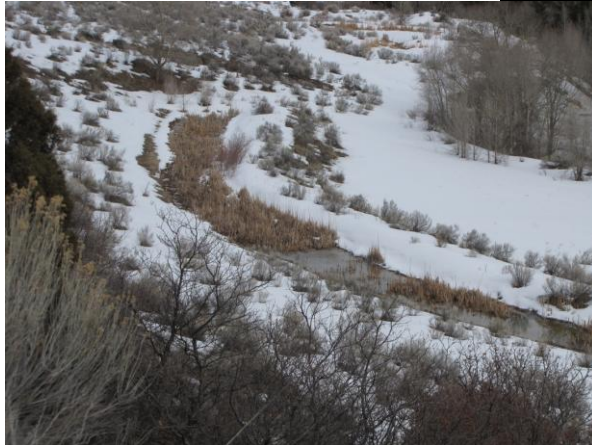
The long pond contained water (photo 1). Ponds T1 and T2 were snow covered. Pond P9 was snow covered and was not discharging. Reeds were visible in Pond P9 indicating the water/ice level was low (photo 2).

Photo 1 – Long Pond

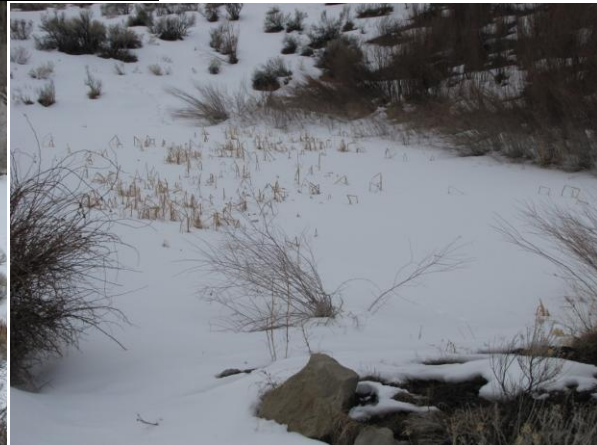
Photo 2 – Pond P9

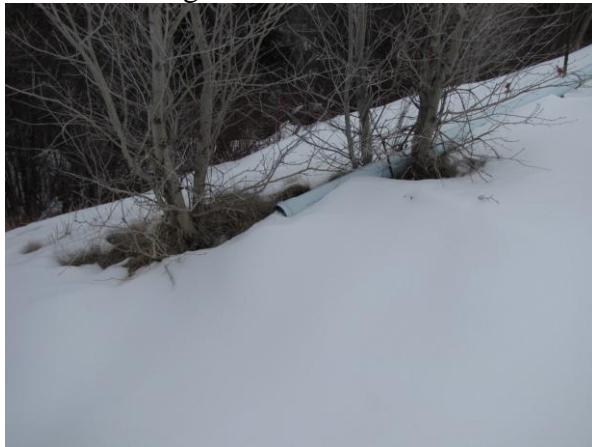
Water was flowing from T2, through the open ditch to Outfall 001A. Usually, the water flows from the outfall into a pipe that directs it to the refuse pile pond ditch and not into North Thompson Creek. During this inspection, the pipe was plugged, presumably ice P (photo 3). The discharge water backed up at the pipe inlet (photo 4), flowed over the embankment under the snow and down the hillside directly to North Thompson Creek (photo 5 & 6). The potential rill or gully resulting from this flow will have to be assessed and repaired sometime after the snow melts.

Photo 3 – Pipe Discharge from Outfall 001A

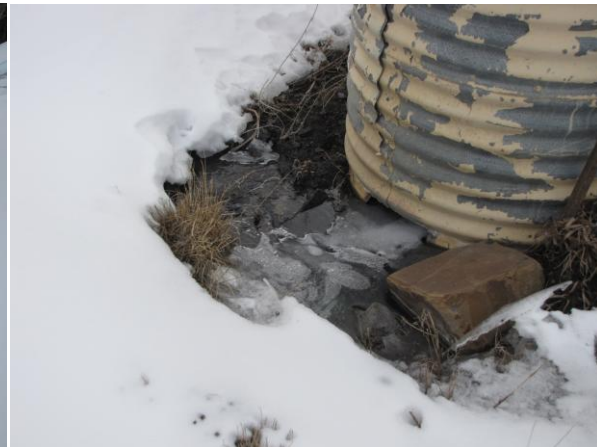
Photo 4 – Water Backed-Up at Outfall 001A

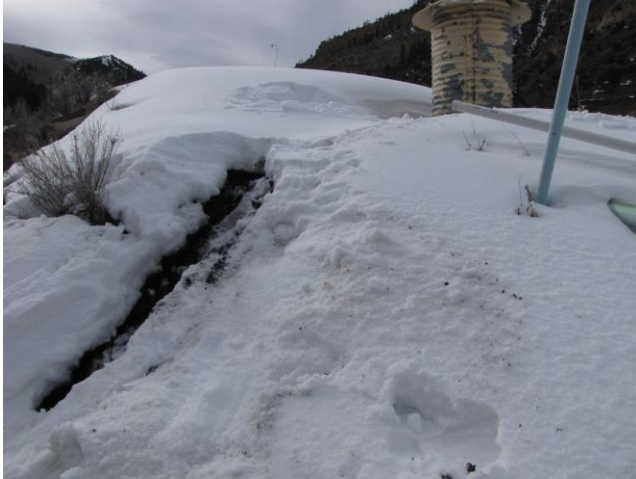
Photo 5 – Water Flowing Below Outfall 001A

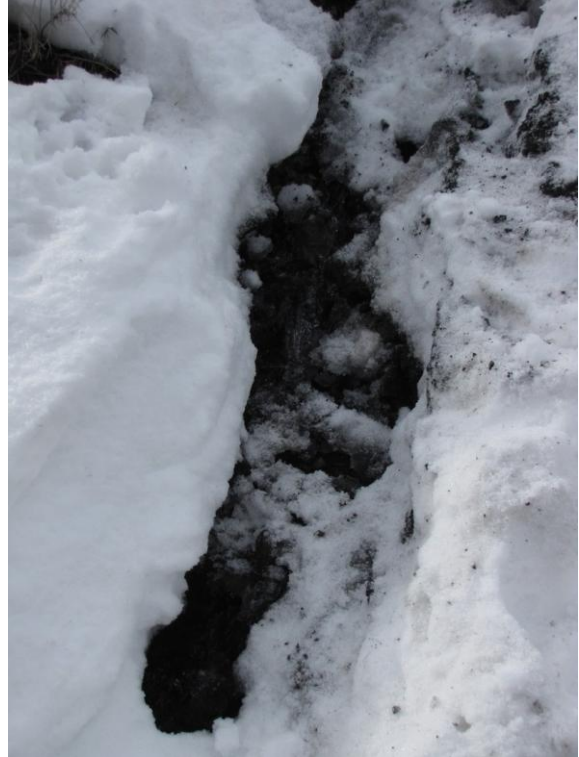
Photo 6 – Water Flowing Down Hillside
