February 26, 2013

Re: Follow-up Notice for Mill Tailing Delivery Line Leak, Permit No. M-1977-342

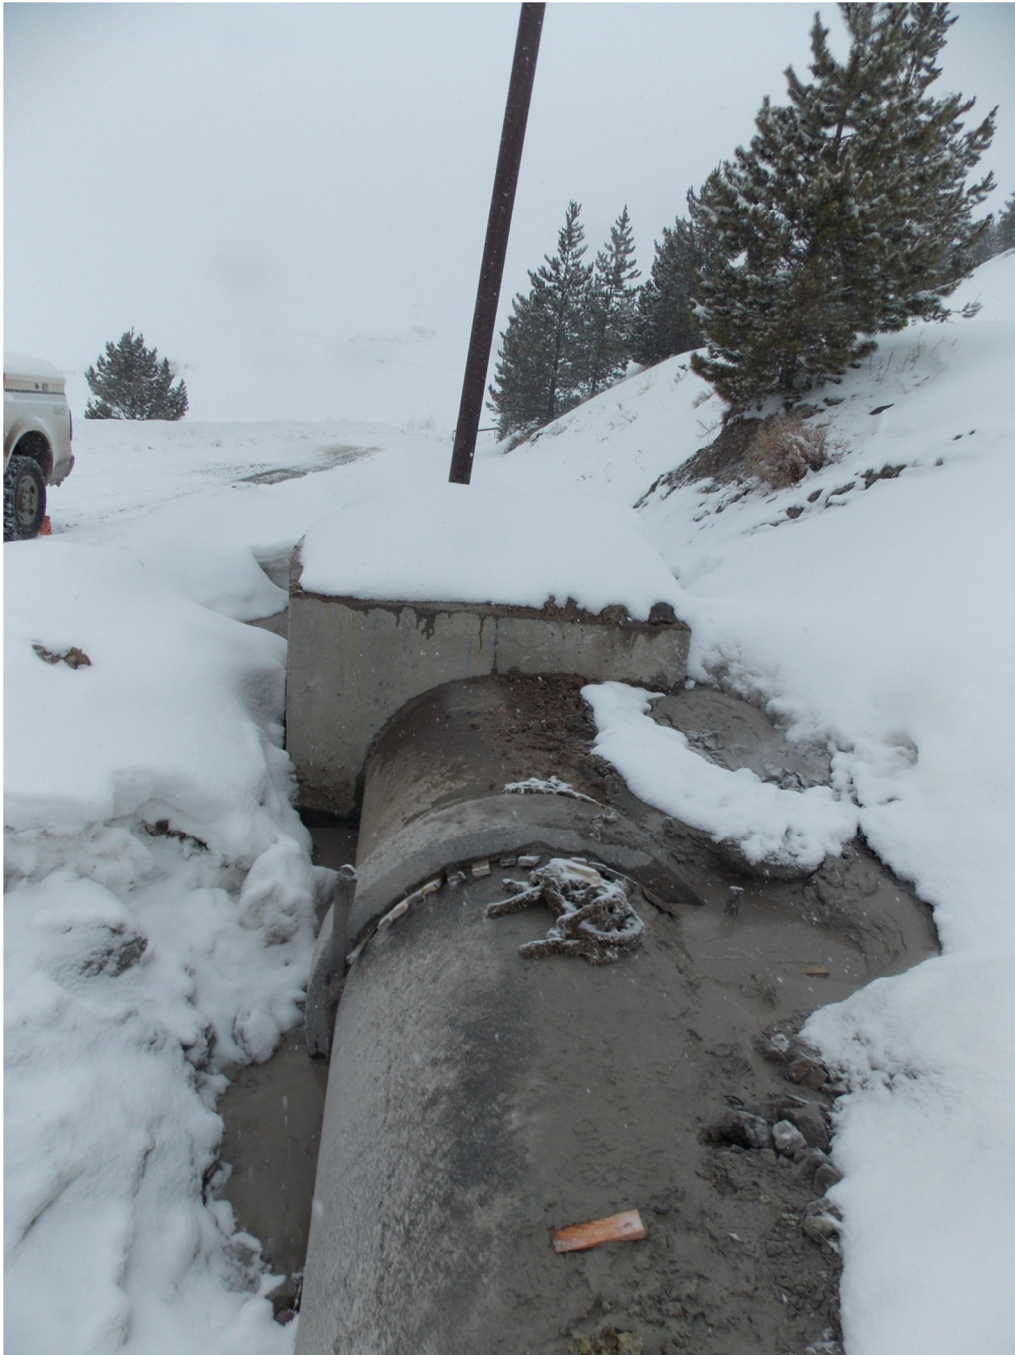
- (e) The investigation following the incident determined that the leak came from packing which had become dislodged inside the joint between two pieces of reinforced concrete

pipe. Contraction of HDPE piping down gradient of an anchor block directly below the joint in question may have had some influence.

**Image #1 – Location of Incident, below droptower 17 on Tailing Delivery Line. Wedges used to drive new packing material back into joint to stop/slow leak.
Leak developed at 1 o' clock position in this perspective.**

- (a) After discovering the issue, Henderson employees promptly wedged more packing into the void where tails slurry was escaping to slow down the escaping flow, estimated at <1gpm following wedging additional packing into the joint.

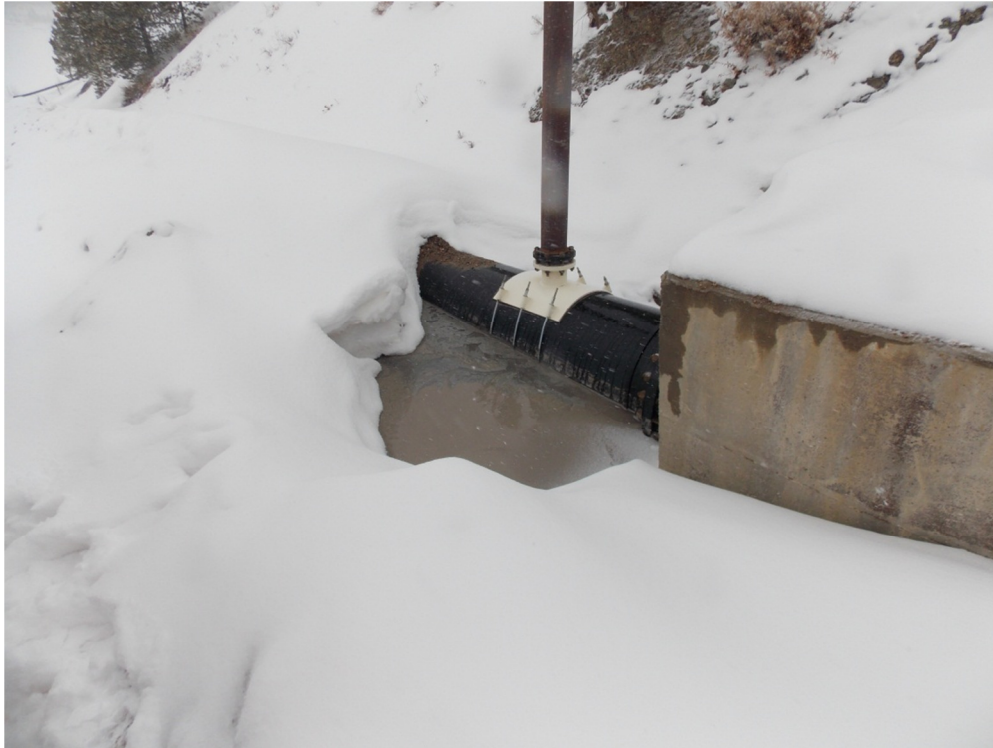
Image #2 – Flow emerging below anchor block, directly below leaking joint

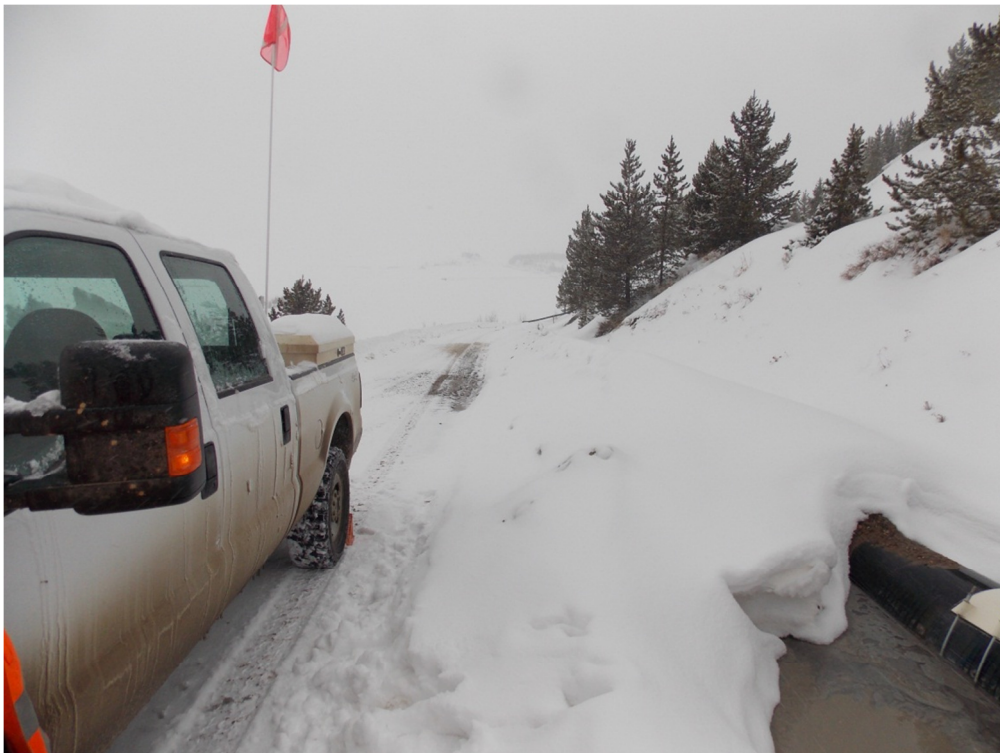
- (b) Mill tailing slurry flow did not adversely impact human health, property or the environment. The entirety of the slurry that leaked from the TDL made its way along the TDL access road for 250 to 300 feet, where the extent of the flow appeared to have stopped. Drainage in this area will channel any resulting flows into the 3-Dam catchment bench, where it assimilates with other tails and process waters.

Image #3 – Water flow down access road looking north. ~250 to 300ft evident flow path

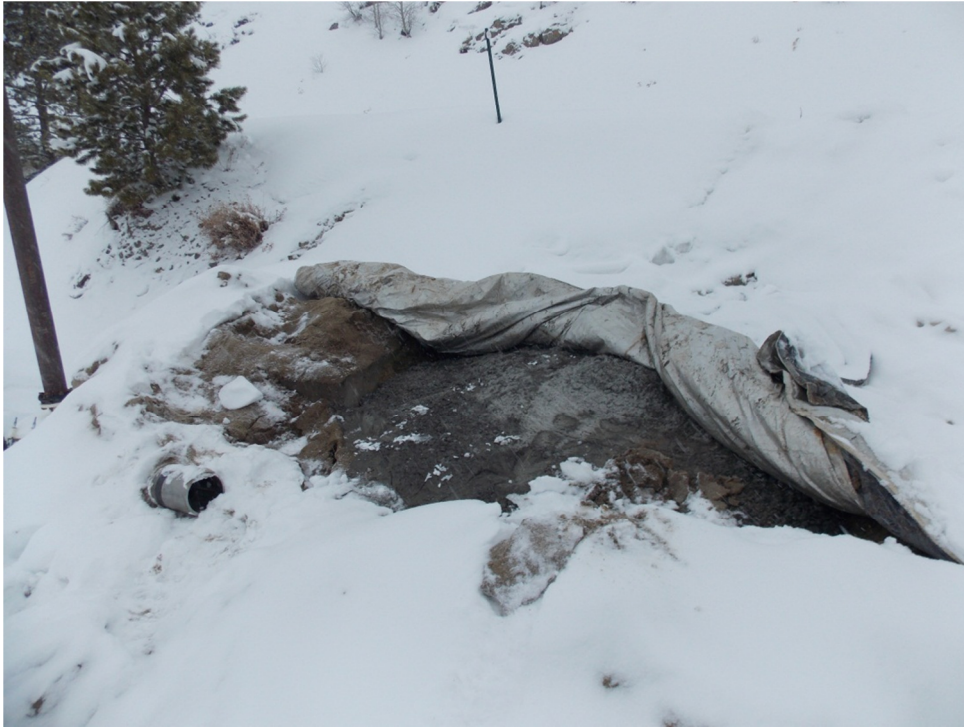
Image #4 – Concrete patch poured over TDL

The day following the event, flows were diverted from the TDL and routed through the #1 Cutout to alleviate any pressure on the joint while a concrete patch was poured over the section of piping where the failure occurred. The concrete was allowed to set before tailing flow was again routed through this section of piping. As of February 26, there is no sign of perpetuated flow from the joint and no sign of flow in areas adjacent to this section of piping.

At the time of this event, Henderson had already planned a project for the spring/summer of 2013, which would exchange RCP piping in this area with HDPE piping. This project should further eliminate leak potential of this type.

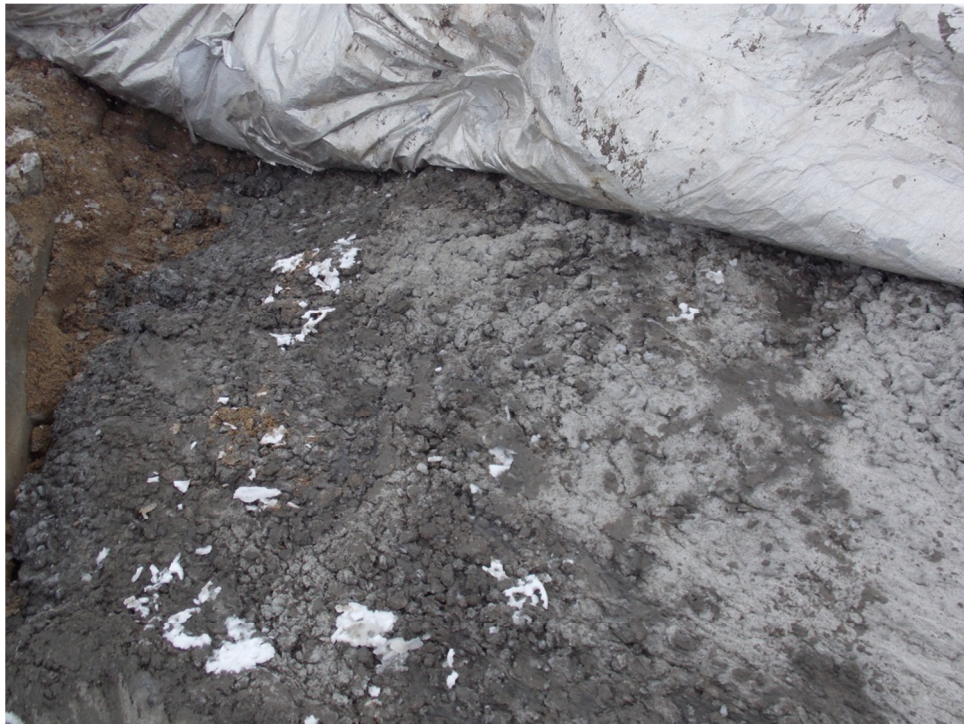
Image #5 – Area above where leak emerged from TDL joint

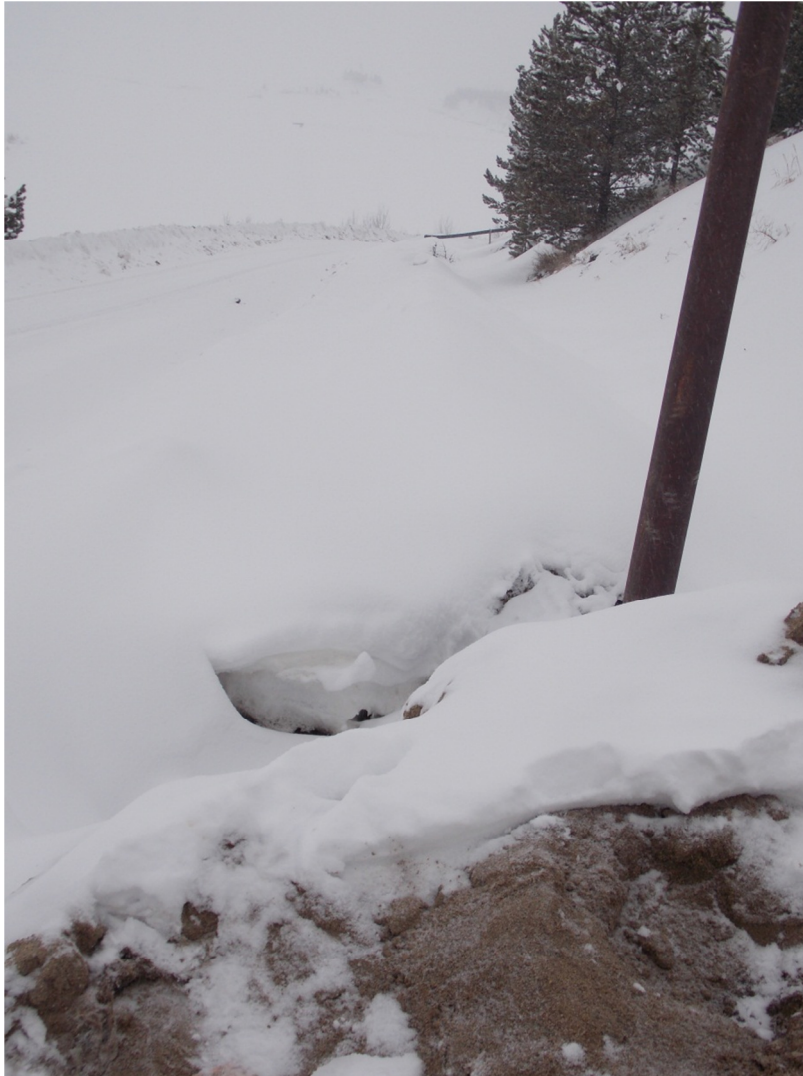
Image #6 – View down road, no evidence of escaping tails slurry
