**COLORADO DIVISION OF RECLAMATION, MINING AND SAFETY
COAL PROGRAM INSPECTION REPORT**

| Permit Number: C-1981-014 Mine Name: Southfield Mine Operator: Energy Fuels Coal, Inc. Operator Address: Mr George Patterson P.O. Box 459 Florence, CO 81226 | County: Fremont Operation Type: Underground Permit Status: Permanent Cessation Ownership: Private |

| Inspection Start Date: February 27, 2013 Inspection Start Time: 10:50 Inspection End Date: February 27, 2013 Inspection End Time: 13:45 | | Inspection Type: Coal Partial Inspection Inspection Reason: Normal I&E Program Weather: Clear | |

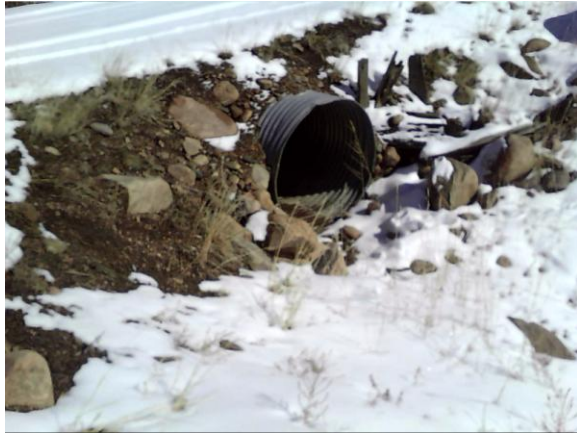
The inspector drove to the southwestern extent of the permit boundary to surface water sampling site NC-2 to observe if there was flow in Newlin Creek. Newlin Creek was still snow covered and not yet flowing. There was no flow in Newlin Creek at the Thompson Driveway culvert.

Photo 1: Thompson driveway culvert inlet. No flow in Newlin Creek yet. Newlin Creek remains snow covered.

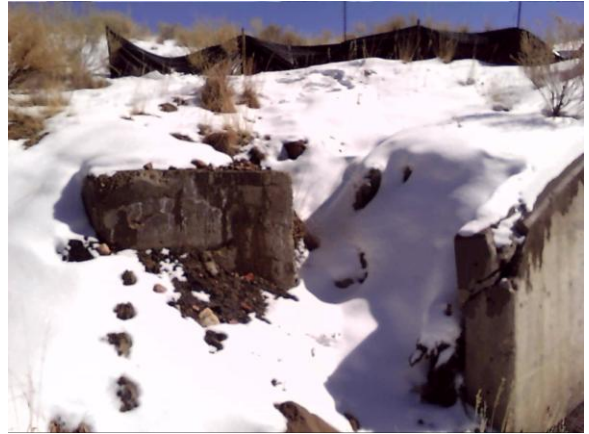
In a telephone conversation with George Patterson of EFCI, on 2/27/2013, George indicated that he had seed to reseed the rill repair on the northwest side of the truck tunnel, but he has not seeded the area yet.

Photo 2: Silt fence at truck tunnel rill repair. Still need seeding for stabilization.

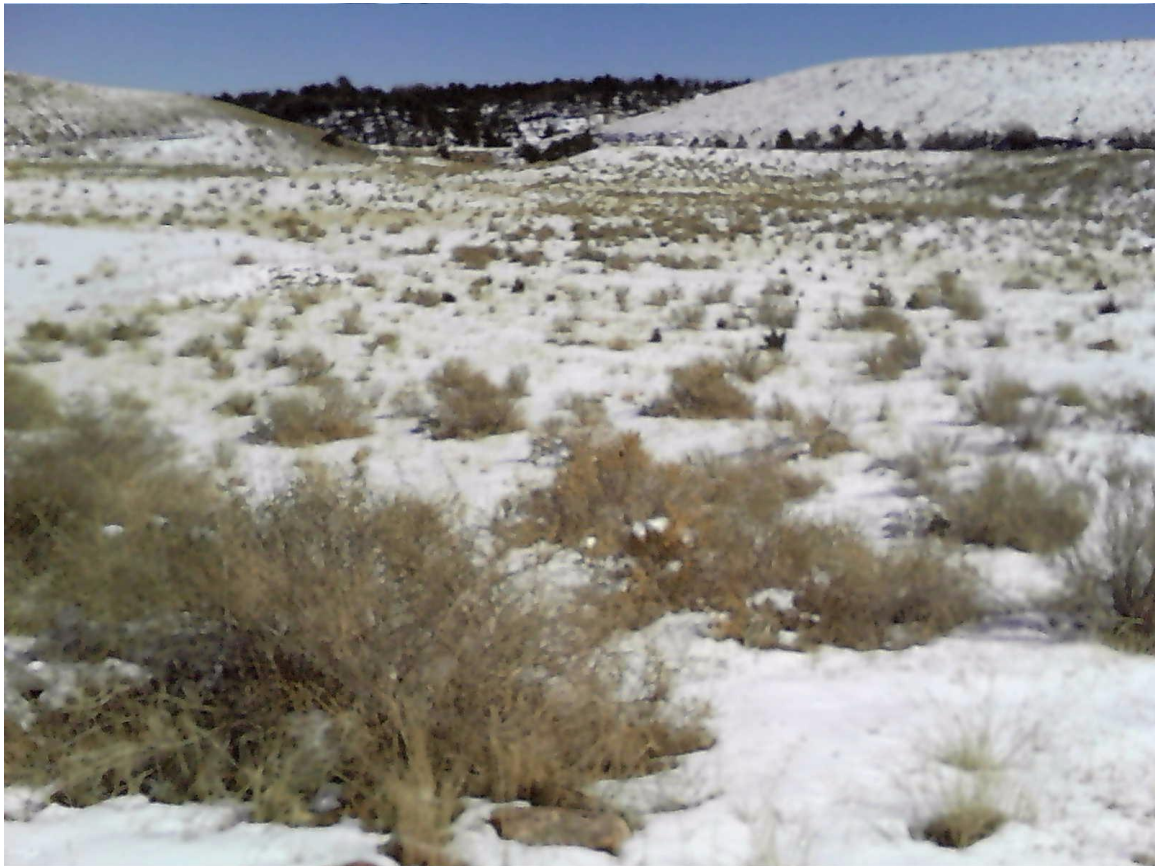
Snow covered the reclaimed facilities area. Pine seedlings and Juniper seedlings show up in stark contrast against the snow. Numerous Ponderosa pine, Pinyon pine and Juniper seedlings continue to survive in this reclaimed area.

Photo 3: Reclaimed portal facilities area. Ponderosa, Pinyon, and Juniper seedlings are noted as darker spots in this photo.

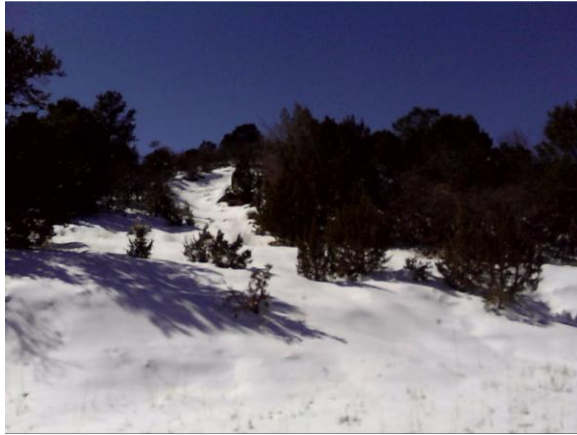
Proposed Pinyon-Juniper reference area was observed. EFCI has not marked the limits of the proposed reference area. Based on the map provided to the Division, it is unclear if two existing disturbances in this location fall within or outside of the proposed reference area.

Photo 4: Disturbance in locale of proposed PJ reference area. Photo 5: North end of proposed PJ reference area.

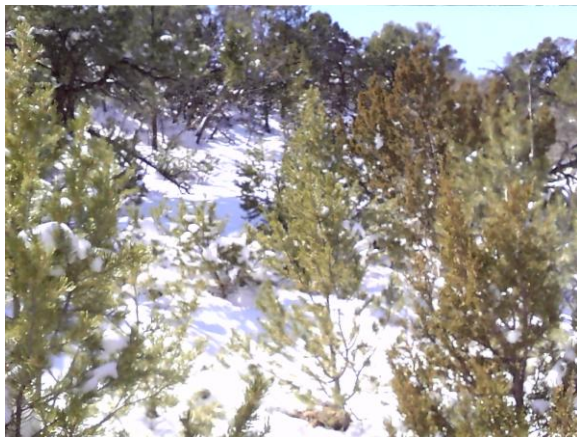
Photo 6: proposed PJ reference area

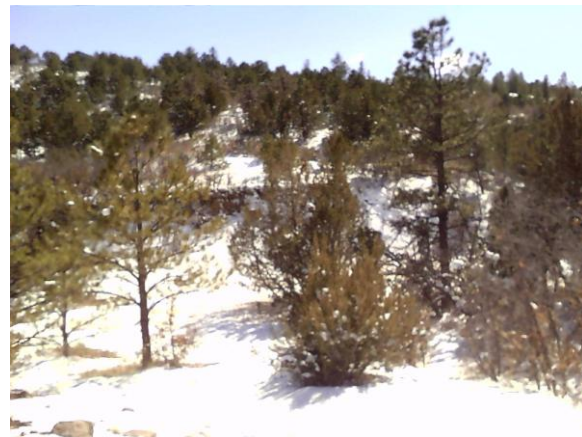
Photo 7: Approved PPJ reference area

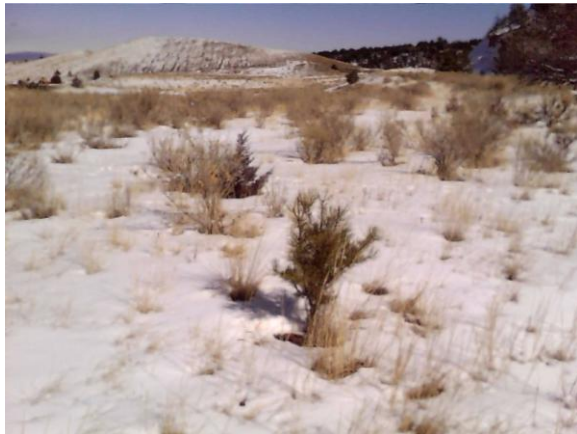
Photo 8: Ponderosa and Juniper seedlings
