**COLORADO DIVISION OF RECLAMATION, MINING AND SAFETY
COAL PROGRAM INSPECTION REPORT**

Permit Number: C-1981-015 Mine Name: Fruita No 1 & 2 Operator: Dorchester Coal Company Operator Address:	County: Mesa Operation Type: Underground Permit Status: Revoked Ownership: Private
	Operator Representative Present: None
Operator Representative Signature: (Field Issuance Only)

Inspection Start Date: February 26, 2013 Inspection Start Time: 11:40 Inspection End Date: February 26, 2013 Inspection End Time: 13:30	Inspection Type: Coal Complete Inspection Inspection Reason: Normal I&E Program Weather: Cloudy
Joint Inspection Agency: None	Joint Inspection Contacts:
Post Inspection Agency: None	Post Inspection Contacts:
Inspector(s): Michael P. Boulay	Inspector's Signature: <i>Michael P. Boulay</i> Signature Date: 3/1/2013

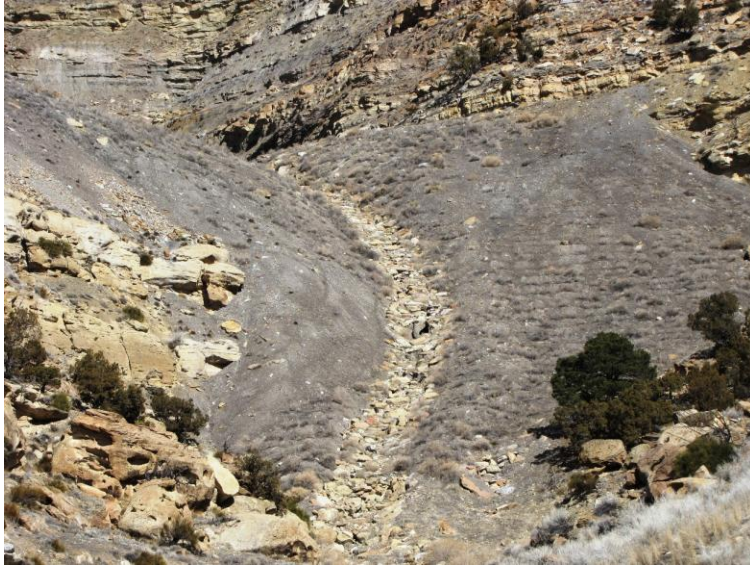
The mine site was wet and muddy from recent precipitation with some snow cover present. The permanent drainage channel remains stable and in good condition. The sediment pond embankment, inlet and spillway were in good condition with no problems identified. There was a significant amount of snow accumulated in the drainage above the pond inlet. The pond itself was wet in the bottom but was not holding any water. The main riprap drainage channel is shown in attached Photograph No. 1. The sediment pond is shown in Photograph No. 2.

Photo No. 1 - Mine #1 outslope and drainage channel.

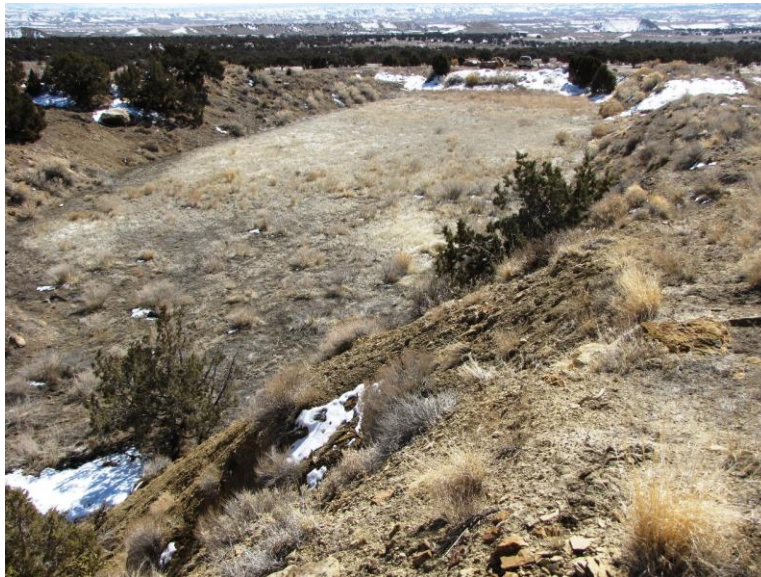
Photo No. 2 - Sediment pond.
