## COLORADO DIVISION OF RECLAMATION, MINING AND SAFETY COAL PROGRAM INSPECTION REPORT

<b>Permit Number:</b> C-1981-013 <b>Mine Name:</b> Golden Eagle Mine <b>Operator:</b> New Elk Coal Company, LLC <b>Operator Address:</b> Mr Ron Thompson 12250 State Highway 12 Weston, CO 81091	<b>County:</b> Las Animas <b>Operation Type:</b> Underground <b>Permit Status:</b> Permanent Cessation <b>Ownership:</b> Private
	<b>Operator Representative Present:</b>  Bobby Steele and Vince Massarotti
<b>Operator Representative Signature: (Field Issuance Only)</b>

<b>Inspection Start Date:</b> February 20, 2013 <b>Inspection Start Time:</b> 16:00 <b>Inspection End Date:</b> February 20, 2013 <b>Inspection End Time:</b> 16:30		<b>Inspection Type:</b> Coal Partial Inspection <b>Inspection Reason:</b> Normal I&E Program <b>Weather:</b> Cloudy	
<b>Joint Inspection Agency:</b>  None		<b>Joint Inspection Contacts:</b>  None	
<b>Post Inspection Agency:</b>  None		<b>Post Inspection Contacts:</b>  None	
<b>Inspector(s):</b>  Zach T. Trujillo	<b>Inspector's Signature:</b>

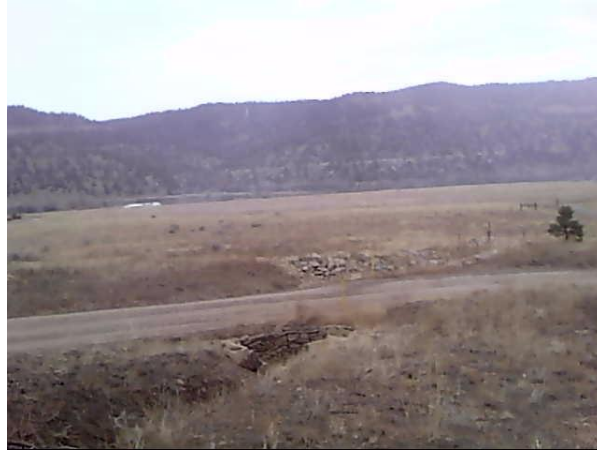
**PHOTOGRAPHS**

The vent shaft pad was inspected for erosion and proper drainage. No erosion was noted.

Above the pad remains an upland diversion ditch. The ditch was stable and clear of any debris.
