**COLORADO DIVISION OF RECLAMATION, MINING AND SAFETY
COAL PROGRAM INSPECTION REPORT**

Permit Number: C-1981-012 Mine Name: New Elk Mine Operator: New Elk Coal Company, LLC Operator Address: Mr Ron Thompson 12250 Highway 12 Weston, CO 81091	County: Las Animas Operation Type: Underground Permit Status: Temporary Cessation Ownership: Private
	Operator Representative Present: Ron Thompson and Vince Massarotti
Operator Representative Signature: (Field Issuance Only)

Inspection Start Date: February 20, 2013 Inspection Start Time: 12:00 Inspection End Date: February 21, 2013 Inspection End Time: 10:00		Inspection Type: Coal Partial Inspection Inspection Reason: Normal I&E Program Weather: Cloudy	
Joint Inspection Agency: None		Joint Inspection Contacts: None	
Post Inspection Agency: None		Post Inspection Contacts: None	
Inspector(s): Zach T. Trujillo	Inspector's Signature:

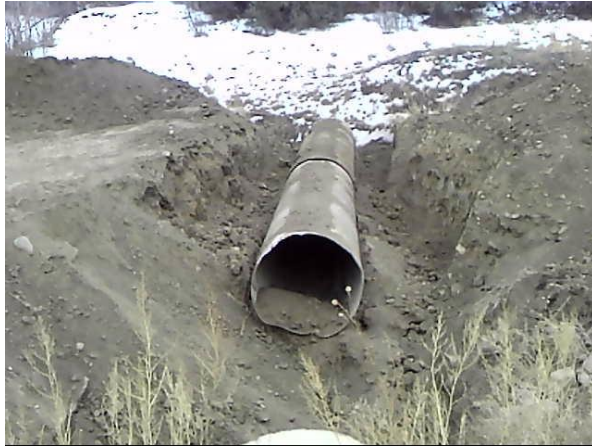
Two additional culverts north and south of culvert C2 have been dugout but remained in place. NECC mentioned that they were to be removed once the proper equipment was fixed and running.

Dugout culvert north of culvert C2.

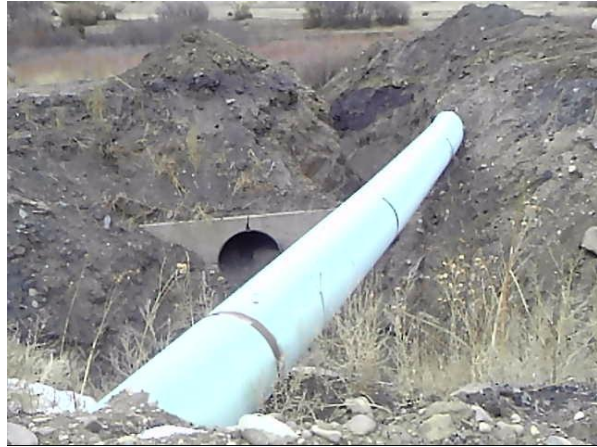
Culvert and ditch realignment south of culvert C2.

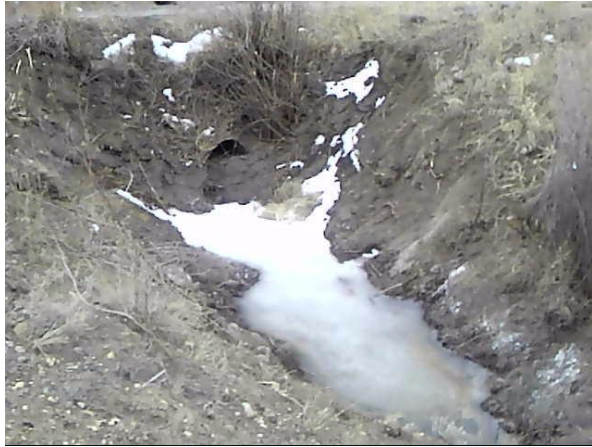
Culvert C3 had been dugout around the inlet and outlet. C3 still needs additional clearing within the culvert. Ditch D7 that conveys runoff through culvert C3 has had the major vegetation growth along the outlet of C3 partially removed. The rest of vegetation still needs to be removed and the ditch reestablished to allow proper drainage. Currently water is ponding just below culvert C3's outlet.

Outlet of culvert C3 and dugout section of Ditch 7.

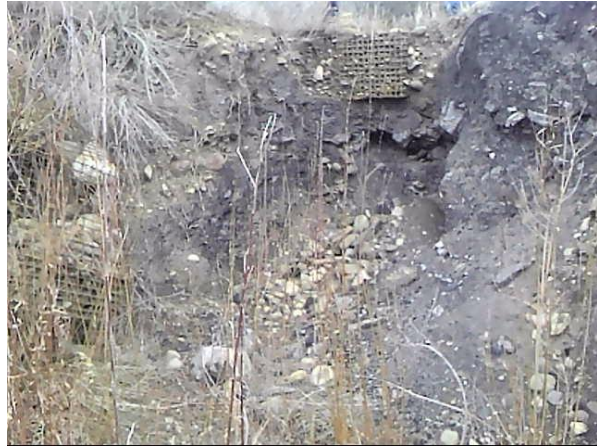
Erosion around the gabions noted in previous inspections has yet to receive maintenance.

Erosion and cutting around gabions.

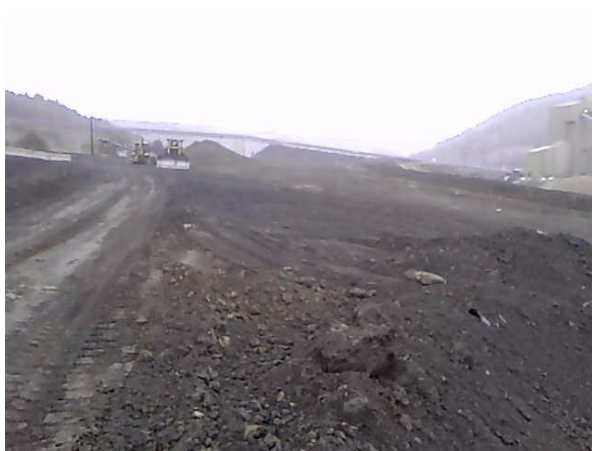
The Topsoil SAE has area has been regraded. The elevated embankment that allowed the temporary conveyor belt to transfer refuse and developmental waste to the main belt line has been removed. Berm along the southern perimeter of the Topsoil SAE has been established and conveys runoff primarily to the west end of the SAE. The drainage channel west of Containment 4 has been reconstructed to allow runoff to flow from beneath the highway and straight to the Purgatoire River.

Regraded Topsoil Pile SAE.

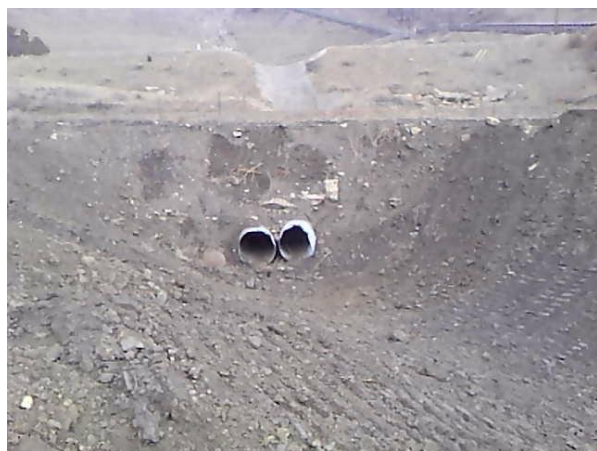
The drainage channel east of the Topsoil Pile SAE has been reestablished with the extra culvert within the previous drainage channel being removed.

Reestablished drainage ditch east of Topsoil Pile SAE.

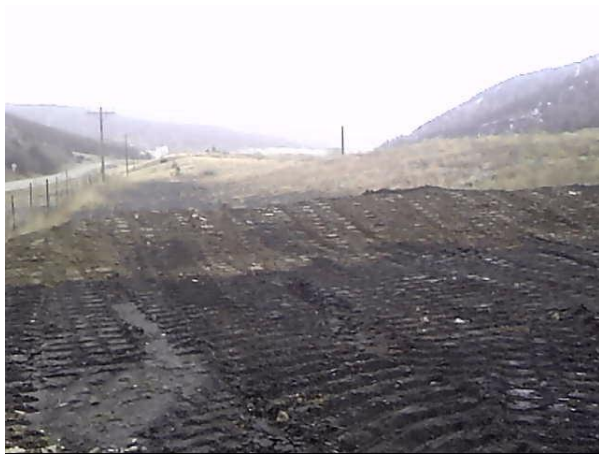
Berm east of Containment 4.

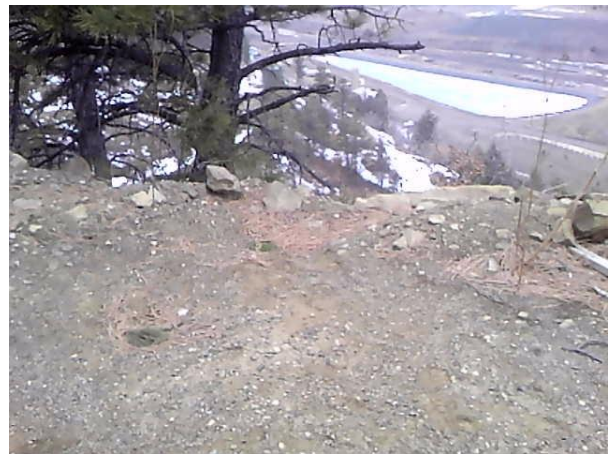
The berm that lines the Water Tank SAE had yet to receive maintenance on the low spot at the time of the inspection. The berm needs to be reestablished to allow drainage to properly runoff to the approved point of discharge.

Water Tank SAE's berm low spot.

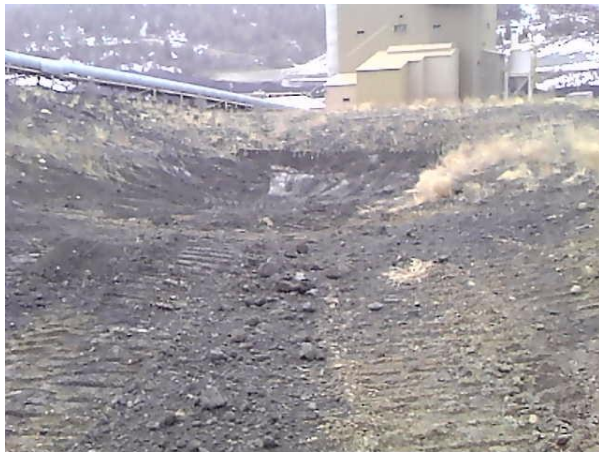
Containment areas 3 and 4 were recently cleaned prior to the inspection. Cleanings were stockpiled on the Temporary DWDA.

Recently cleaned Containment 3.

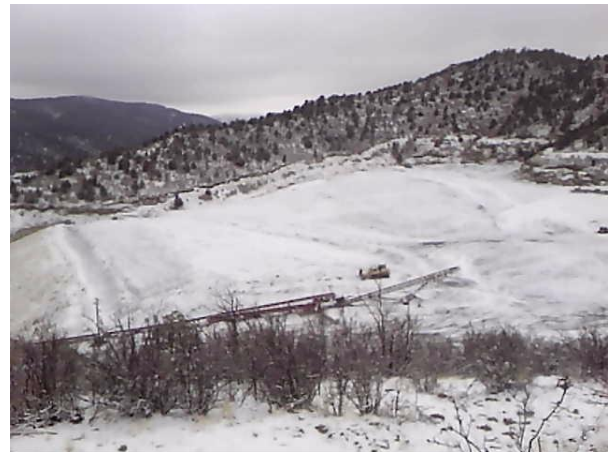
The Refuse Disposal Area was inspected. No refuse placement has occurred recently. The RDA was graded to allow surface runoff to be routed to perimeter ditches before entering the RDA pond. Older sections of the RDA have been reclaimed and are well vegetated. No signs of slumping or erosion were observed along the face.

Refuse Disposal Area.
