**COLORADO DIVISION OF RECLAMATION, MINING AND SAFETY  
COAL PROGRAM INSPECTION REPORT**

<b>Permit Number:</b> C-1981-014 <b>Mine Name:</b> Southfield Mine <b>Operator:</b> Energy Fuels Coal, Inc. <b>Operator Address:</b> Mr George Patterson P.O. Box 459 Florence, CO 81226	<b>County:</b> Fremont <b>Operation Type:</b> Underground <b>Permit Status:</b> Permanent Cessation <b>Ownership:</b> Private
	<b>Operator Representative Present:</b>  None
<b>Operator Representative Signature: (Field Issuance Only)</b>

<b>Inspection Start Date:</b> February 27, 2013 <b>Inspection Start Time:</b> 10:50 <b>Inspection End Date:</b> February 27, 2013 <b>Inspection End Time:</b> 13:45		<b>Inspection Type:</b> Coal Partial Inspection <b>Inspection Reason:</b> Normal I&E Program <b>Weather:</b> Clear	
<b>Joint Inspection Agency:</b>  None		<b>Joint Inspection Contacts:</b>	
<b>Post Inspection Agency:</b>  None		<b>Post Inspection Contacts:</b>	
<b>Inspector(s):</b>  Janet H. Binns	<b>Inspector's Signature:</b>

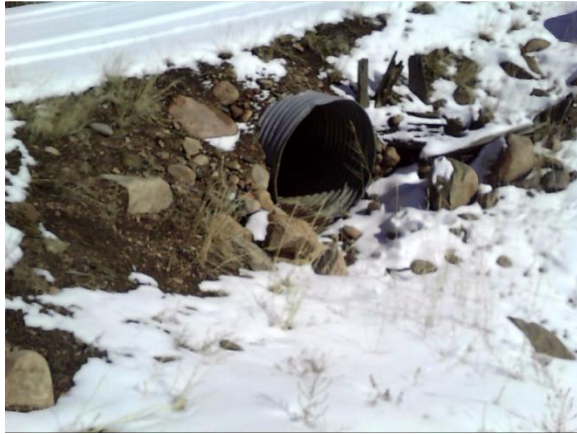
The inspector drove to the southwestern extent of the permit boundary to surface water sampling site NC-2 to observe if there was flow in Newlin Creek. Newlin Creek was still snow covered and not yet flowing. There was no flow in Newlin Creek at the Thompson Driveway culvert.

Photo 1: Thompson driveway culvert inlet. No flow in Newlin Creek yet. Newlin Creek remains snow covered.

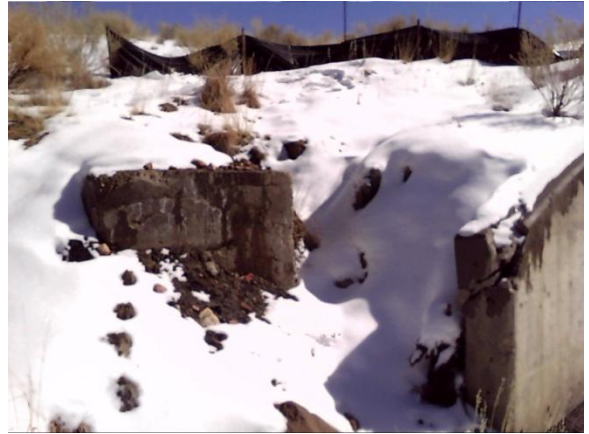
In a telephone conversation with George Patterson of EFCI on 2/27/2013, George indicated that he had seeded the rill repair on the northwest side of the truck tunnel on 2/26/2013 with the approved Corley permanent seed mix. George Patterson confirmed this in an e-mail to the Division on 3/1/2013. Snow that had fallen since 2/26/2013 had covered the seed so the inspector was unable to visually verify the seed application. The recent moisture should be beneficial to this mitigation effort.

Photo 2: Silt fence at truck tunnel rill repair. Operator seeded with Corley seed mix on 2/26/2013

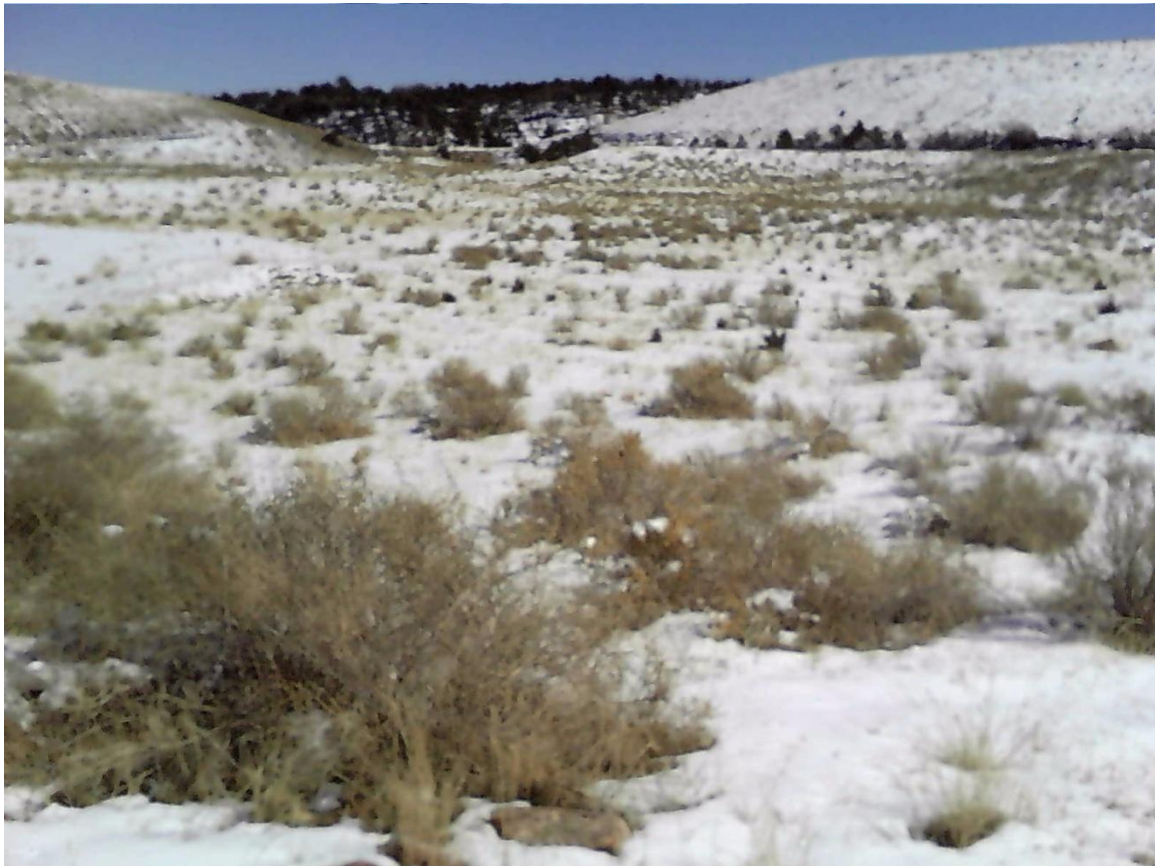
Snow covered the reclaimed facilities area. Pine seedlings and Juniper seedlings show up in stark contrast against the snow. Numerous Ponderosa pine, Pinyon pine and Juniper seedlings continue to survive in this reclaimed area.

Photo 3: Reclaimed portal facilities area. Ponderosa, Pinyon, and Juniper seedlings are noted as darker spots in this photo.

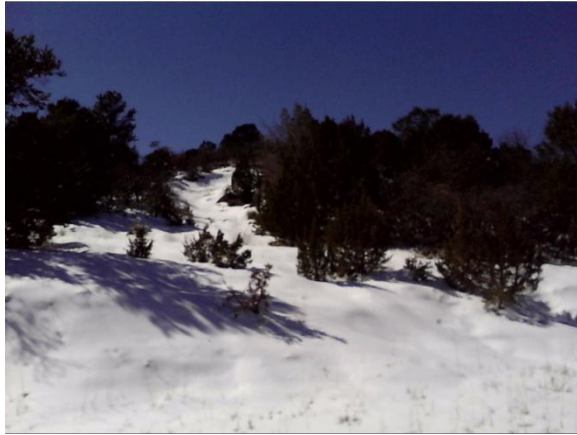
Proposed Pinyon-Juniper reference area was observed. EFCI has not marked the limits of the proposed reference area. Based on the map provided to the Division, it is unclear if two existing disturbances in this location fall within or outside of the proposed reference area.

Photo 4: Disturbance in locale of proposed PJ reference area. Photo 5: North end of proposed PJ reference area.

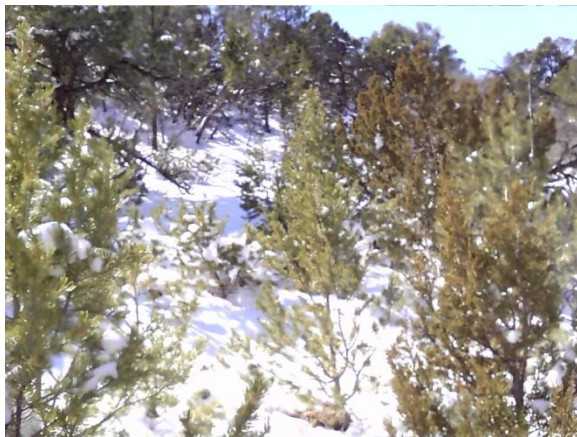
Photo 6: proposed PJ reference area

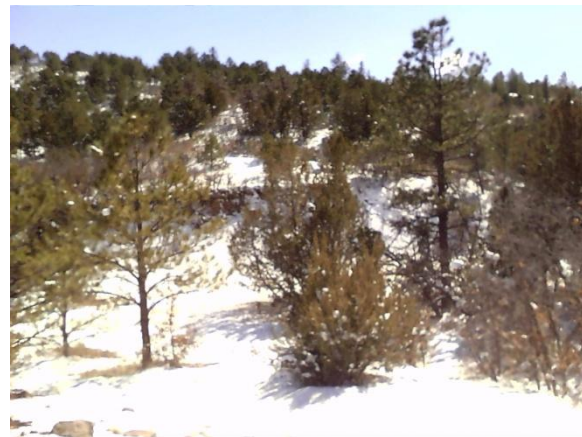
Photo 7: Approved PPJ reference area

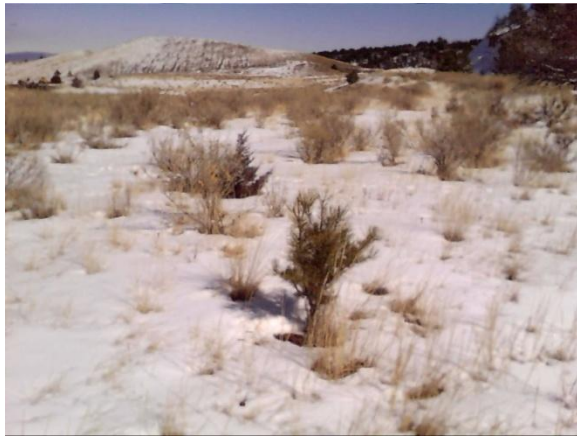
Photo 8: Ponderosa and Juniper seedlings
