**COLORADO DIVISION OF RECLAMATION, MINING AND SAFETY  
COAL PROGRAM INSPECTION REPORT**

<b>Permit Number:</b> C-1981-041 <b>Mine Name:</b> Roadside Portals <b>Operator:</b> Snowcap Coal Company, Inc. <b>Operator Address:</b> Ms. Tonya Hammond P.O. Box 1430 Palisade, CO 81526	<b>County:</b> Mesa <b>Operation Type:</b> Underground <b>Permit Status:</b> Permanent Cessation <b>Ownership:</b> Federal
<b>Operator Representative Present:</b>	
<b>Operator Representative Signature: (Field Issuance Only)</b>

<b>Inspection Start Date:</b> February 25, 2013 <b>Inspection Start Time:</b> 12:00 <b>Inspection End Date:</b> February 25, 2013 <b>Inspection End Time:</b> 14:15	<b>Inspection Type:</b> Coal Partial Inspection <b>Inspection Reason:</b> Normal I&E Program <b>Weather:</b> Cloudy
<b>Joint Inspection Agency:</b>  None	<b>Joint Inspection Contacts:</b>
<b>Post Inspection Agency:</b>  None	<b>Post Inspection Contacts:</b>
<b>Inspector(s):</b>  Michael P. Boulay	<b>Inspector's Signature:</b>  <i>Michael P. Boulay</i>  <b>Signature Date:</b>  3/4/13

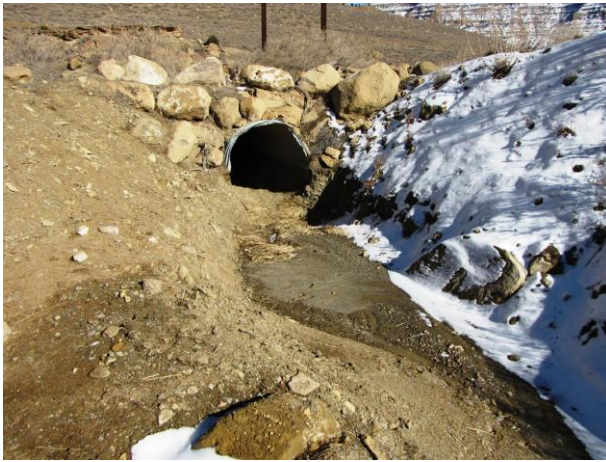
Photo No. 1 - Coal Gulch

The North Portals and South Portals areas were inspected. Drainage and diversion ditches were stable with no significant erosion or other problems noted. Coal Creek at the North Portal was damp from recent snowmelt. Coal Gulch at the south end of reclaimed Pond 11 is stable and remains in good condition. The large culvert in Coal Gulch beneath the access road is well maintained with no accumulation of sediment (see attached Photograph No. 1).

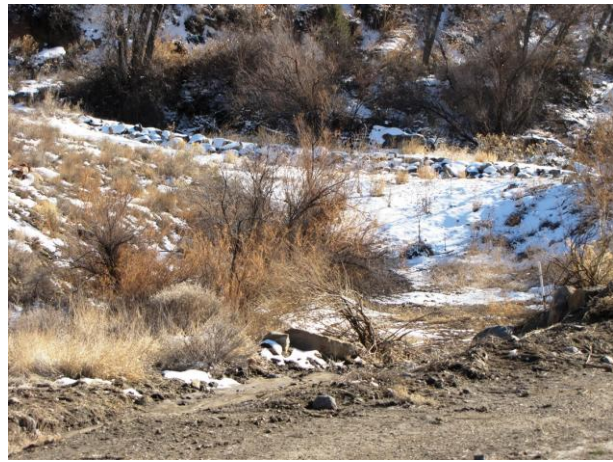
Photo No. 2 - Pond 9

The one remaining site sedimentation pond (Pond 9) at the South Portal area was inspected. The pond was partially snow covered but was not retaining any water. The pond embankment and inlet were stable. Pond 9 is scheduled to be reclaimed in the near future. SCC has been approved to reclaim the pond and construct a permanent channel at this location via TR-63. Pond 9 is shown in Photograph No. 2.

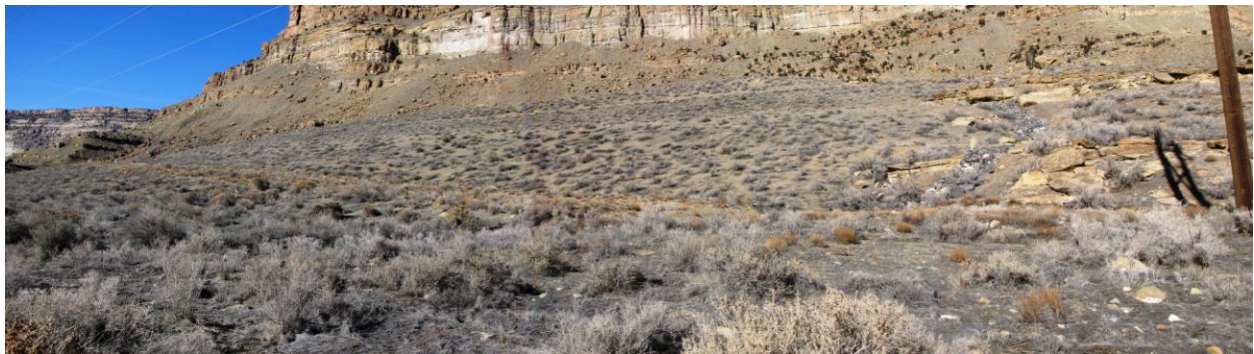
Photo No. 3 - CRDA-2

The CRDA waste disposal sites were stable, diversions and perimeter ditches appeared functional. CRDA-2 at the North Portal area is shown in Photograph No. 3. The RSRDA was inspected at the South Portal. This refuse pile is stable with well constructed lateral and perimeter ditches (see Photo No. 4).
