**COLORADO DIVISION OF RECLAMATION, MINING AND SAFETY
COAL PROGRAM INSPECTION REPORT**

Permit Number: C-1981-008 Mine Name: New Horizon Mine Operator: Western Fuels - Colorado, LLC Operator Address: Mr. Ross L Gubka, P.E. P.O. Box 628 Nucla, CO 81424	County: Montrose Operation Type: Surface Permit Status: Active Ownership: Private
Operator Representative Present: None (Aerial Inspection)	
Operator Representative Signature: (Field Issuance Only) This report was issued electronically from the Division's Durango Field Office.

Inspection Start Date: February 19, 2013 Inspection Start Time: 13:51 Inspection End Date: February 19, 2013 Inspection End Time: 13:53	Inspection Type: Aerial Inspection Inspection Reason: Normal I&E Program Weather: Cloudy	
Joint Inspection Agency: None	Joint Inspection Contacts:	
Post Inspection Agency: None	Post Inspection Contacts:	
Inspector(s): Marcia L. Talvitie, P.E.	Inspector's Signature:

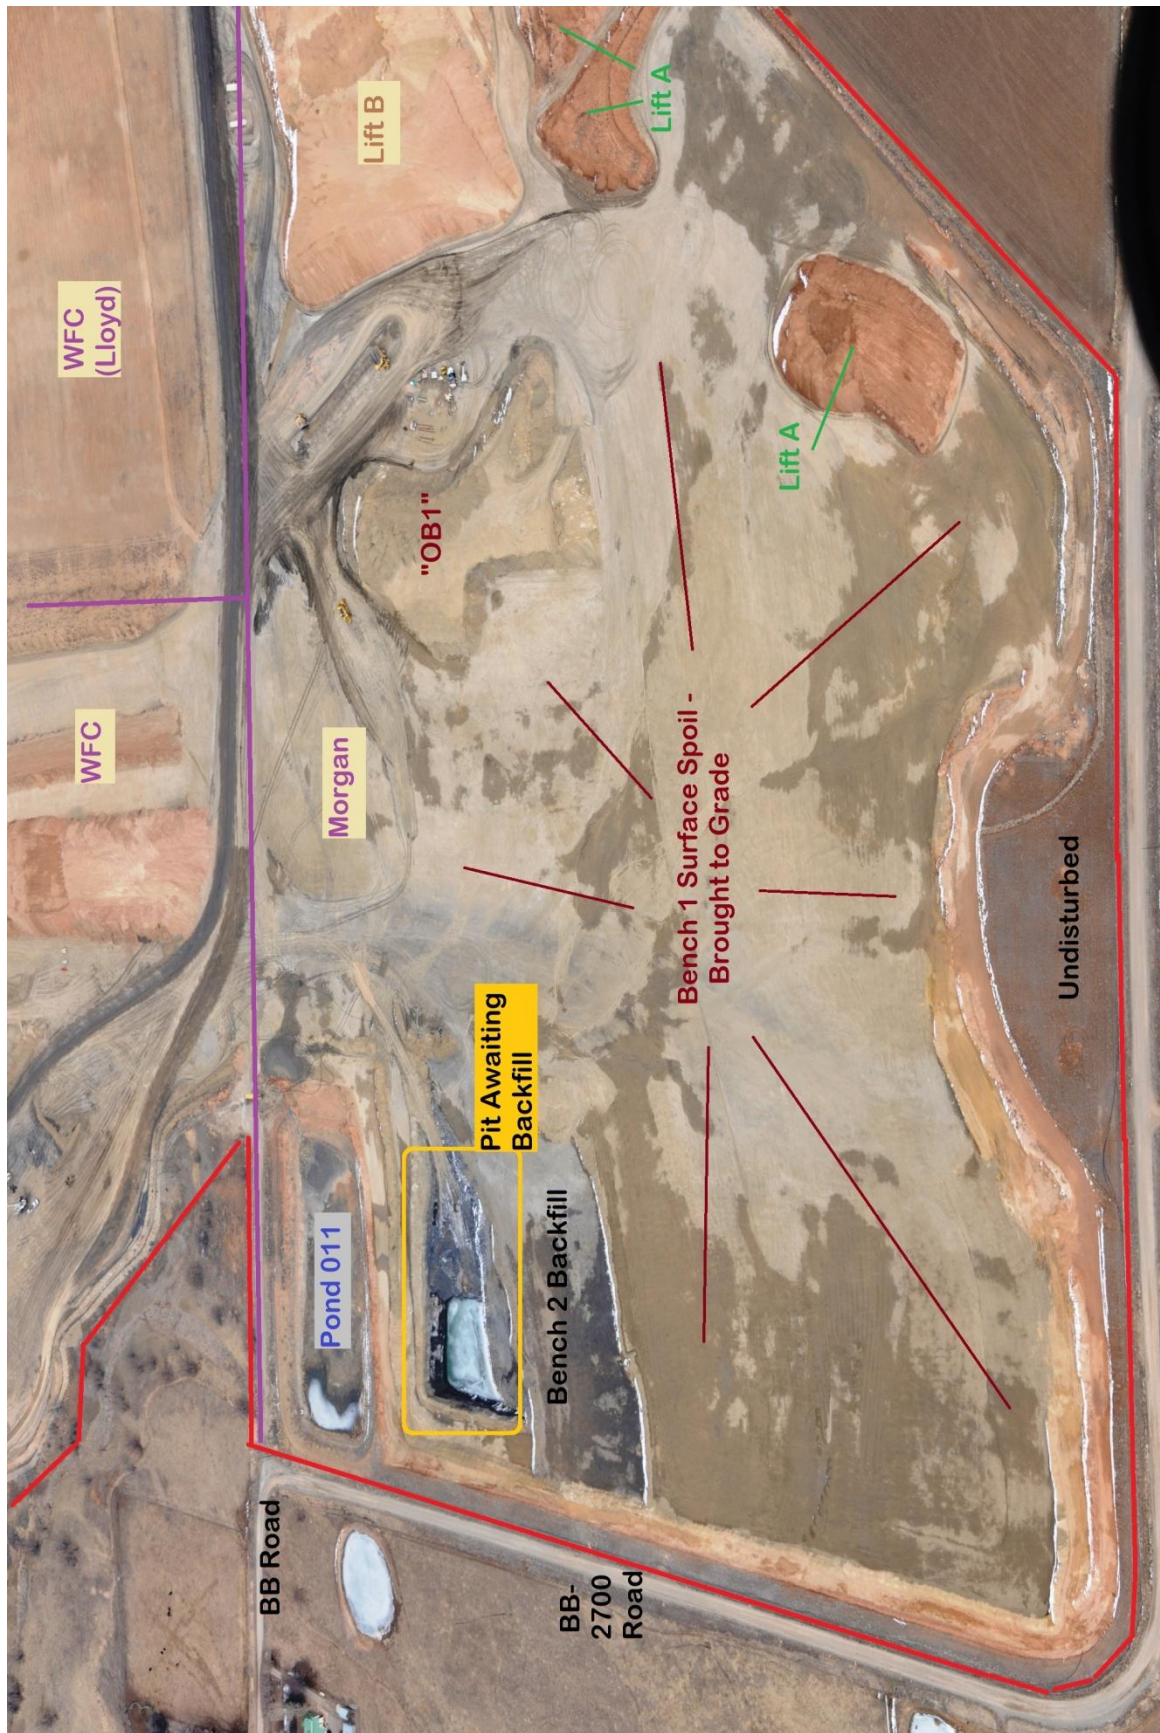
Photo 1 – West end of Morgan property, looking north

- Backfilling operations are nearly complete for the southern limb of the pit, located on the Morgan property.
- A small area immediately south of Pond 011 has not yet been backfilled, but it appears that a majority of this area has been brought to grade with Bench 2 Backfill and Bench 1 Surface Spoil (Photo 1).

- Prime farmland (“Begay”) soil salvaged from the WFC parcel is stockpiled immediately east of Pond 013 (Photo 3).
- On the Morgan property, soil stockpiles for “Mixed”, “Lift B” and “Lift A” appear not to have been disturbed (Photo 6). No additional redistribution of soil has occurred since 2009.
- A majority of the Bench 1 Overburden (“OB1”) material stockpiled on the Morgan property has been redistributed across the backfilled area. The stockpile does still contain some material, however, which will be needed for backfilling the remaining pit and Pond 011 on Morgan's property (Photo 1).

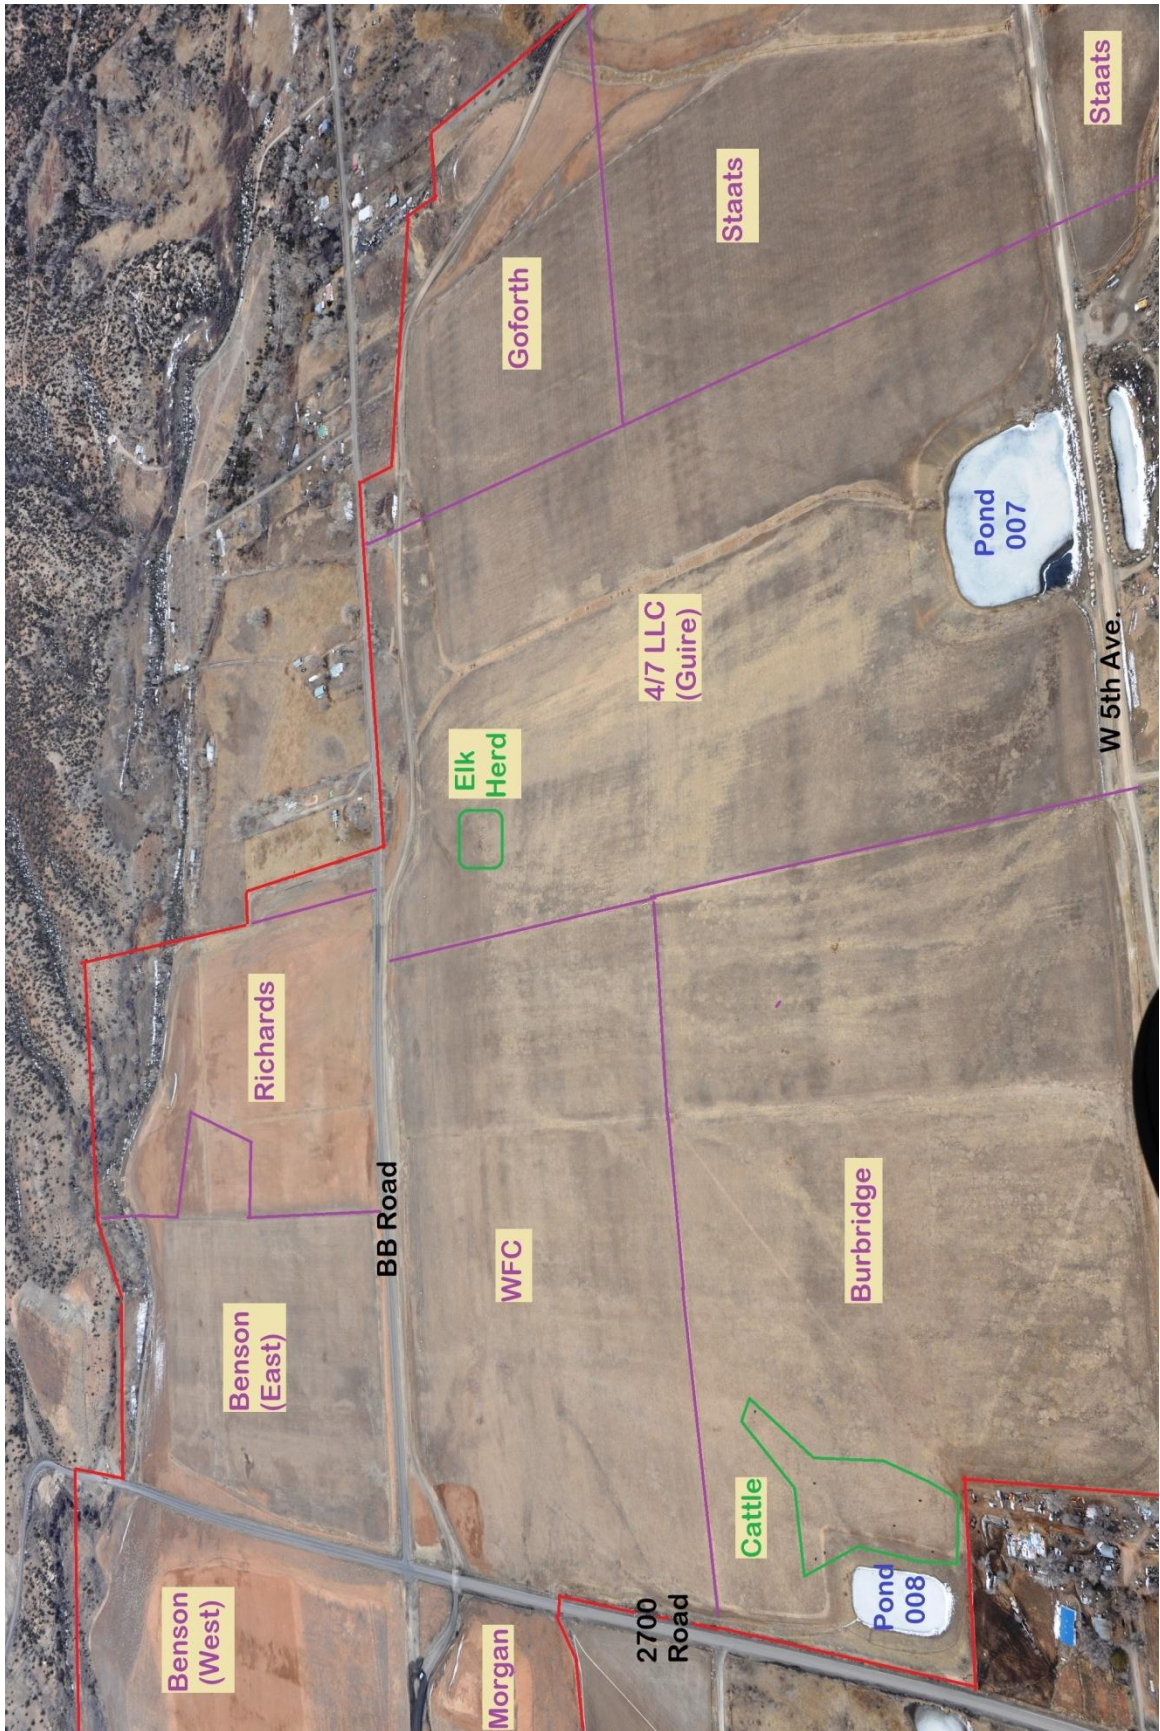
Photo 2 – Reclaimed areas located east of 2700 Road, looking north

- A small herd of elk was occupying the northern portion of the 4/7, LLC (Guire) parcel, to the west of the reconstructed “San Miguel Draw” (Photo 2). The Division estimates there were approximately a dozen animals in the herd.

- No livestock were observed to be grazing the Irrigated Pasture Reference Area (Photo 5).
- Approximately a dozen head of cattle were visible near Pond 008, on the Burbridge parcel (Photo 2).

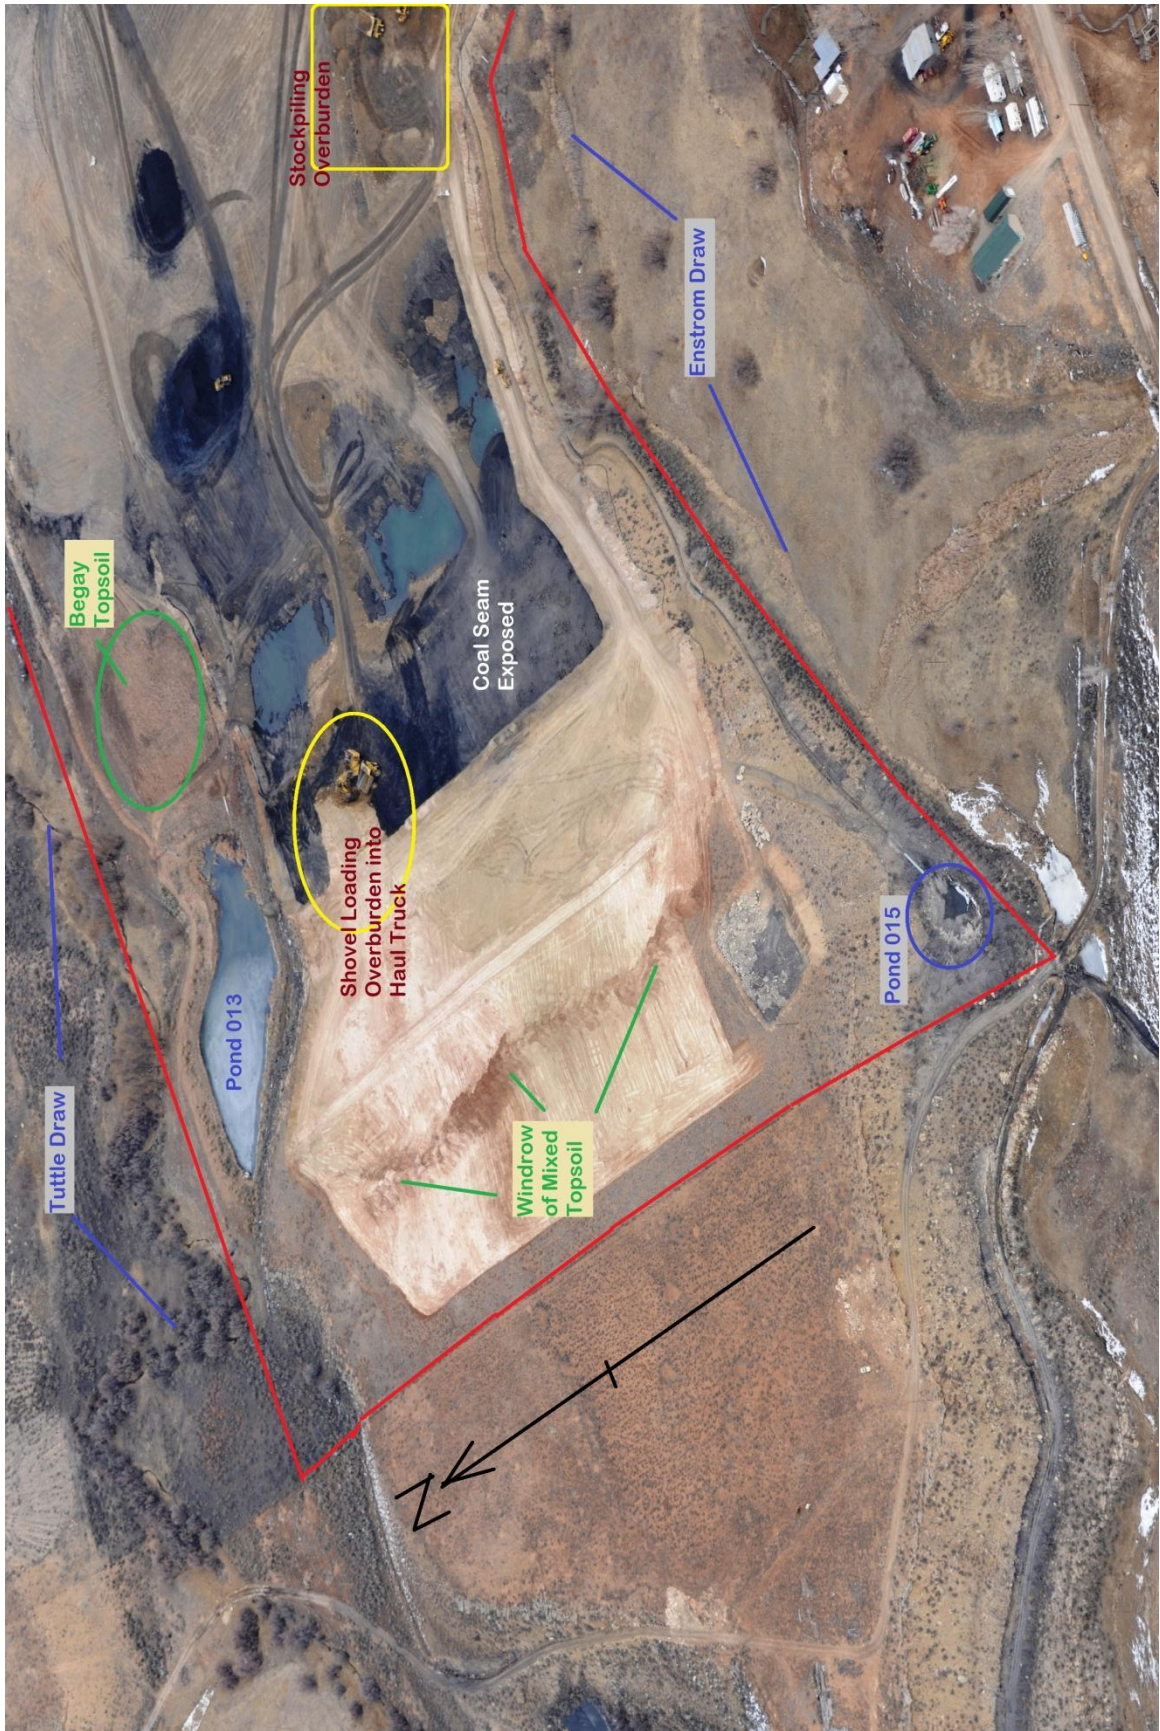
Photo 3 – Active operations – on parcel owned by WFC, looking NE

- With the exception of north-facing slopes, the snow noted in the January 2013 aerial inspection report had melted from the permit area.
- Standing water was present in the deeper portions of the active pit on the WFC parcel (Photos 3 and 4). The source of this water is unknown.
- Pond 008 appeared to be completely frozen, and Pond 007 was frozen, with the exception of the southwestern corner (Photo 2). The surface of Pond 013 was partially covered with ice (Photos 3 and 4).
- Ponds 011 and 015 were essentially dry.

- The mine's shovel was actively loading haul trucks with overburden from an area just south of Pond 013. It appeared that the trucks were dumping the material to the southeast of the pit, as shown on Photos 3 and 4.

- Topsoil stockpiles constructed in the earliest phase of mining are located south of the facilities area, next to the Irrigated Pasture Reference Area (Photo 5).
- Elongated ridges of “Mixed” topsoil have been constructed on the WFC parcel, east of the active pit operations (Photo 4).
- Topsoil from the final extent of the pit on the WFC parcel appears to have been pushed into a windrow in preparation for hauling the material to the area behind (east of) the pit (Photo 3).

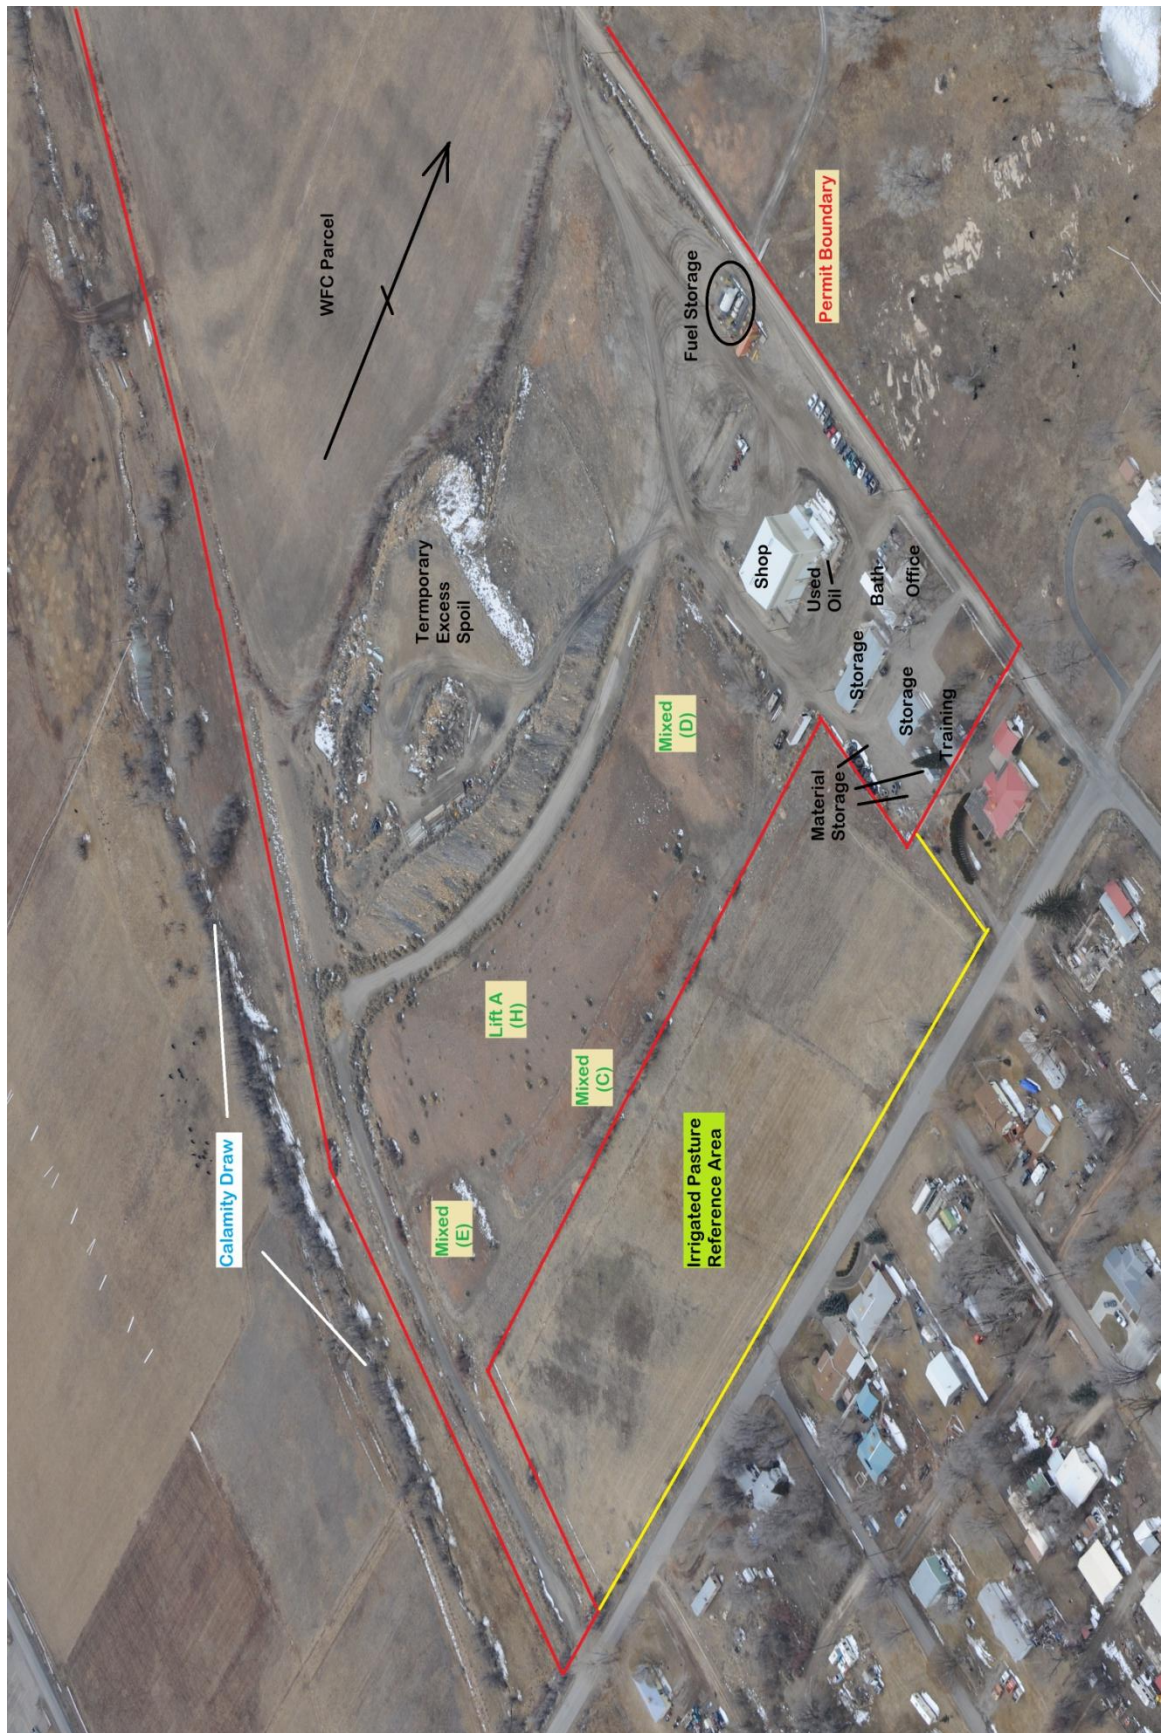
Photo 5 – Surface facilities, IP Reference Area, topsoil storage and boxcut overburden

- Support facilities for the mine are identified in Photo 5. The area appears to be neatly organized and well-kept.
