**COLORADO DIVISION OF RECLAMATION, MINING AND SAFETY
COAL PROGRAM INSPECTION REPORT**

Permit Number: C-1981-020 Mine Name: Munger Canyon Mine Operator: CAM Mining, LLC Operator Address: Mr. Gary Isaac P.O. Box 98 Loma, CO 81524	County: Garfield, Mesa Operation Type: Underground Permit Status: Permanent Cessation Ownership: Federal
	Operator Representative Present: None
Operator Representative Signature: (Field Issuance Only)

Inspection Start Date: February 27, 2013 Inspection Start Time: 12:15 Inspection End Date: February 27, 2013 Inspection End Time: 13:20	Inspection Type: Coal Partial Inspection Inspection Reason: Normal I&E Program Weather: Cloudy
Joint Inspection Agency: None	Joint Inspection Contacts:
Post Inspection Agency: None	Post Inspection Contacts:
Inspector(s): Michael P. Boulay	Inspector's Signature: <i>Michael P. Boulay</i> Signature Date: 3/5/13

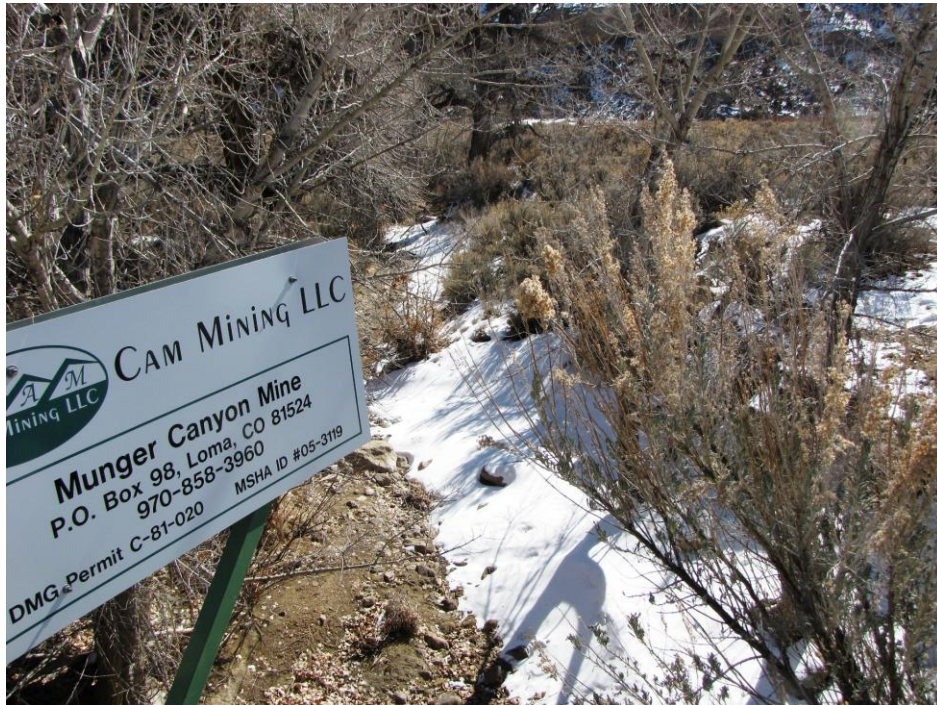
The mine identification sign with operator information, DRMS Permit Number and MSHA ID is in good condition and clearly visible at the gated entrance to the site. See attached photograph at the end of this inspection report.
