COLORADO DIVISION OF RECLAMATION, MINING AND SAFETY
MINERALS PROGRAM INSPECTION REPORT
PHONE: (303) 866-3567

MINE NAME: Thomeczek Pit	MINE/PROSPECTING ID#: M-1995-007	MINERAL: Sand and gravel	COUNTY: Bent
INSPECTION TYPE: Monitoring	INSPECTOR(S): Tyler V. O'Donnell	INSP. DATE: February 7, 2013	INSP. TIME: 15:00
OPERATOR: Bent County Ready Mix	OPERATOR REPRESENTATIVE: NONE	TYPE OF OPERATION: 110c - Construction Limited Impact

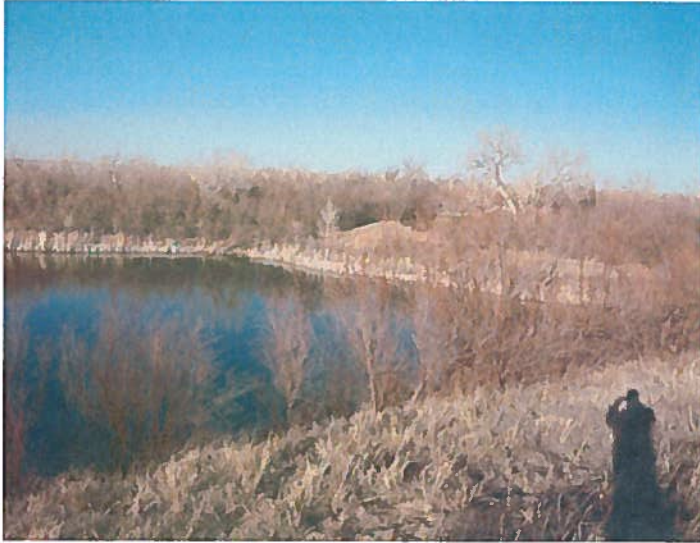
The excavated pit is now an approximate 3.5-acre pond that has shorelines with slopes of approximately 1.5H:1V to 2.5H:1V. The west side of the pond is a beach having a slope of approximately 4.5H:1V. A stockpile of excavated material extends along the southern permit boundary and is estimated to contain approximately 13,500 cubic yards of topsoil and overburden.

During the inspection, the surface area of the pond area was measured with a hand held GPS unit and was found to be approximately 3.5 acres. Division staff has determined the operator has a valid permanent augmentation plan to account for evaporative losses of the pond. The augmentation plan was obtained through the Lower Arkansas Water Management Association (LAWMA).

Photo 1: View looking northeast at the excavated pond.

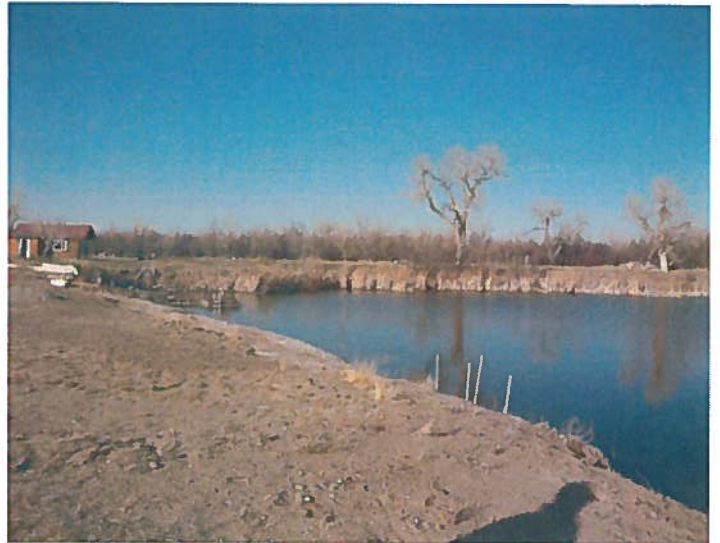
Photo 2: View looking north, sloped beach in foreground.

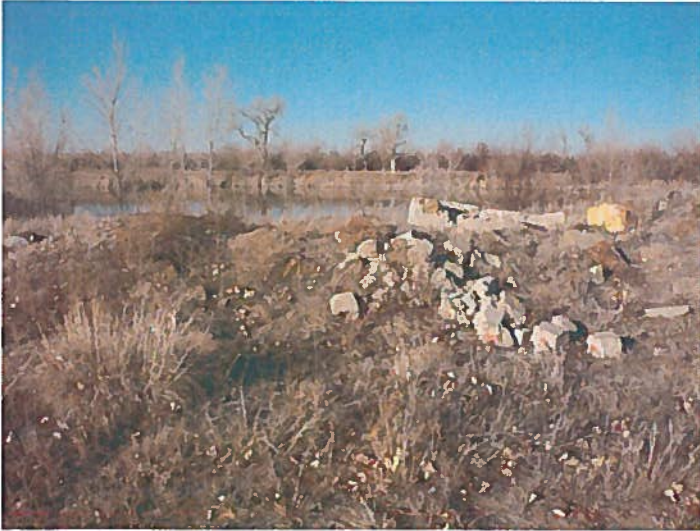
There was a small amount of construction waste located within the permit boundary see photo 3. This material needs to be removed.

Photo 3: Small pile of construction waste.

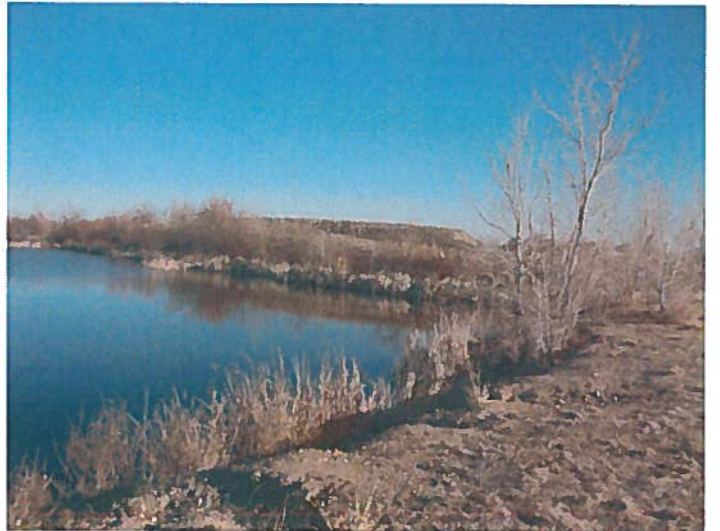
Photo 4: View looking southeast, stockpile in the background.

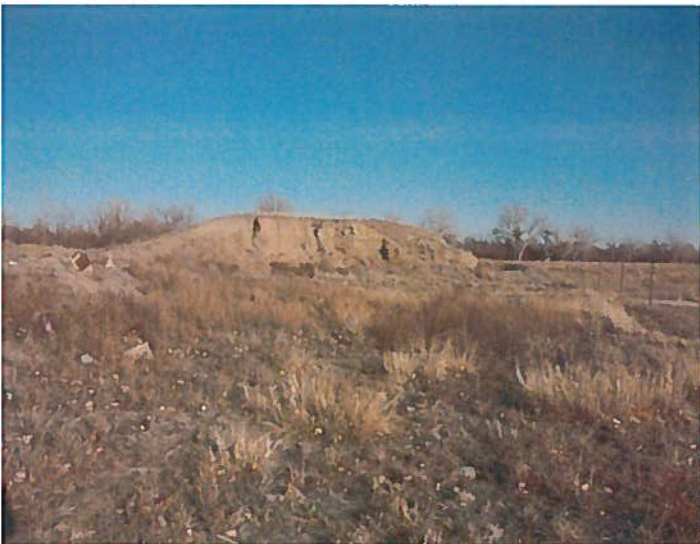
Photo 5: View looking east at the topsoil stockpile.

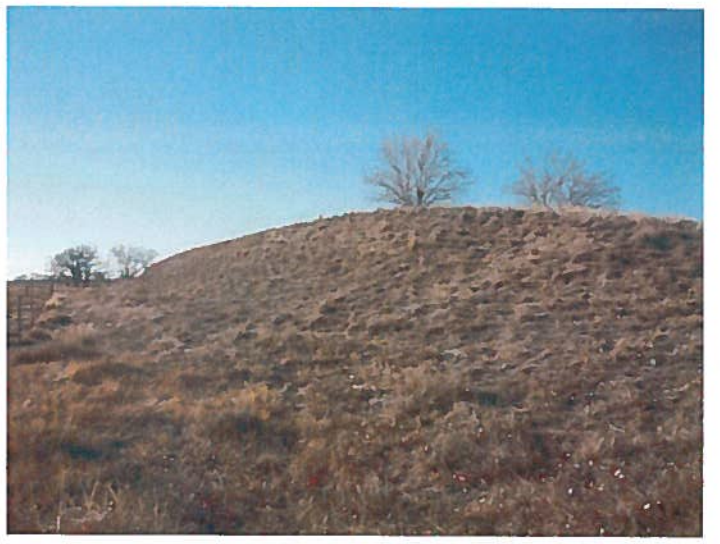
Photo 6: View looking west at the topsoil stockpile.
