**COLORADO DIVISION OF RECLAMATION, MINING AND SAFETY
COAL PROGRAM INSPECTION REPORT**

Permit Number: C-1996-084 Mine Name: Lorencito Canyon Mine Operator: New Elk Coal Company, LLC Operator Address: Mr Ron Thompson 12250 Highway 12 Weston, CO 81091	County: Las Animas Operation Type: Surface Permit Status: Permanent Cessation Ownership: Private
	Operator Representative Present: Ron Thompson
Operator Representative Signature: (Field Issuance Only)

Inspection Start Date: February 21, 2013 Inspection Start Time: 09:30 Inspection End Date: February 21, 2013 Inspection End Time: 12:00	Inspection Type: Coal Partial Inspection Inspection Reason: Normal I&E Program Weather: Cloudy
Joint Inspection Agency: None	Joint Inspection Contacts: None
Post Inspection Agency: None	Post Inspection Contacts: None
Inspector(s): Zach T. Trujillo	Inspector's Signature:

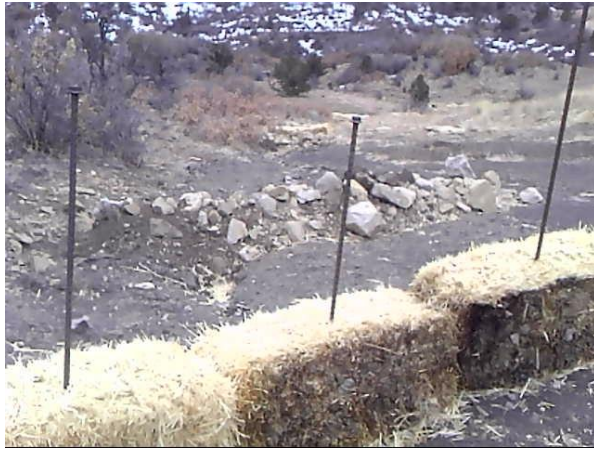
Pond 6 recently had repair work done to erosional cutting below the emergency spill way. Three sets of hay bales and rock check dams were placed as erosion mitigation. Check dams and hay bales were stable and secure. No fresh erosion and cutting were observed. Pond 6 was dry with stable embankments. Spillways were clear.

Maintenance below Pond 6.

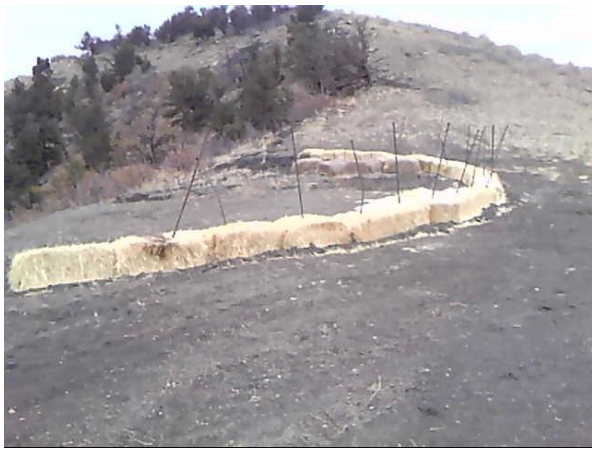
Pond 5 held no water and is stable. Near the top of the natural drainage into Pond 5, maintenance was performed to mitigate erosion. Two rows of hay bales were placed near the cutting. No additional erosion appears to have occurred.

Hay bales above natural drainage to Pond 5.

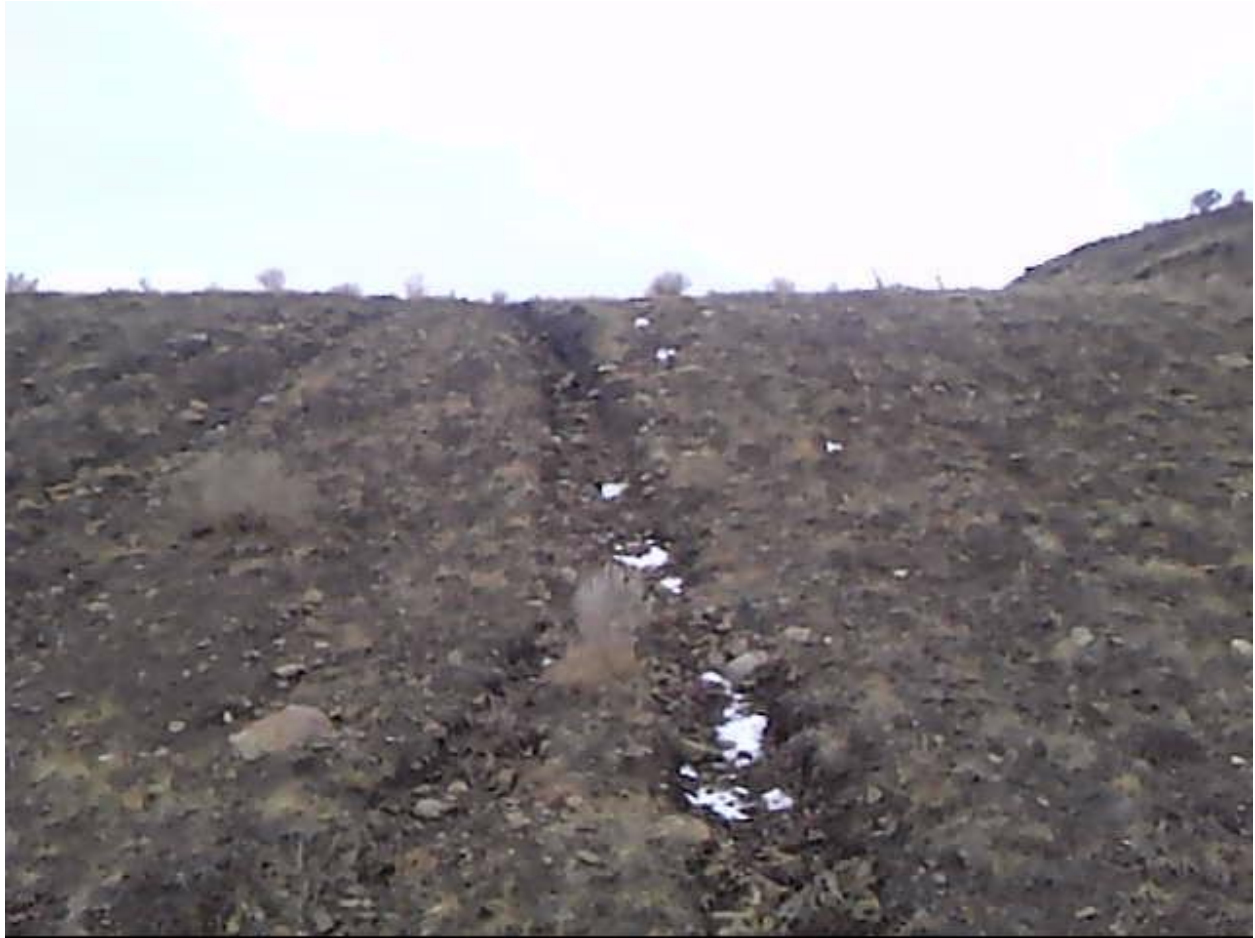
Fills numbered 7, 8 and 9 were inspected. All fills were stable and well vegetated. As previously noted in the January inspection report, a large gully has formed along the north facing slope in the area between pond 8 and pond 9b, near the top of the drainage and should have been repaired. The gully is several feet wide and deep and **will need to be repaired by March 31, 2013.**

Gully between Pond 8 and Pond 9b in need of repair **by March 31, 2013.**

As previously noted in the Excess Spoil and Developmental Waste section of this report and previous inspection reports, the gully formed along is in need of maintenance. **The gully will need to be repaired by March 31, 2013.**
