## COLORADO DIVISION OF RECLAMATION, MINING AND SAFETY COAL PROGRAM INSPECTION REPORT

<b>Permit Number:</b> C-1981-035 <b>Mine Name:</b> King Coal Mine <b>Operator:</b> GCC Energy, LLC <b>Operator Address:</b> Mr Tom Bird 6473 County Road 120 Hesperus, CO 81326	<b>County:</b> La Plata <b>Operation Type:</b> Underground <b>Permit Status:</b> Active <b>Ownership:</b> Federal
	<b>Operator Representative Present:</b>  Tom Bird and Wade Wymore
<b>Operator Representative Signature: (Field Issuance Only)</b>  This report was issued electronically from the Division's Durango Field Office.

<b>Inspection Start Date:</b> February 21, 2013 <b>Inspection Start Time:</b> 13:45 <b>Inspection End Date:</b> February 21, 2013 <b>Inspection End Time:</b> 16:25		<b>Inspection Type:</b> Coal Complete Inspection <b>Inspection Reason:</b> Normal I&E Program <b>Weather:</b> Snowing	
<b>Joint Inspection Agency:</b>  None		<b>Joint Inspection Contacts:</b>	
<b>Post Inspection Agency:</b>  None		<b>Post Inspection Contacts:</b>	
<b>Inspector(s):</b>  Marcia L. Talvitie, P.E.	<b>Inspector's Signature:</b>

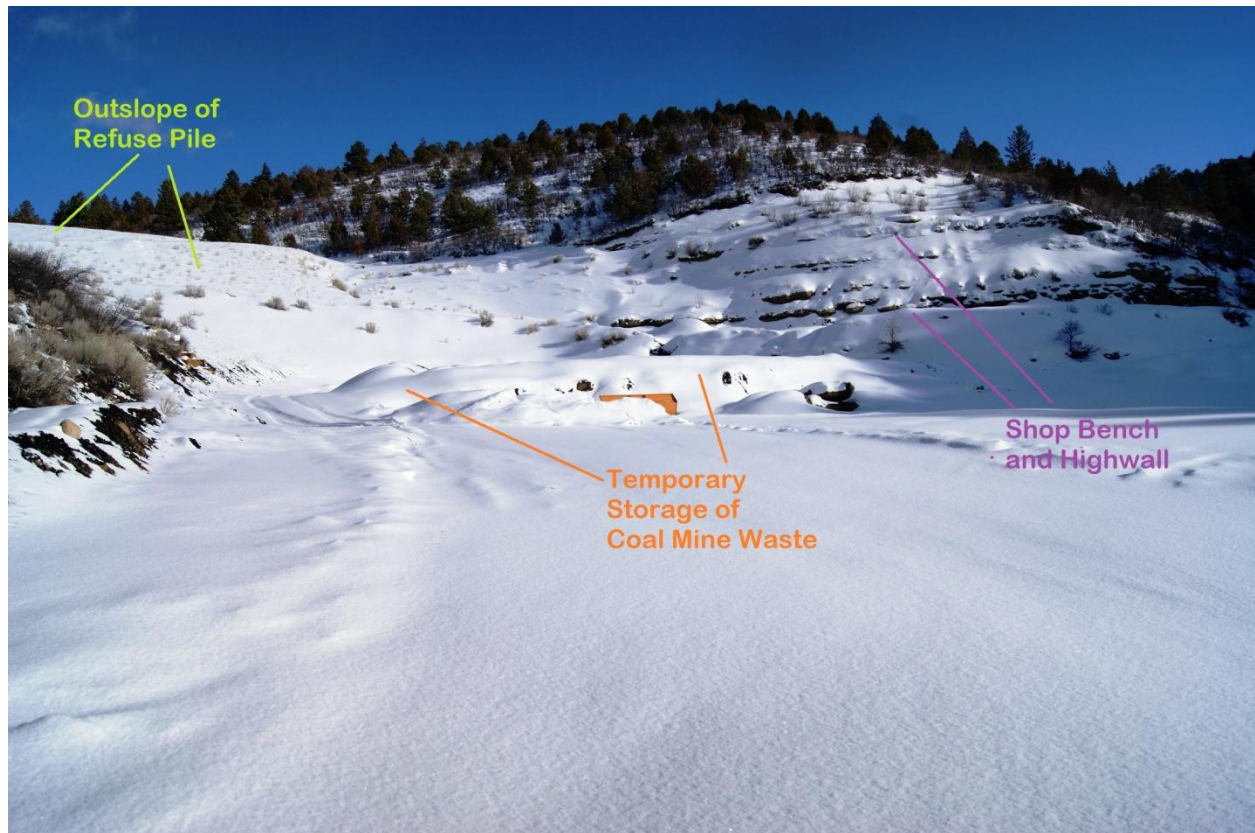
- The refuse pile at King I was covered with snow (Photo 1), and access to the pile was not attempted.
- During the winter, the operator has been dumping loads of development waste in the yard at King I, for temporary storage until final placement can be accomplished on the refuse pile.

Photo 1 – King I refuse pile, temporary CMW storage, and shop bench

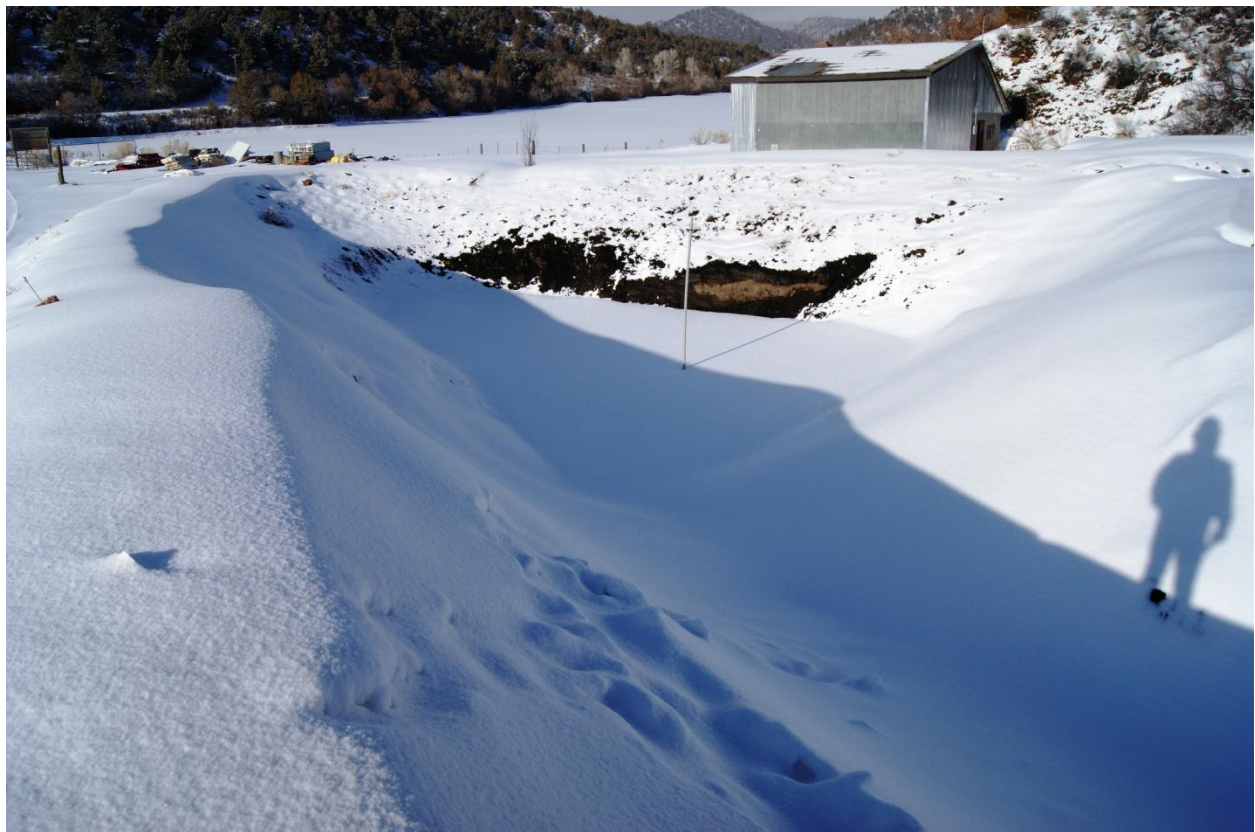
- The ponds at King I, which lies in a shaded, northward-trending valley, were covered in snow. The east sediment pond may have held some water, which had iced over prior to the snow fall (Photo 2).

Photo 2 – East sedimentation pond at King I

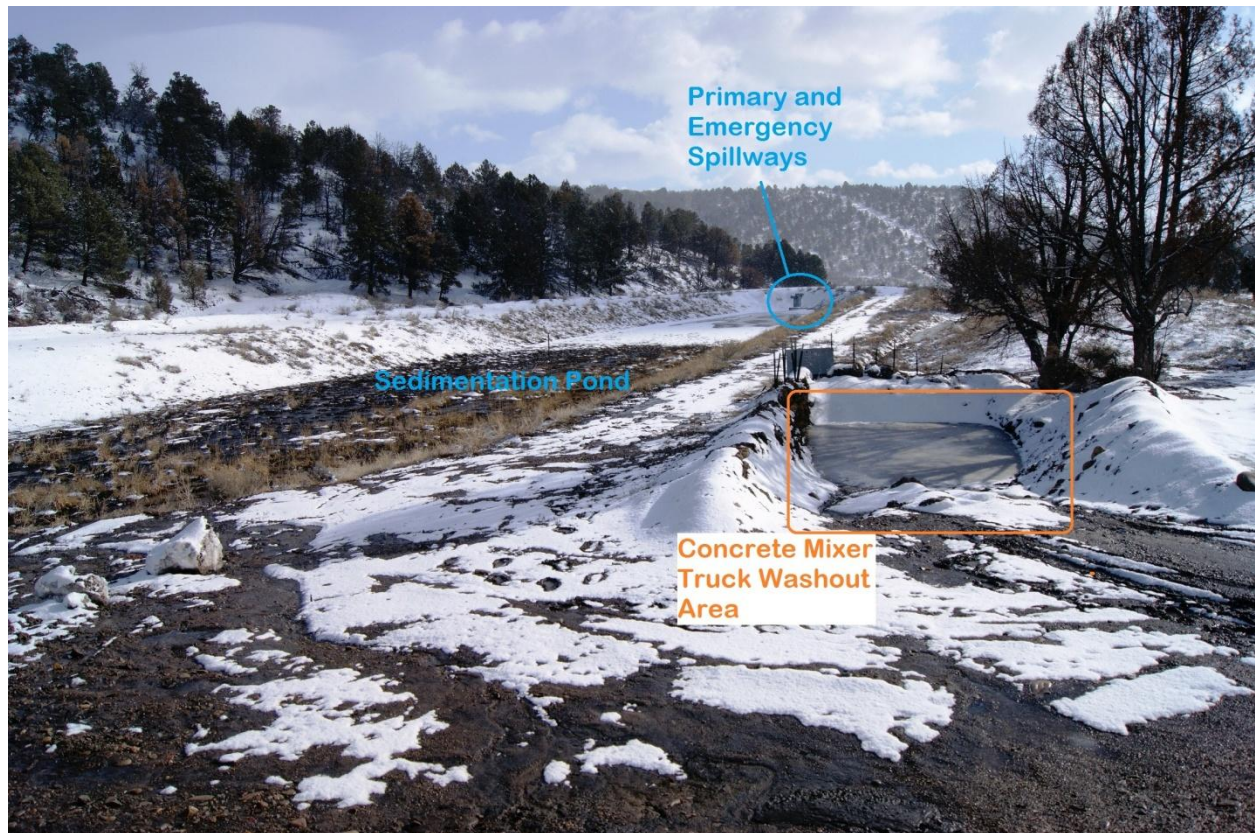
- At King II, the floor of the sediment pond was wet at the north, snow-covered in the middle, and iced over at the southern end, near the spillways (Photo 3).

Photo 3 – King II sedimentation pond, looking SE

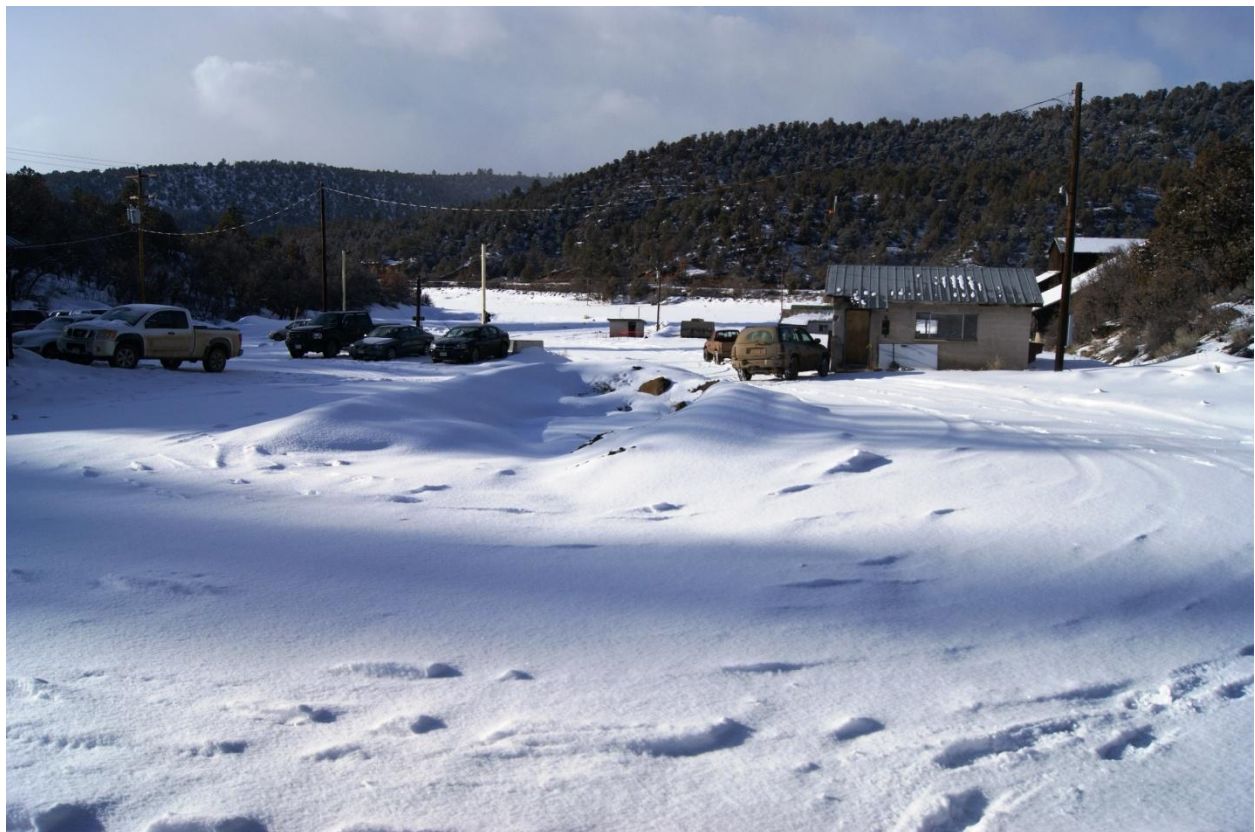
- The King I haul/access road was covered with fresh snow that had fallen during the inspection, in addition to the snow-packed surface that existed beneath (Photo 4).
- Roadways at King II had been cleared of snow, and highway-legal trucks were arriving at the site to be loaded with coal.

Photo 4 – King I surface facilities, looking north

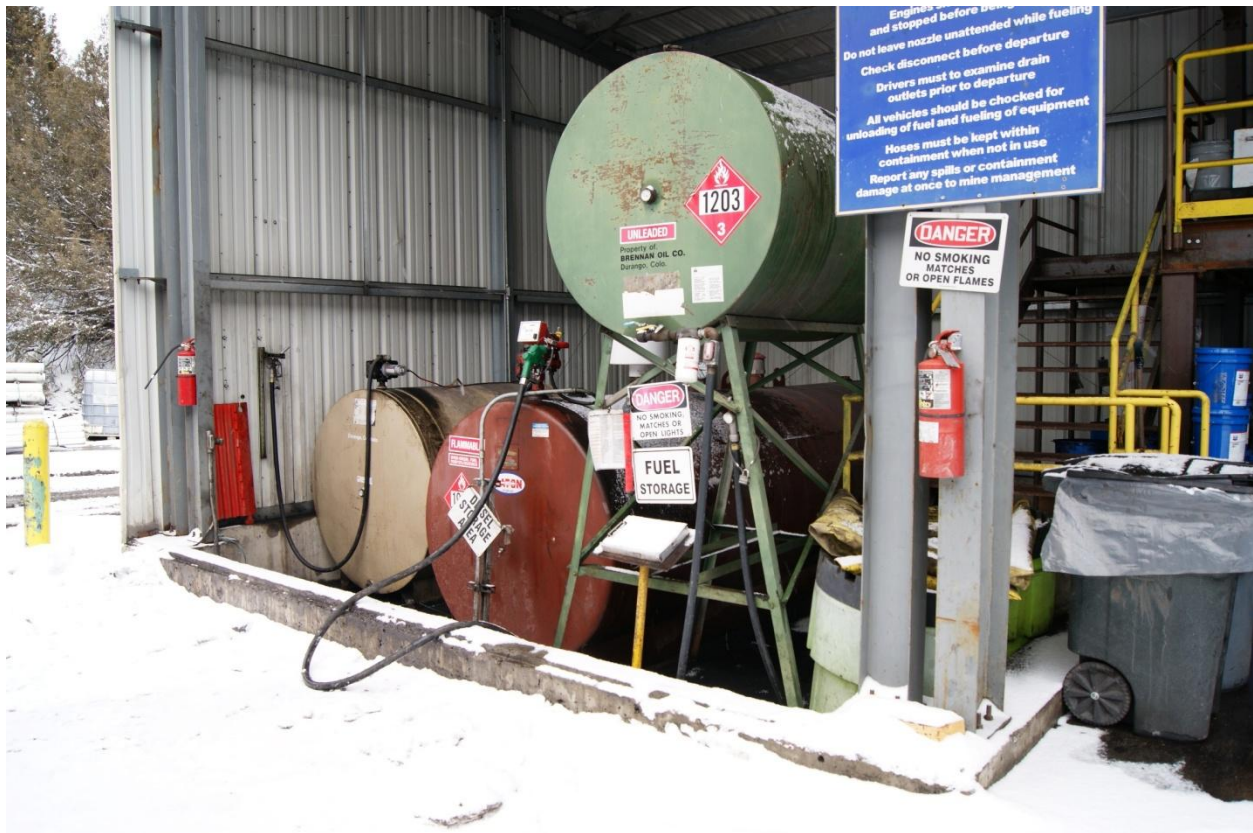
- Petroleum products are stored in a three-sided structure at the King II surface facilities (Photo 5). Secondary containment is provided for the large fuel tanks in the form of a concrete-lined depression in the floor. Drums and smaller items are kept on grates above an oil collection area or on pallets which provide secondary containment (Photo 6).
- Construction of the foundation for the permanent office and bath house building appears to be complete (Photo 7). Mr. Bird said that GCC is still working with the County to obtain approval to finish the superstructure.
- The area surrounding the rock dust silo has been regraded, and surfaced with concrete (Photo 8).

Photo 5 – Petroleum storage – fuel tanks

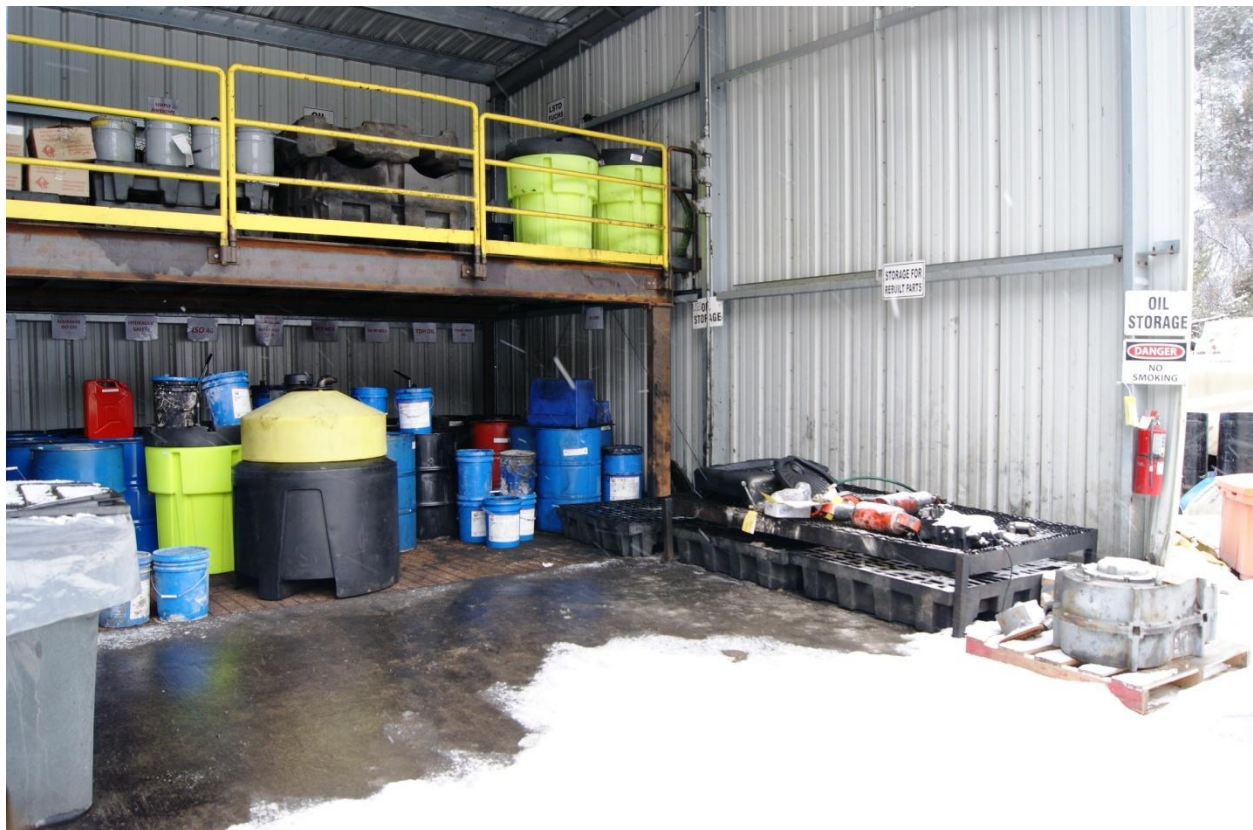
Photo 6 – Petroleum storage – drums and smaller containers

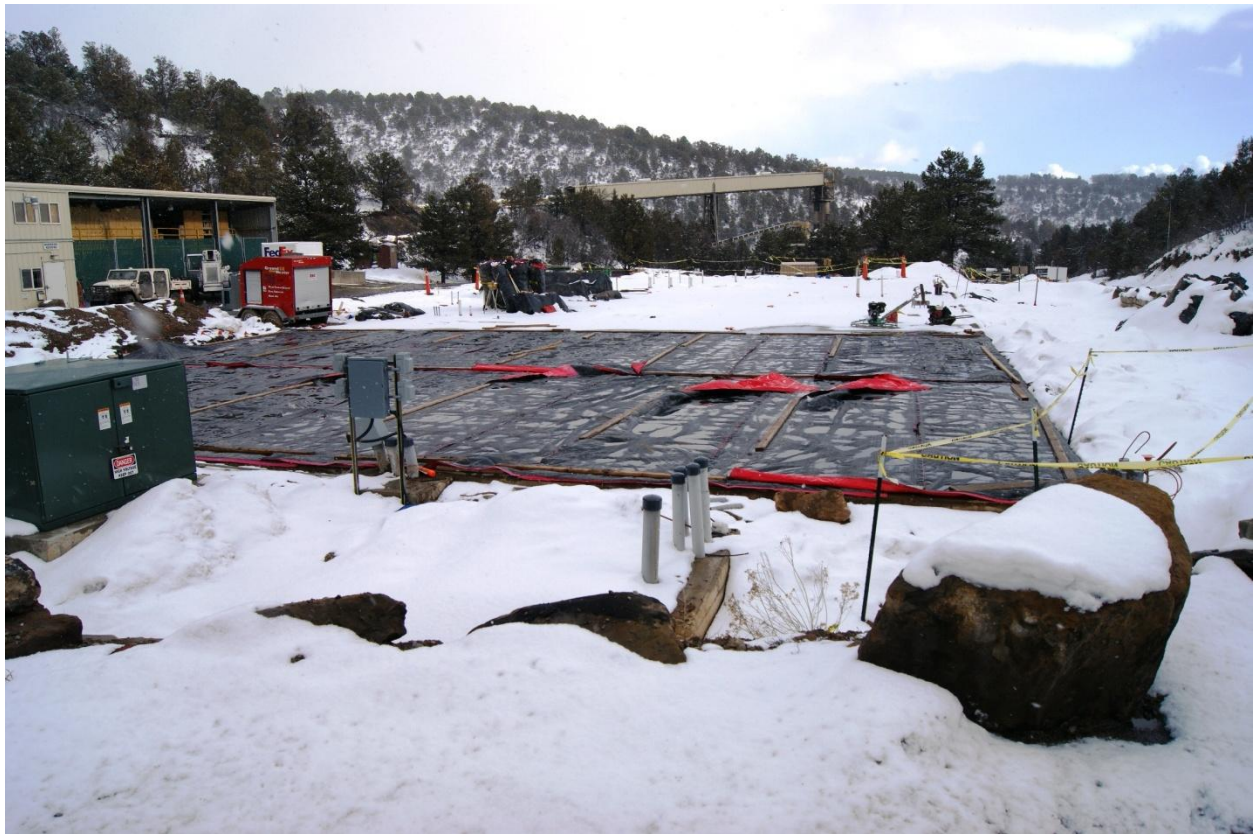
Photo 7 – Foundation for office / bath building at King II

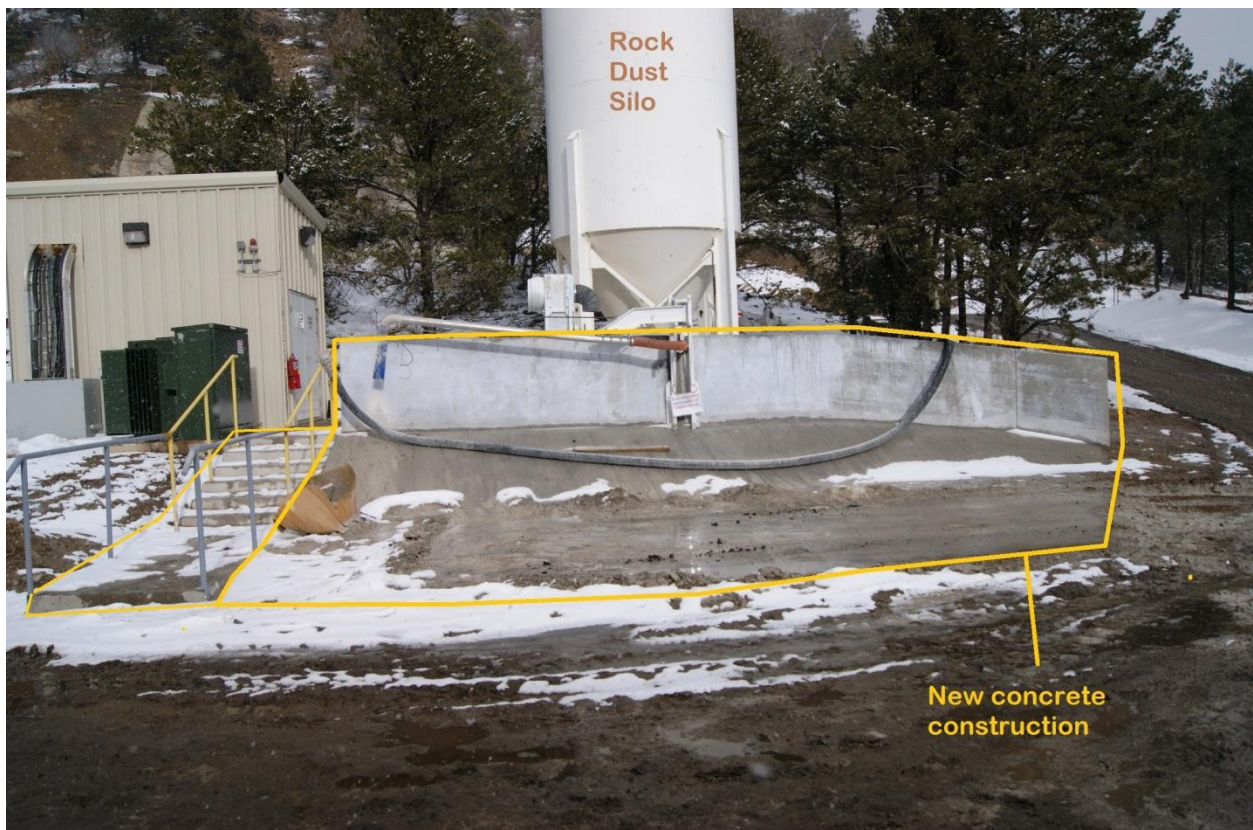
Photo 8 – Rock dust silo modifications
