COLORADO DIVISION OF RECLAMATION, MINING AND SAFETY
MINERALS PROGRAM INSPECTION REPORT
PHONE: (303) 866-3567

MINE NAME: Mid-Continent LST	MINE/PROSPECTING ID#: M-1982-121	MINERAL: Limestone (general)	COUNTY: Garfield
INSPECTION TYPE: Monitoring	INSPECTOR(S): Stephanie J. Reigh	INSP. DATE: February 7, 2013	INSP. TIME: 10:15
OPERATOR: CalX Minerals, L.L.C.	OPERATOR REPRESENTATIVE: Peter Babin & Justin Olin	TYPE OF OPERATION: 112c - Construction Regular Operation

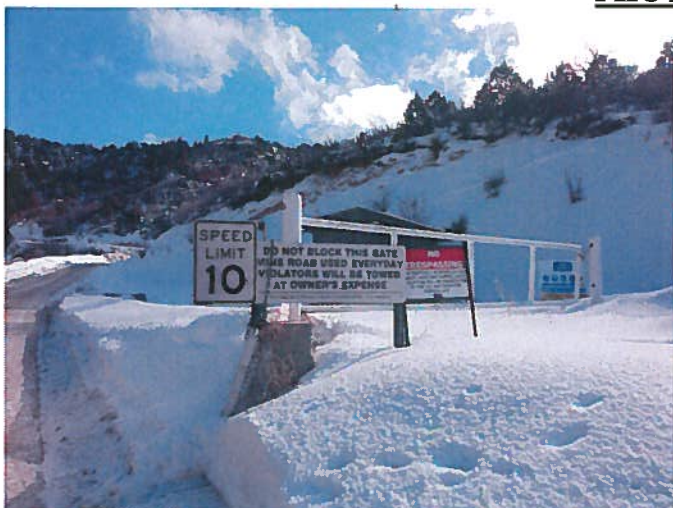
Signage, but no MLRB Permit Number

Adequate mine identification signage was noted at the entrance to the site in accordance with Rule 3.1.12(1). However, the Division would like to see the permit identification number added to the signage. Please add the permit identification number M-1982-121 to the signage and submit photo by email or mail to the Division by March 22, 2013.

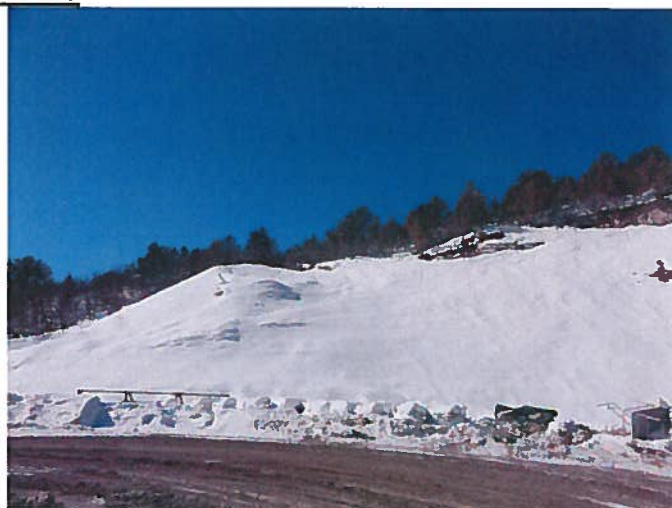
Topsoil Stockpile

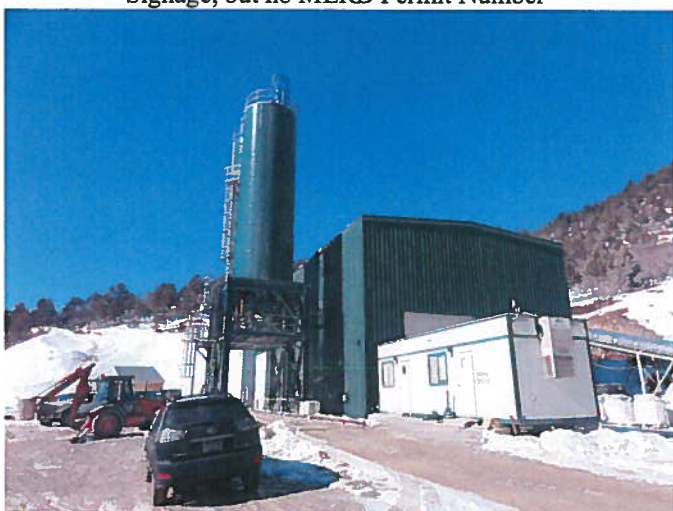
Mill

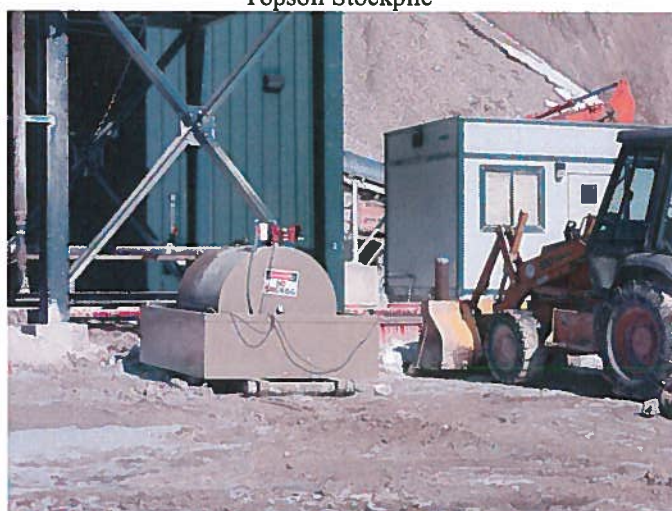
Fuel Storage with adequate containment system

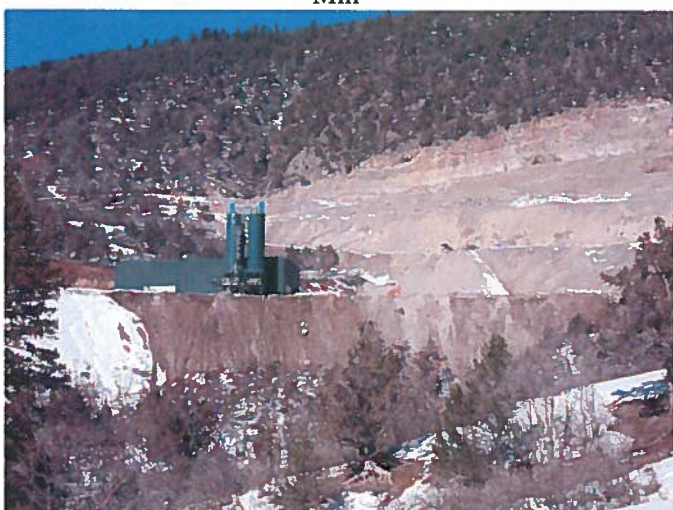
Overall site, note rilling on south side of mill bench

Mining is progressing to the north. Three production benches were noted above the process bench, which is located just north and uphill from the mill bench. The topsoil stock pile appeared to be stable. Rilling is starting to become apparent on the south side of the mill bench. Please address the rilling by maintaining the berm that is present on the mill bench.
