# COLORADO DIVISION OF RECLAMATION, MINING AND SAFETY COAL PROGRAM INSPECTION REPORT

<b>Permit Number:</b> C-1980-001 <b>Mine Name:</b> Edna Strip Mine <b>Operator:</b> Chevron Mining, Inc. <b>Operator Address:</b> Mr. Ian Robb 6101 Bollinger Canyon Road, Room 5390 San Ramon, CA 94583	<b>County:</b> Routt <b>Operation Type:</b> Surface <b>Permit Status:</b> Permanent Cessation <b>Ownership:</b> Federal
<b>Operator Representative Present:</b>	
<b>Operator Representative Signature: (Field Issuance Only)</b>

<b>Inspection Start Date:</b> March 14, 2013 <b>Inspection Start Time:</b> 10:57 <b>Inspection End Date:</b> <b>Inspection End Time:</b>	<b>Inspection Type:</b> Aerial Inspection <b>Inspection Reason:</b> Normal I&E Program <b>Weather:</b> Clear
<b>Joint Inspection Agency:</b>  None	<b>Joint Inspection Contacts:</b>
<b>Post Inspection Agency:</b>  None	<b>Post Inspection Contacts:</b>
<b>Inspector(s):</b>  Robert D. Zuber	<b>Inspector's Signature:</b>  <i>Robert D. Zuber</i>  <b>Signature Date:</b>  3/18/2013

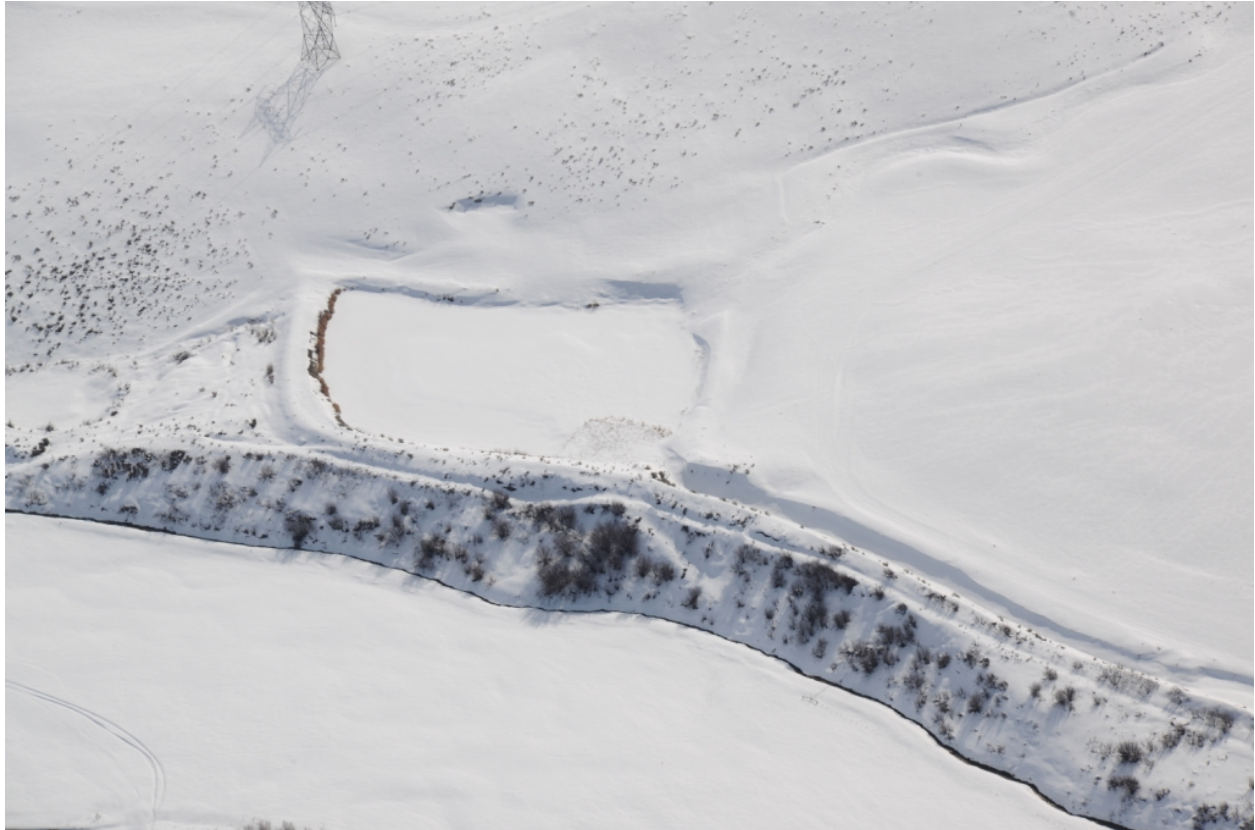
**West Ridge Pond**

West Ridge Pond and Center Ridge Pond were inspected and no problems were seen. The check dams above West Ridge Pond (aka the “String of Pearls”) were also inspected and no problems were seen.

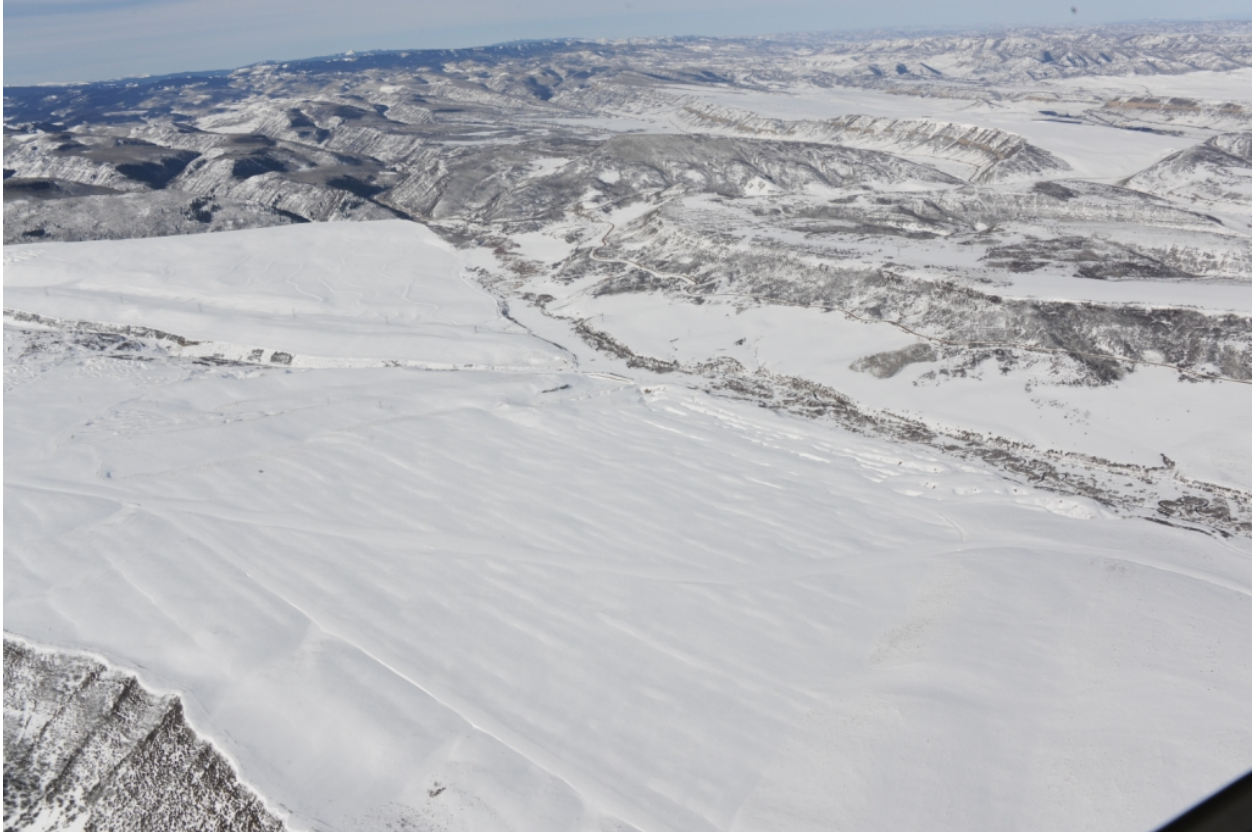
**Edna Mine, looking south**

No large gullies or other problems were detected on any of the reclamation.
