**COLORADO DIVISION OF RECLAMATION, MINING AND SAFETY  
COAL PROGRAM INSPECTION REPORT**

<b>Permit Number:</b> C-1981-012 <b>Mine Name:</b> New Elk Mine <b>Operator:</b> New Elk Coal Company, LLC <b>Operator Address:</b> Mr Ron Thompson 12250 Highway 12 Weston, CO 81091	<b>County:</b> Las Animas <b>Operation Type:</b> Underground <b>Permit Status:</b> Temporary Cessation <b>Ownership:</b> Private
	<b>Operator Representative Present:</b>  Ron Thompson
<b>Operator Representative Signature:</b> (Field Issuance Only)

<b>Inspection Start Date:</b> March 11, 2013 <b>Inspection Start Time:</b> 14:45 <b>Inspection End Date:</b> March 12, 2013 <b>Inspection End Time:</b> 10:00	<b>Inspection Type:</b> Coal Partial Inspection <b>Inspection Reason:</b> Normal I&E Program <b>Weather:</b> Clear
<b>Joint Inspection Agency:</b>  None	<b>Joint Inspection Contacts:</b>
<b>Post Inspection Agency:</b>  None	<b>Post Inspection Contacts:</b>
<b>Inspector(s):</b>  Jason D. Musick  Elliott R. Russell	<b>Inspector's Signature:</b>

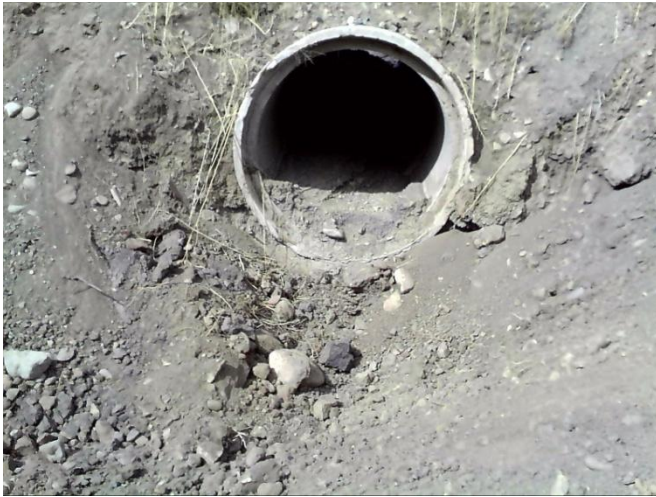
- Culvert C-2 has been reduced to one concrete culvert. The ditch at the inlet and the outlet ditch have been shaped. Approximately 1/4 of sediment remains in the bottom of C-2 that will be flushed out.

Culvert C-2 Inlet

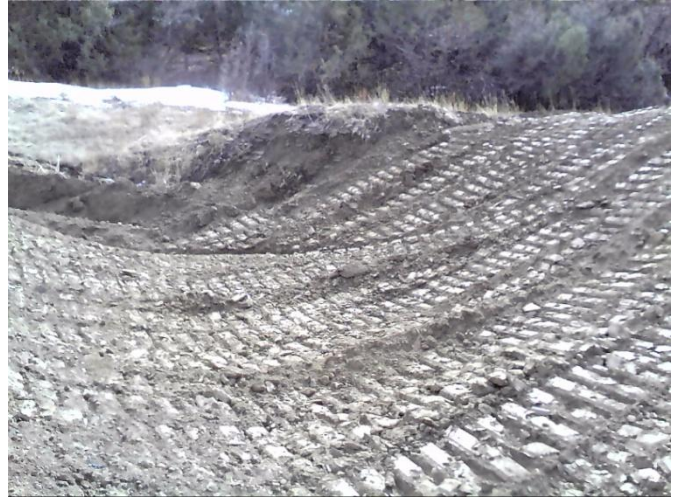
D-34 Re-established at Inlet to C-2

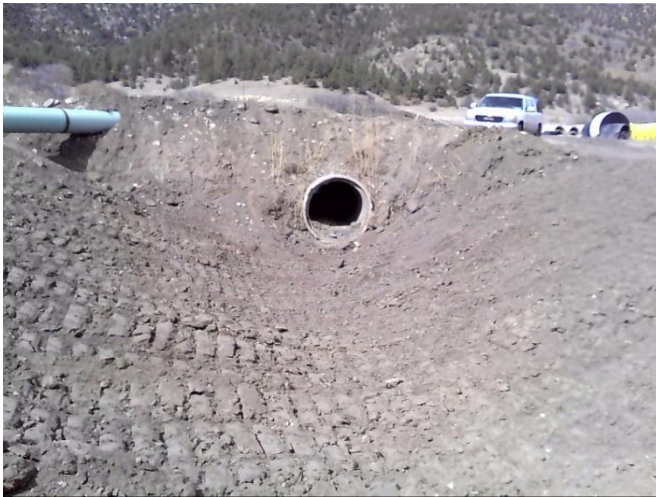
Culvert C-2 Inlet

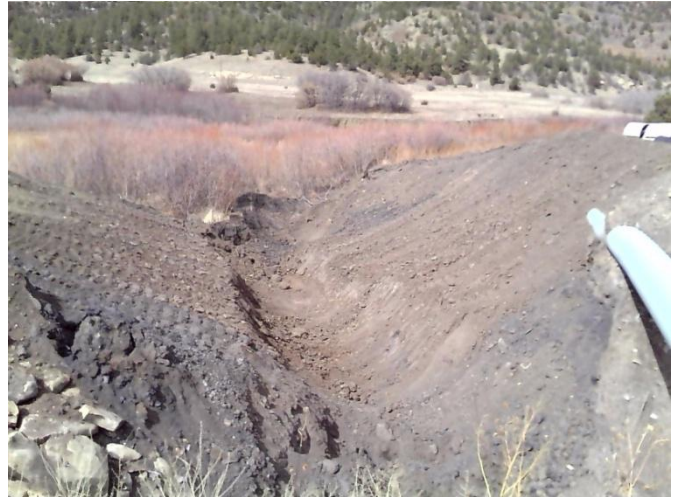
Removal of Second C-2 Location/Re-established Ditch

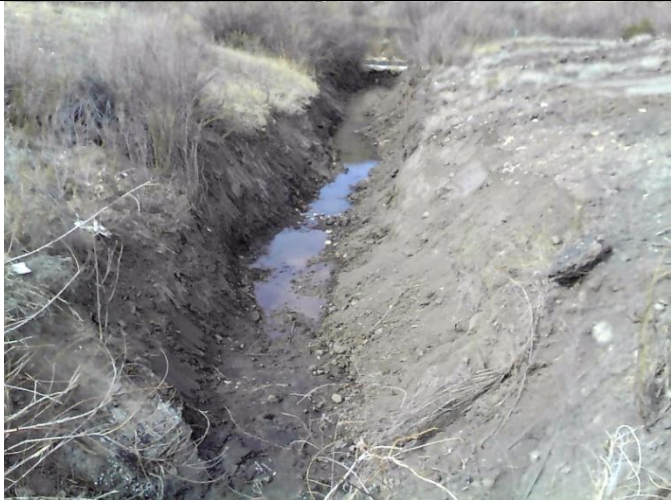
Re-established Ditch 7 from C-3 to River

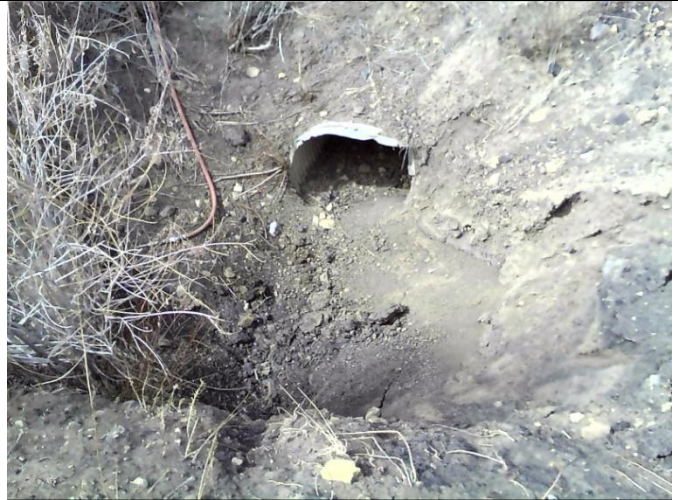
- The ditch at the outlet of culvert C-3 has been reestablished. The inlet of Culvert C-3 has been cleared with ~1/4 of sediment remaining in the culvert, which will require flushing. A water hose was at the inlet. **The culvert will require cleaning by March 31, 2013.**

Inlet of Culvert C-3

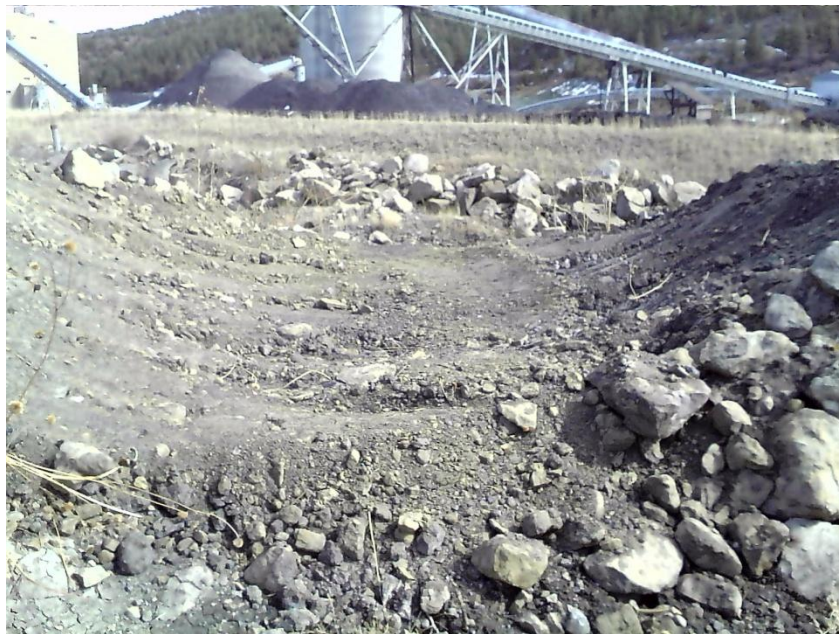
- Culvert C-26 has been removed. Ron Thompson of NECC stated that the area in which C-26 was previously installed will be graded down to a channel and rip-rapped. The channel was established and the riprap was on-site. Note that the reestablished channel appears higher than the existing ditch, the channel at the previous C-26 location will require proper flow to the outlet.

Area of Culvert C-26 Removal and Channel Establish

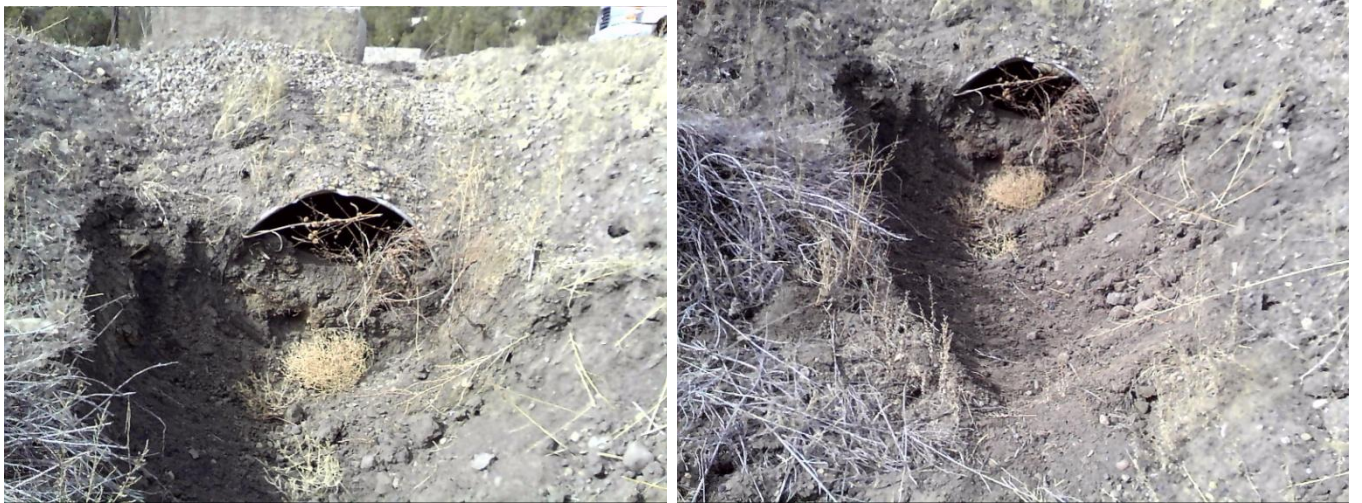
- Culvert C-17B was near completion. The culvert was removed.
- Culvert C-6 has been cleaned at the inlet of the culvert; however, the culvert remains ~3/4 full of sediment. This material will require removal. **The culvert will require cleaning by March 31, 2013.**

Culvert C-6 Inlet Clean-out and Sediment in Culvert

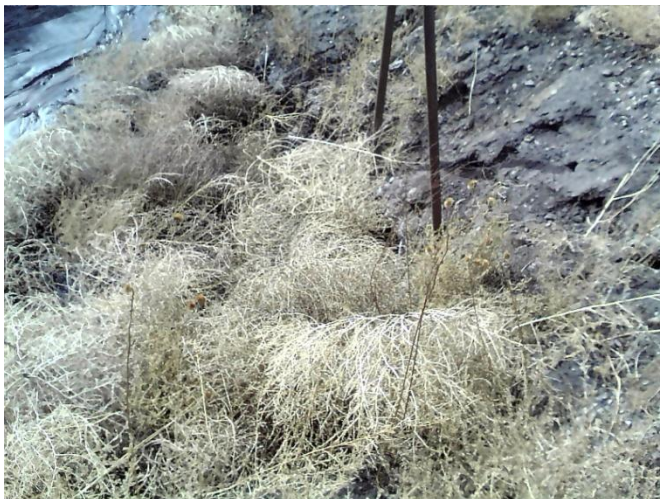
- Culvert C-20 at Pond 007 has yet to be cleaned out at the inlet. **The culvert will require cleaning by March 31, 2013.**

Culvert C-20 Inlet

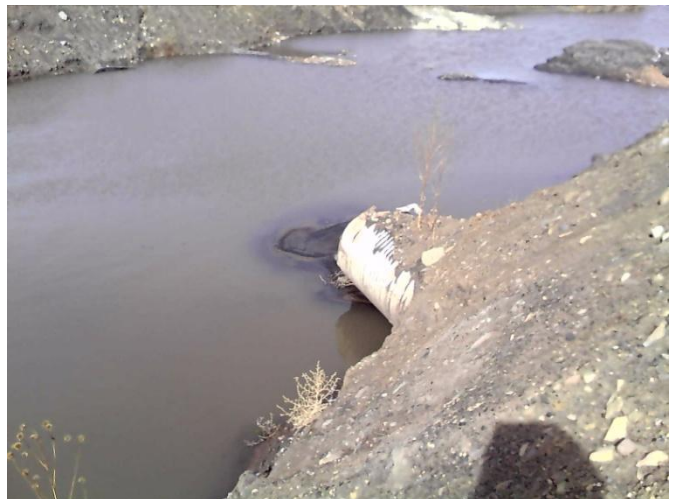
Culvert C-20 Outlet

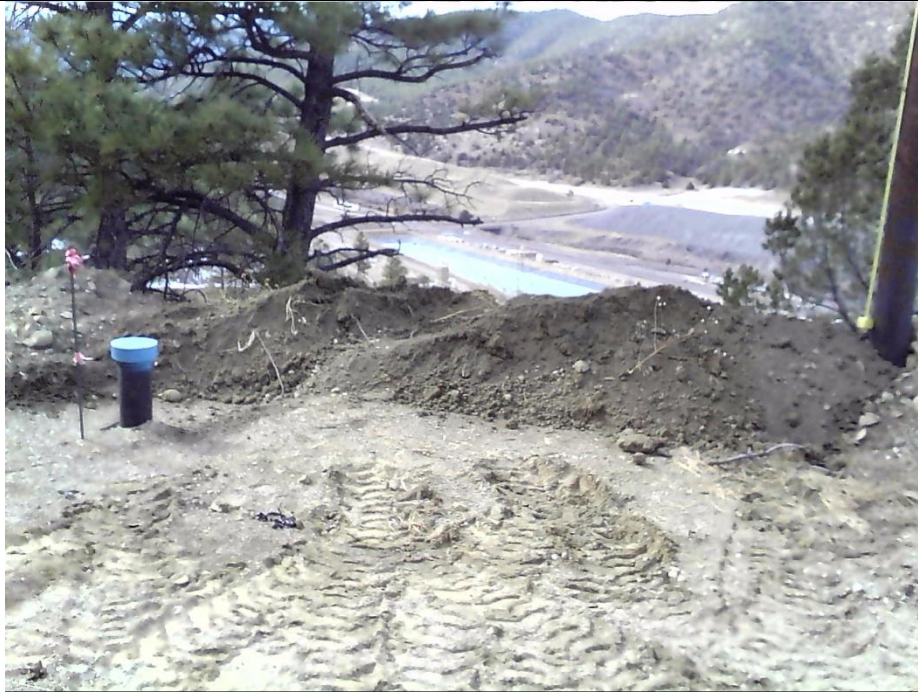
- The berm at the Water Tank SAE has been repaired with no problems noted.

Water Tank SAE Berm Repair

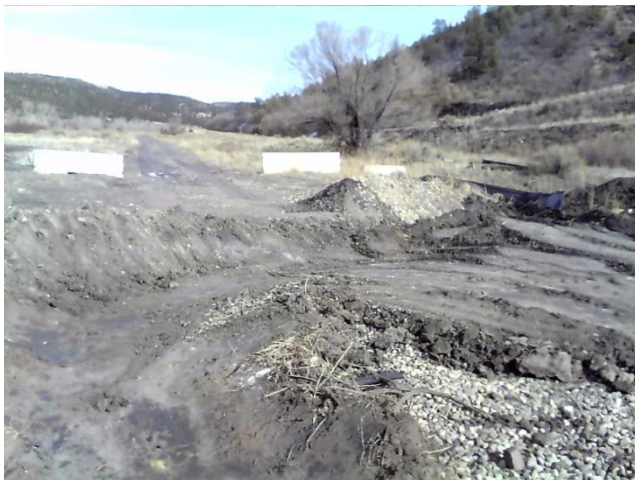
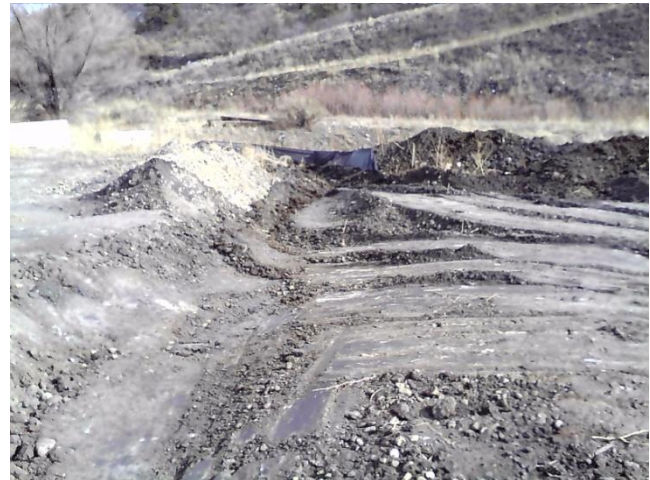
- The silt fence at the topsoil pile SAE and the silt fence at the Pond 007 SAE will need to be reinstalled as designed to ensure functionality. The SAEs has been recently re-graded and the silt fence damaged. **The reestablishment of the silt fence will require maintenance by March 31, 2013.**
- Straw bale BMP's at the conveyor supports south of the river and north of the wash plant have yet to be replaced. New straw bales have been placed to be installed, but work had yet to be completed at the time of this inspection.
- The SAE berm east of Pond 007 had yet to be restored. However, NECC has established a drainage channel to divert flow through the permitted rock filter outlet point. This channel allows the capture of the run-off while allowing access to the light use road to the east.

SAE East of Pond 007 Repair Work

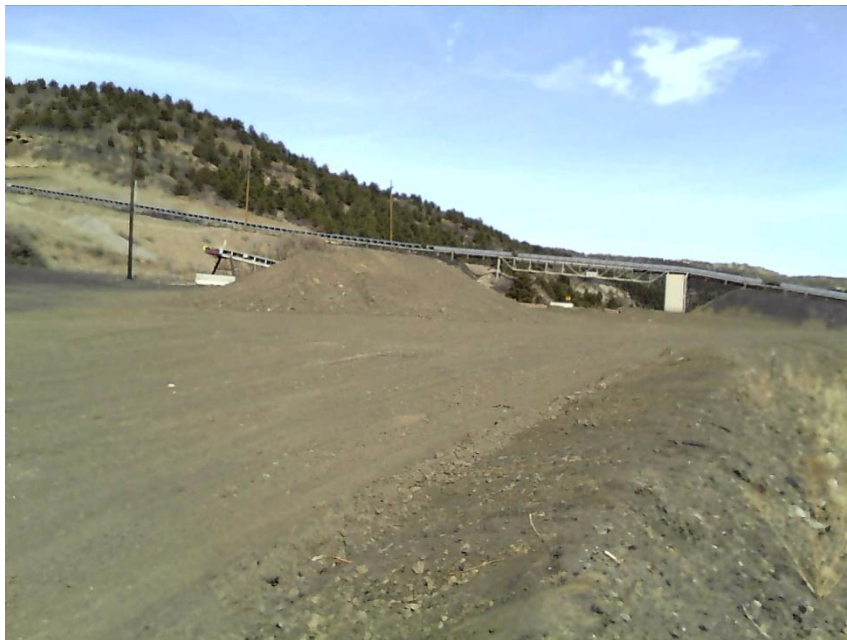
The topsoil SAE has been recently re-graded and is stable. A subsoil pile is currently on the site. No problems were noted with the exception of the following:

Soil Located on Topsoil SAE

- If NECC intends for the stockpiled subsoil to remain on the SAE, appropriate seeding will be required in addition to the appropriate markers per 4.02.7.
