**COLORADO DIVISION OF RECLAMATION, MINING AND SAFETY  
COAL PROGRAM INSPECTION REPORT**

<b>Permit Number:</b> C-1981-013 <b>Mine Name:</b> Golden Eagle Mine <b>Operator:</b> New Elk Coal Company, LLC <b>Operator Address:</b> Mr Ron Thompson 12250 State Highway 12 Weston, CO 81091	<b>County:</b> Las Animas <b>Operation Type:</b> Underground <b>Permit Status:</b> Permanent Cessation <b>Ownership:</b> Private
	<b>Operator Representative Present:</b>  Ron Thompson
<b>Operator Representative Signature: (Field Issuance Only)</b>

<b>Inspection Start Date:</b> March 11, 2013 <b>Inspection Start Time:</b> 11:45 <b>Inspection End Date:</b> March 11, 2013 <b>Inspection End Time:</b> 12:00	<b>Inspection Type:</b> Coal Partial Inspection <b>Inspection Reason:</b> Normal I&E Program <b>Weather:</b> Clear
<b>Joint Inspection Agency:</b>  None	<b>Joint Inspection Contacts:</b>
<b>Post Inspection Agency:</b>  None	<b>Post Inspection Contacts:</b>
<b>Inspector(s):</b>  Jason D. Musick  Elliott R. Russell	<b>Inspector's Signature:</b>

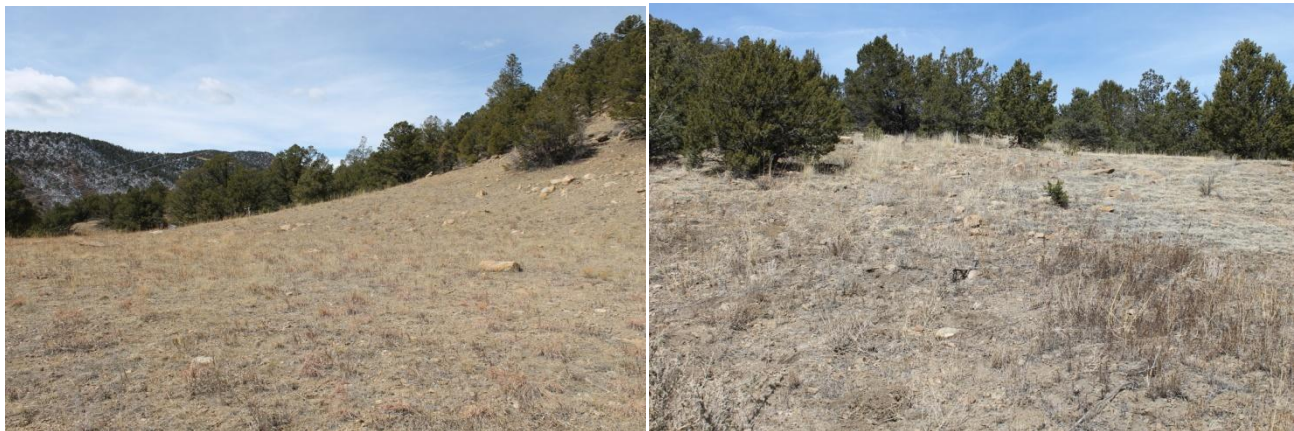
SCF-1 Vent Shaft Pad

No evident problems on reclaimed vent shaft SCF-1. The site was stable with no problems noted.

The reclaimed SCF-1 site remains unchanged from the previous inspection conducted in February, 2013.

Vegetative cover of the site was adequate to control erosion. No evidence of erosion was observed on the site and no infestations of noxious or invasive weeds were present at the time of the inspection.

Disturbance area markers were in place delineating the extent of SCF-1. The markers were white pvc pipe on underground mining roof bolts. No problems were noted.
