**COLORADO DIVISION OF RECLAMATION, MINING AND SAFETY
COAL PROGRAM INSPECTION REPORT**

Permit Number: C-1996-084 Mine Name: Lorencito Canyon Mine Operator: New Elk Coal Company, LLC Operator Address: Mr. Ron Thompson 12250 Highway 12 Weston, CO 81091	County: Las Animas Operation Type: Surface Permit Status: Permanent Cessation Ownership: Private
	Operator Representative Present: Ron Thompson
Operator Representative Signature: (Field Issuance Only)

Inspection Start Date: March 11, 2013 Inspection Start Time: 12:15 Inspection End Date: March 11, 2013 Inspection End Time: 14:15	Inspection Type: Coal Partial Inspection Inspection Reason: Normal I&E Program Weather: Clear
Joint Inspection Agency: None	Joint Inspection Contacts:
Post Inspection Agency: None	Post Inspection Contacts:
Inspector(s): Jason D. Musick Elliott R. Russell	Inspector's Signature:

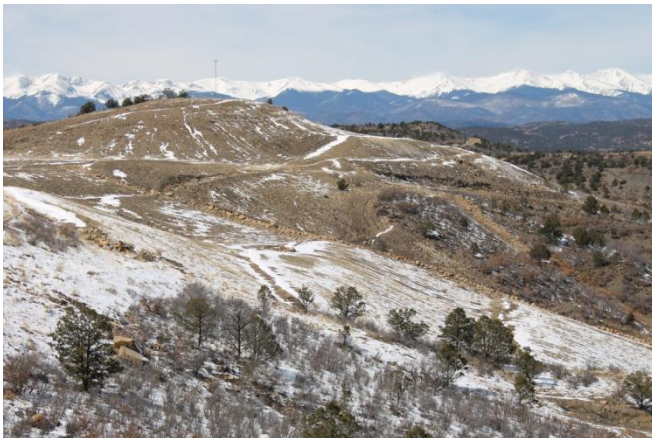
Fill 8

Excess spoil fills No. 8, No. 9, and No. 7 were observed during the inspection. All fills were stable with adequate vegetative cover to prevent erosion. No major rills, gullies or stability problems were observed on the fills during the inspection.

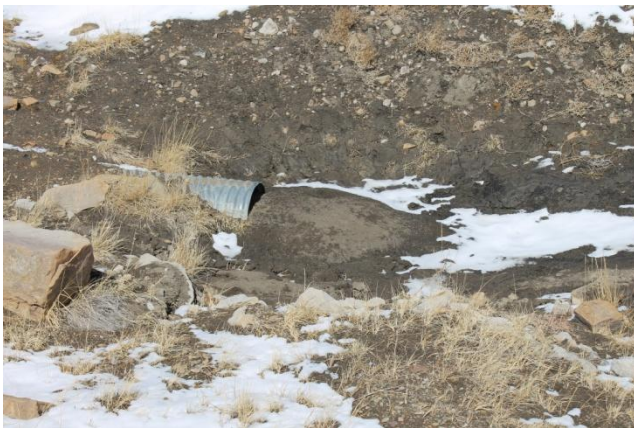
- Concrete culvert C-2 was ~1/2 full of sediment at the time of the inspection at the outlet.
- Culvert C-9 was ~3/4 full of sediment at the outlet and will need to be maintained.

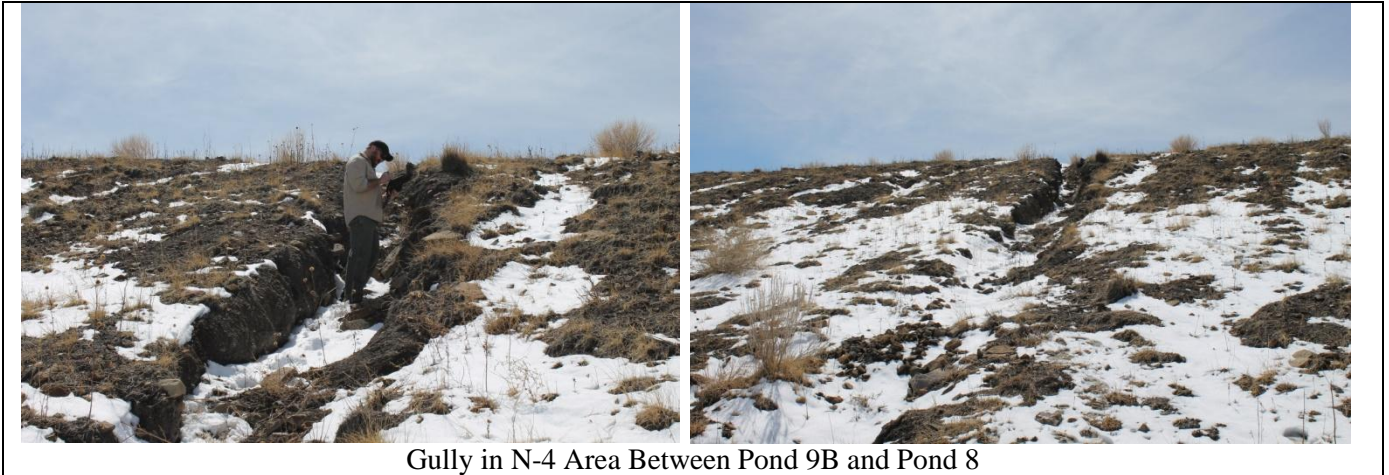
Gully in N-4 Area Between Pond 9B and Pond 8

- As noted in the January and February inspection reports, a gully has formed along the north facing slope in the area between Pond 8 and Pond 9A near the top of the drainage in the area identified as N-4 on Map 2.05.3-5. This erosional feature has not been repaired as of the date of this inspection. Equipment for repair and maintenance of the site was in the process of mobilization from the New Elk Mine to the Lorencito Mine. It is noted that the Division has established March 31, 2013 as a repair date for the gully.
