COLORADO DIVISION OF RECLAMATION, MINING AND SAFETY COAL PROGRAM INSPECTION REPORT

Permit Number: C-1996-083 Mine Name: Bowie No. 2 Mine Operator: Bowie Resources, LLC Operator Address: Mr William A Bear P.O. Box 483 Paonia, CO 81428	County: Delta Operation Type: Underground Permit Status: Active Ownership: Federal
Operator Representative Present: Bill Bear	
Operator Representative Signature: (Field Issuance Only)

Inspection Start Date: March 19, 2013 Inspection Start Time: 13:45 Inspection End Date: March 20, 2013 Inspection End Time: 10:15	Inspection Type: Coal Complete Inspection Inspection Reason: Normal I&E Program Weather: Clear
Joint Inspection Agency: None	Joint Inspection Contacts:
Post Inspection Agency: None	Post Inspection Contacts:
Inspector(s): Susan L. Burgmaier	Inspector's Signature:

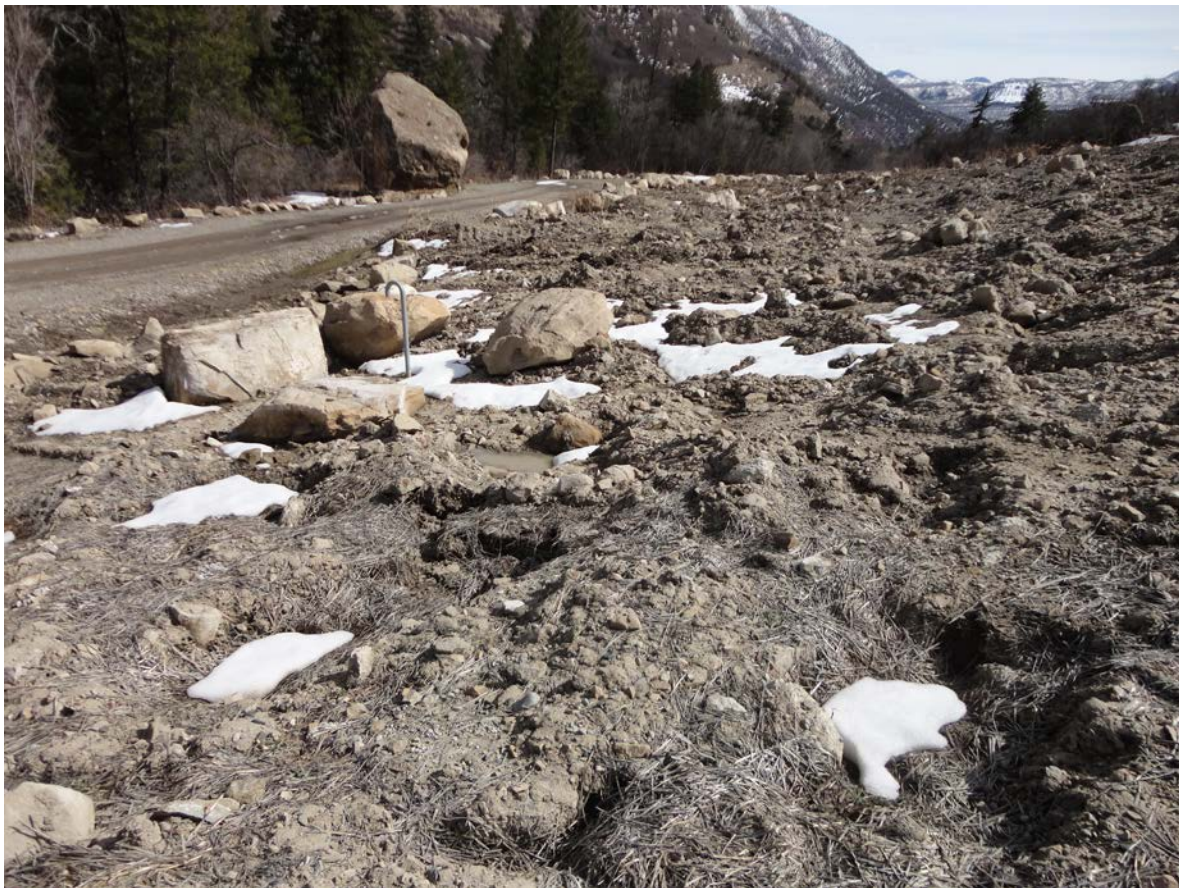
The backfilling of the Hubbard Creek fan shaft site appeared to be settling. There were cracks and sunken areas near the center marker of the reclaimed shaft. The operator indicated that when conditions allow, since the area was still fairly wet, equipment would be brought in to fill the settled area.⁵

Hubbard Creek Vent shaft site

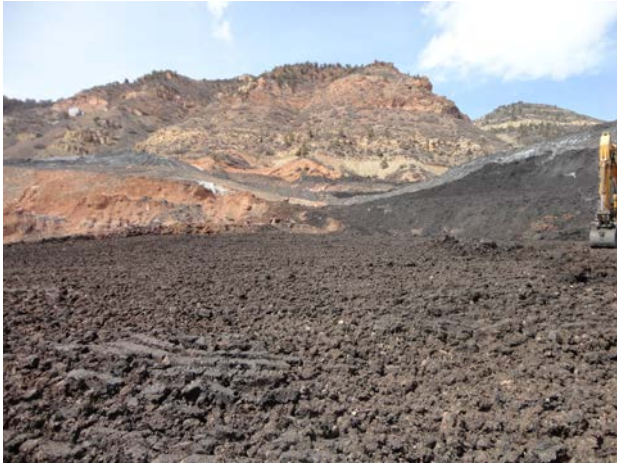
Gob was being transported to Gob Pile #2. Grading, lift construction and compaction of waste were taking place in the lower bench area of Gob Pile #2 in the former location of the cover material stockpile. Refuse material had been end dumped on the central southern lobe of Gob Pile #2, until moisture content in the material is conducive to grading and compaction. Material had also been end dumped in the area between Gob Pile #2 and #4; that material was being placed below (northward) at the cover material stockpile footprint.

Gob Pile #2 – gob placed on former cover mat'l footprint

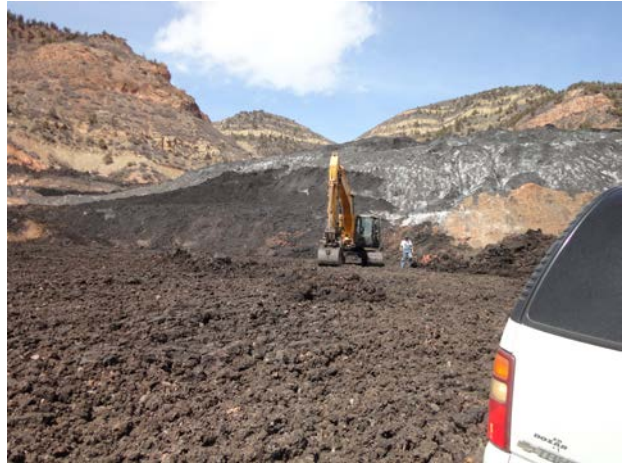
End dumped gob being moved, spread, and compacted

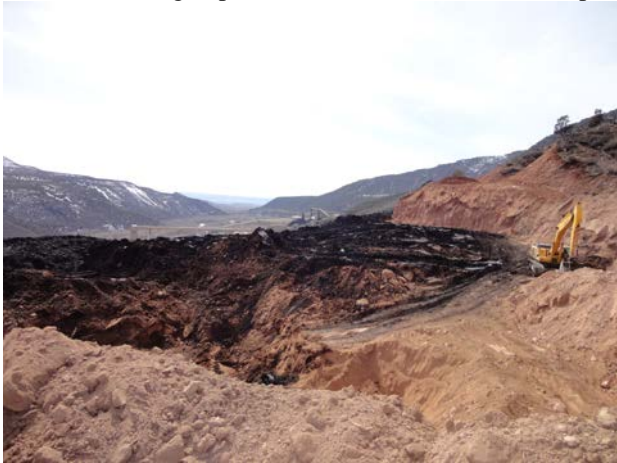
The excavation of the ridge between the two stockpiles (Gob Pile #2 expansion approved in TR 76) was idle during the inspection.

Topsoil salvage was in process at the Gob Pile #3 footprint area. Topsoil salvage operations appeared to be complete in the Gob Pile #2 expansion area, with the exception of the steeper areas along the ridge line. The operator will provide an update of topsoil salvage operations and what salvage variances were applied in the Gob Pile #2 expansion area with the 2012 Annual Reclamation Report.

Gob Pile #2 expansion area

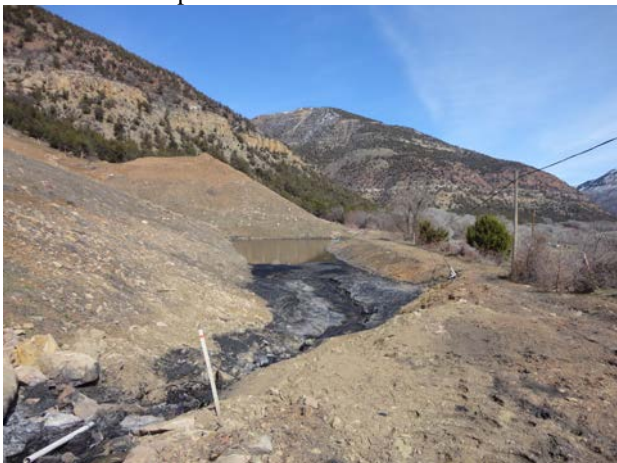
Pond F inlet

Ponds B, C, D, and F all held water but were not being discharged. Ponds J and K were dry. Ponds F and B will likely need dredging this year.

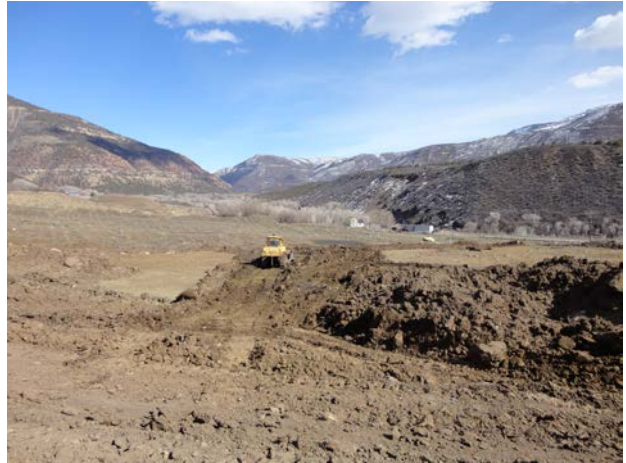
Construction of the upland diversion of Gob Pile #3 was underway. The operator was excavating the J-82 ditch line on the west end of the gob pile footprint. An excavator with a hammer implement was breaking down the excavated rock for use as rip rap within the mine site.

Gob Pile #3 footprint excavation

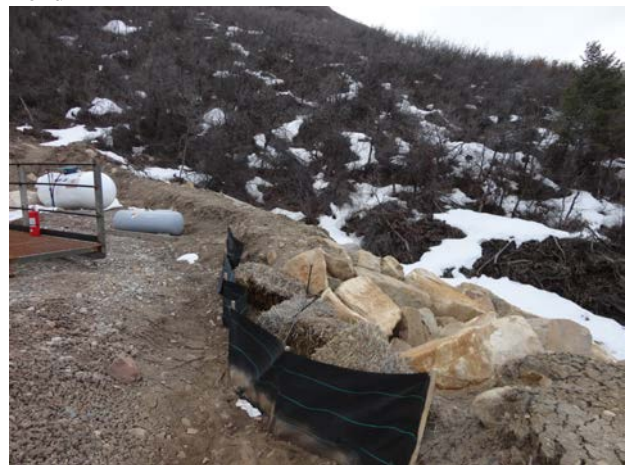
Small area exemption sediment control measures were in place and functional at the Terror Creek and Hubbard Creek vent shafts and the pump house and filter buildings.

SAE outfall at Terror Creek vent shaft
