## COLORADO DIVISION OF RECLAMATION, MINING AND SAFETY COAL PROGRAM INSPECTION REPORT

<b>Permit Number:</b> C-1981-022 <b>Mine Name:</b> Elk Creek Mine <b>Operator:</b> Oxbow Mining, LLC <b>Operator Address:</b> Mr Jim Kiger P.O. Box 535 3737 Highway 133 Somerset, CO 81434	<b>County:</b> Delta, Gunnison <b>Operation Type:</b> Underground <b>Permit Status:</b> Active <b>Ownership:</b> Federal
	<b>Operator Representative Present:</b>  Tom Anderson
<b>Operator Representative Signature:</b> (Field Issuance Only)

<b>Inspection Start Date:</b> March 20, 2013 <b>Inspection Start Time:</b> 12:10 <b>Inspection End Date:</b> March 20, 2013 <b>Inspection End Time:</b> 12:45	<b>Inspection Type:</b> Coal Partial Inspection <b>Inspection Reason:</b> Normal I&E Program <b>Weather:</b> Cloudy
<b>Joint Inspection Agency:</b>  None	<b>Joint Inspection Contacts:</b>
<b>Post Inspection Agency:</b>  None	<b>Post Inspection Contacts:</b>
<b>Inspector(s):</b>  Susan L. Burgmaier	<b>Inspector's Signature:</b>

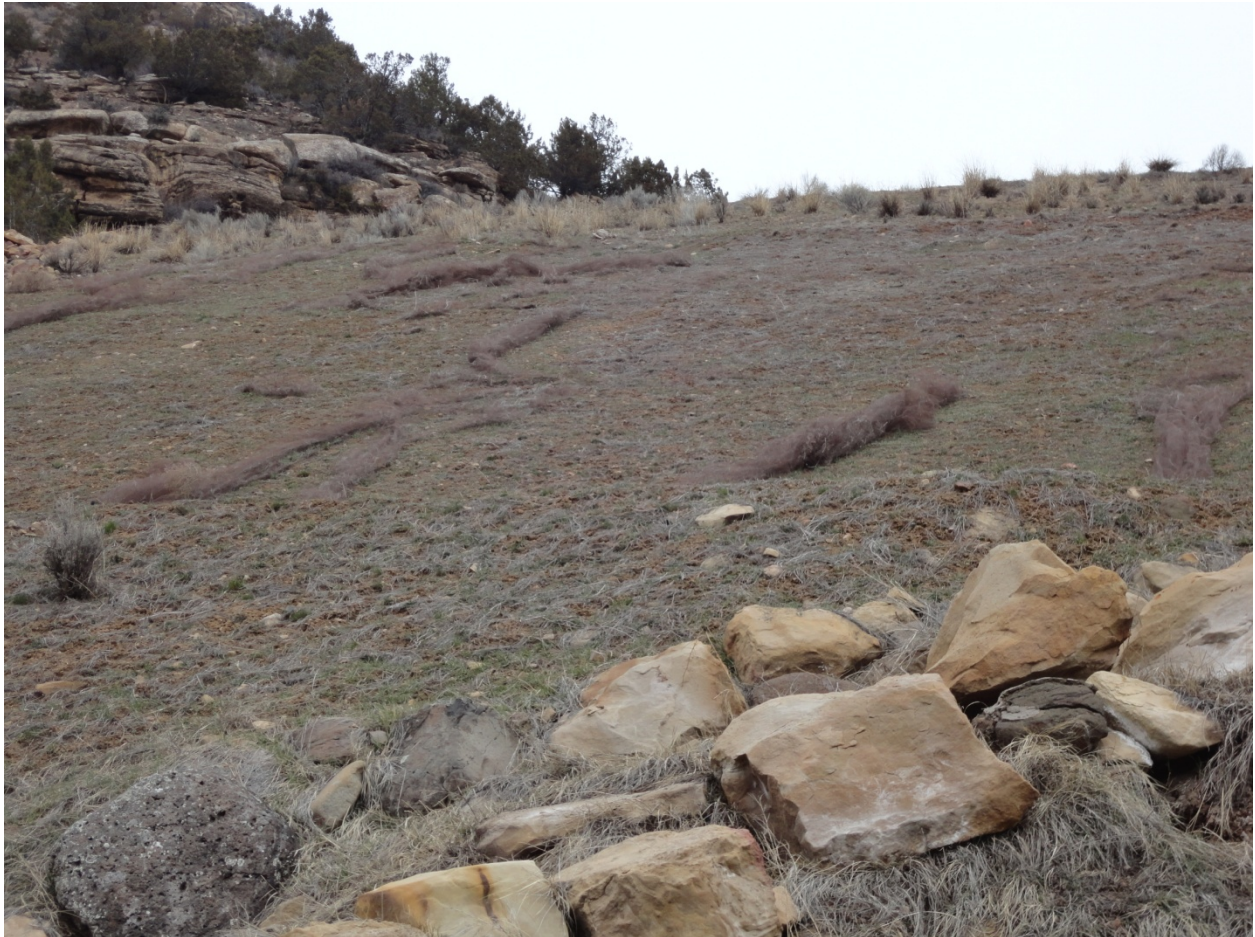
The purpose of the inspection was to follow up on a possible issue identified during a March 14, 2013 aerial inspection of the site that indicated a possible stability issue on the West Valley refuse disposal area. The inspection was limited to inspection of the West Valley disposal area only. The area in question was the lower bench of the disposal area where it appeared that soil movement had occurred. The ground inspection revealed that netting used to mulch the revegetated slopes had been bunched up by the wind into linear rolls.

Netting rolls on West Valley fill surface
