**COLORADO DIVISION OF RECLAMATION, MINING AND SAFETY
COAL PROGRAM INSPECTION REPORT**

Permit Number: C-1992-081 Mine Name: Hayden Gulch Loadout Operator: Hayden Gulch Terminal, LLC Operator Address: Mr. Roy Karo 37796 Routt County Road 53 P.O. Box 670 Hayden, CO 81639	County: Routt Operation Type: Loadout Permit Status: Permanent Cessation Ownership: Private
	Operator Representative Present: Roy Karo
Operator Representative Signature: (Field Issuance Only)

Inspection Start Date: March 18, 2013 Inspection Start Time: 11:46 Inspection End Date: March 18, 2013 Inspection End Time: 12:46	Inspection Type: Coal Partial Inspection Inspection Reason: Normal I&E Program Weather: Cloudy
Joint Inspection Agency: None	Joint Inspection Contacts:
Post Inspection Agency: None	Post Inspection Contacts:
Inspector(s): Jared L. Ebert	Inspector's Signature:

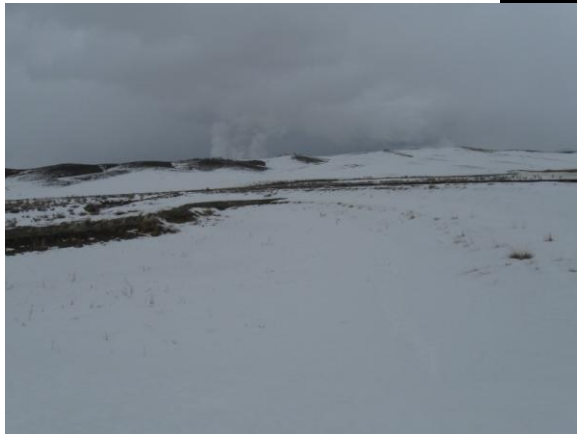
The rail loop pond was holding snow but was not discharging. The embankment and pond slopes appeared stable and the primary and emergency spillway appeared clear and functional.

Rail Loop Pond, from the west end looking east.

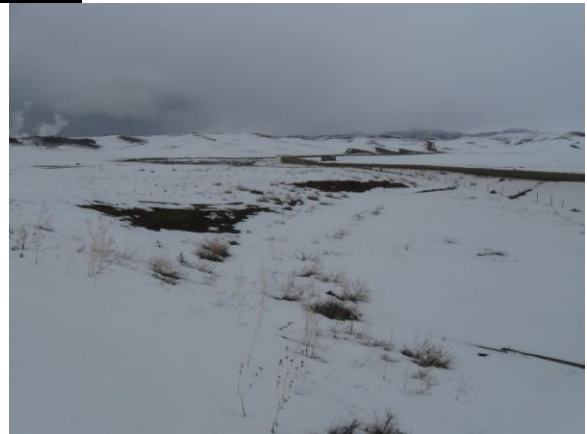
Drainage ditch 3A was holding snow and the straw waddles were in place directing runoff to the outlet culvert.

Drainage ditches 2, 3, 7 and 8 was also observed, these ditches were covered in snow.

From the west end of Ditch 3A and 3 looking east.

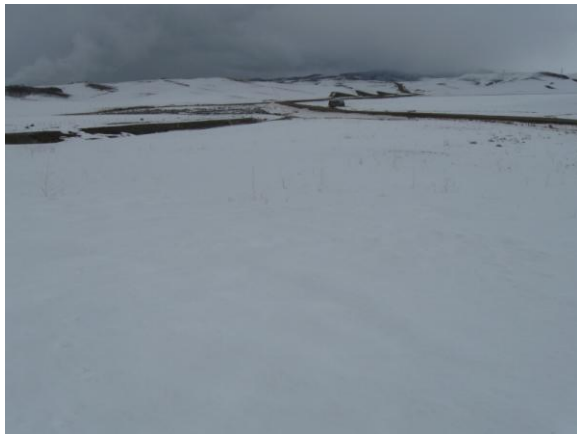
The backfilled and graded area was covered in snow.

Backfilled and graded area looking east.

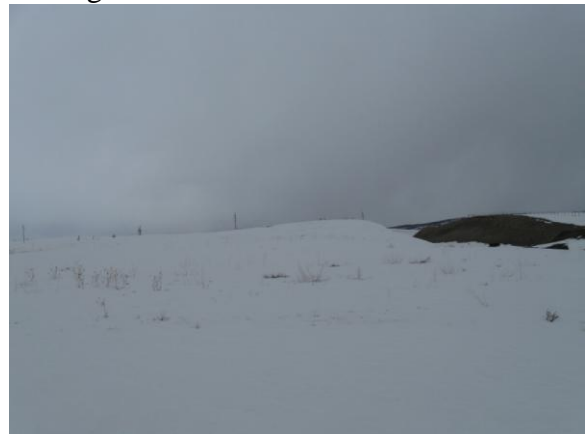
Backfilled and graded area from the east end looking west.
