**COLORADO DIVISION OF RECLAMATION, MINING AND SAFETY
COAL PROGRAM INSPECTION REPORT**

Permit Number: C-1981-014 Mine Name: Southfield Mine Operator: Energy Fuels Coal, Inc. Operator Address: Mr George Patterson P.O. Box 459 Florence, CO 81226	County: Fremont Operation Type: Underground Permit Status: Permanent Cessation Ownership: Private
	Operator Representative Present: George Patterson
Operator Representative Signature: (Field Issuance Only)

Inspection Start Date: March 21, 2013 Inspection Start Time: 11:00 Inspection End Date: March 21, 2013 Inspection End Time: 17:00	Inspection Type: Coal Complete Inspection Inspection Reason: Normal I&E Program Weather: Windy
Joint Inspection Agency: None	Joint Inspection Contacts:
Post Inspection Agency: None	Post Inspection Contacts:
Inspector(s): Janet H. Binns	Inspector's Signature:

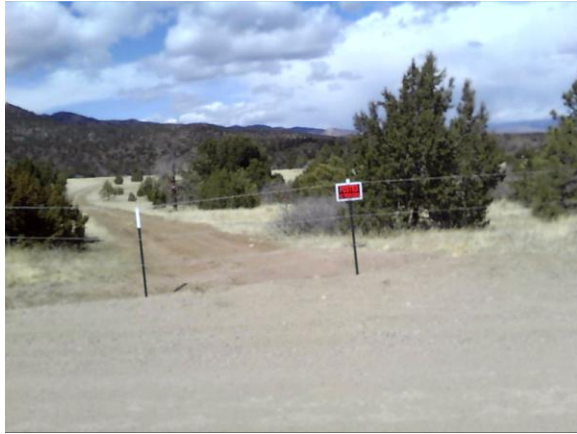
The landowner, Dr. Corley, has installed a new 3-wire fence on the north side of Fremont County Road 15. This fence has blocked the access road to MW-8. (Photo 1) MW-8 is no longer included in the monitoring plan for the Southfield mine, but it still is required to be sealed and properly abandoned.

Photo 1: fenced off access road to MW-8

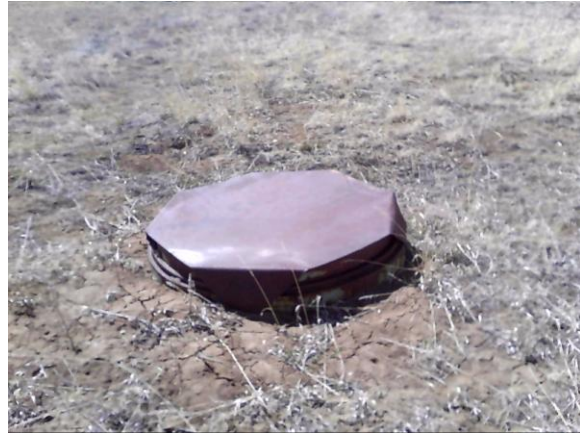
At the North end of MW-NW disturbance area there is a green metal casing. (Photo 2) This feature is not shown on Map 12. Photo taken.

photo 2: casing on reclaimed road NE of MW-NW

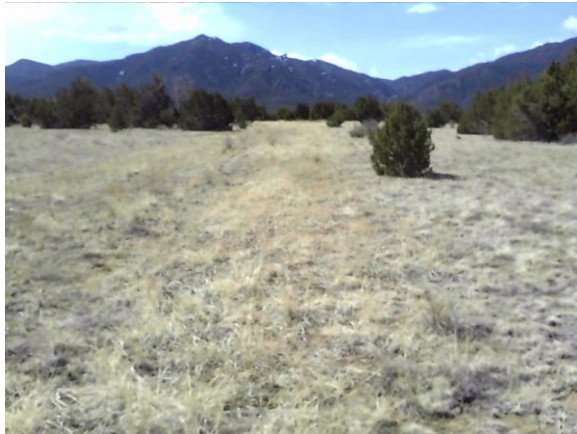
Reclaimed waterline access road by MW-NW has fairly good vegetative cover on most of this area. (Photo 3) The track to MW-NW still appears as a two-track road. No erosional features were noted with this reclaimed portion of roadway.

Photo 3: reclaimed access road near MW-NW

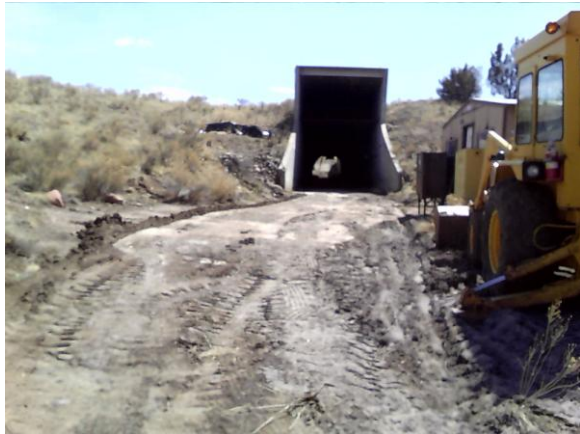
The operator has graded sediment away from the NW corner of the truck tunnel. (Photo 4) This material has been stored west of the backhoe. Silt fence has been anchored near the top of the slope above the repaired rill next to the truck tunnel. (Photos 5 and 6) This area has been seeded according to the operator.

Photo 4: Sediment removed from NW of truck tunnel

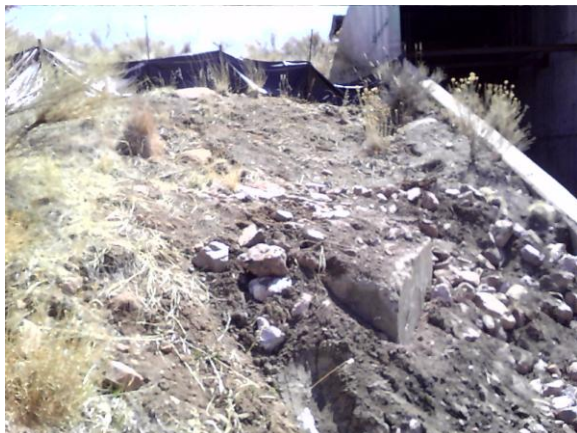
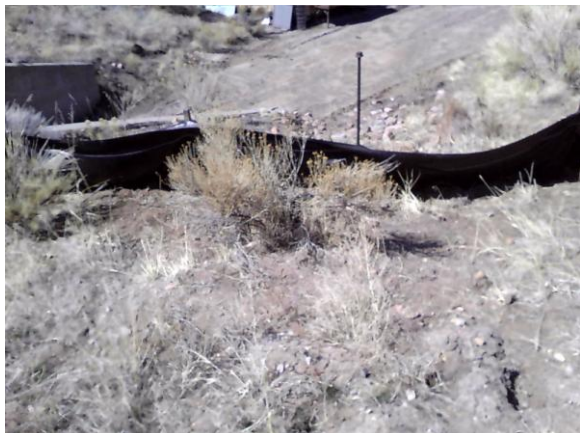
Photo 5: repair to rilling by truck tunnel

Photo 6: Silt fence well anchored at truck tunnel

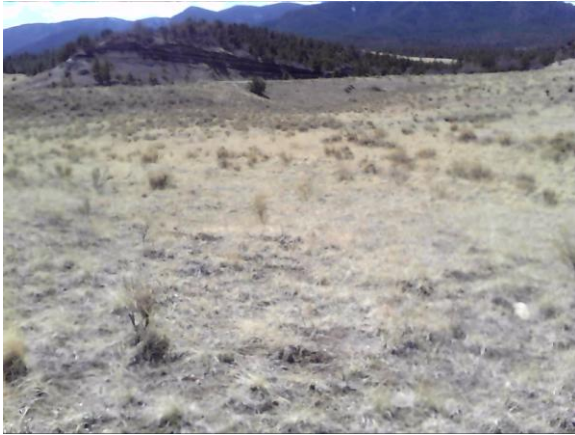
Photo 7: reclaimed portal area from truck tunnel

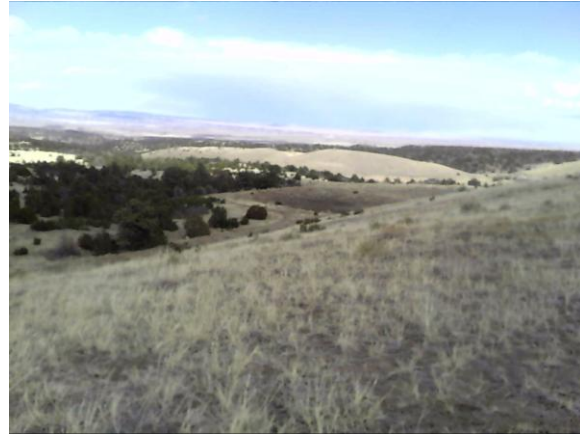
Photo 8: North slope of RDA

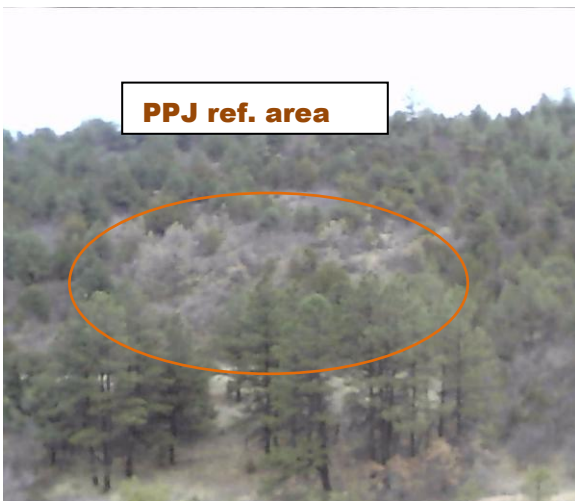
Observation of the reference areas noted that the Grassland reference area appears to be in good condition. The PPJ reference area (plot B) appears to have experienced considerable natural die off. (photo 9) Observations along County road 15 and the general mine area has observed patchy die off throughout the area, possibly from the droughty conditions experienced the last few years.

Photo 9: PPJ ref area vegetation appears to be dying out

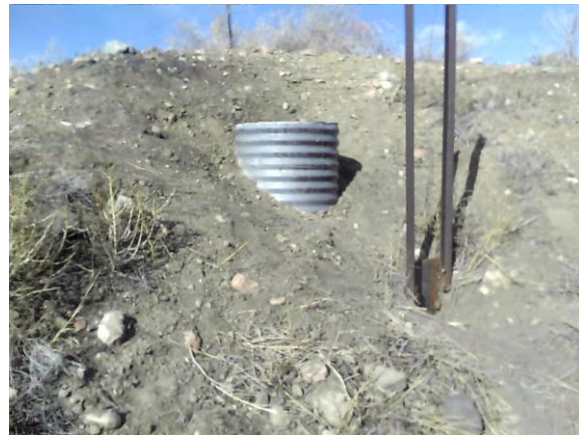
Pond L1 spillway riser has been cleaned out and metal plate secured to the old valve location as designed. (Photo 10) Pond L2 was dry.

Photo 10: Pond L1 repaired primary riser & sealed gate.

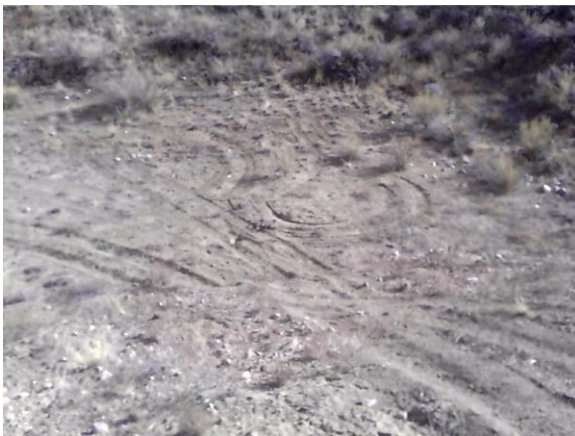
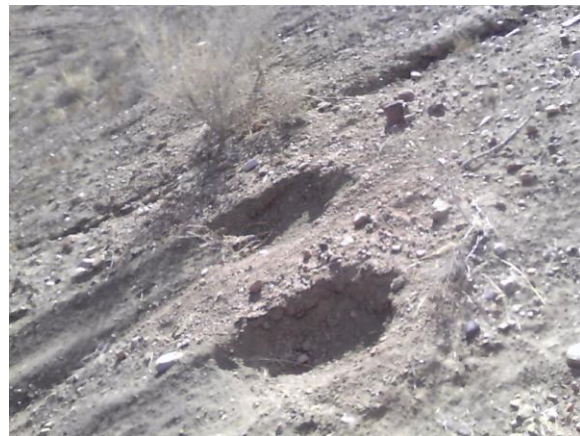
At the load out an ATV has driven in Pond L1, and the wheels have dug into side slopes. (Photos 11 & 12) Train

Photo 11: tracks in Pond L1

Photo 12: tire "divots" dug into pond L1 slope
