COLORADO DIVISION OF RECLAMATION, MINING AND SAFETY COAL PROGRAM INSPECTION REPORT

Permit Number: C-1981-019 Mine Name: Colowyo Coal Mine Operator: Colowyo Coal Company L.P. Operator Address: Mr. Tony Tennyson 5731 State Highway 13 Meeker, CO 81641	County: Moffat, Rio Blanco Operation Type: Surface Permit Status: Active Ownership: Federal
Operator Representative Present: Kurt Blunt, Tony Tennyson	
Operator Representative Signature: (Field Issuance Only)

Inspection Start Date: March 18, 2013 Inspection Start Time: 15:30 Inspection End Date: March 20, 2013 Inspection End Time: 13:00	Inspection Type: Coal Complete Inspection Inspection Reason: Normal I&E Program Weather: Cloudy	
Joint Inspection Agency: None	Joint Inspection Contacts:	
Post Inspection Agency: None	Post Inspection Contacts:	
Inspector(s): Robert D. Zuber	Inspector's Signature:

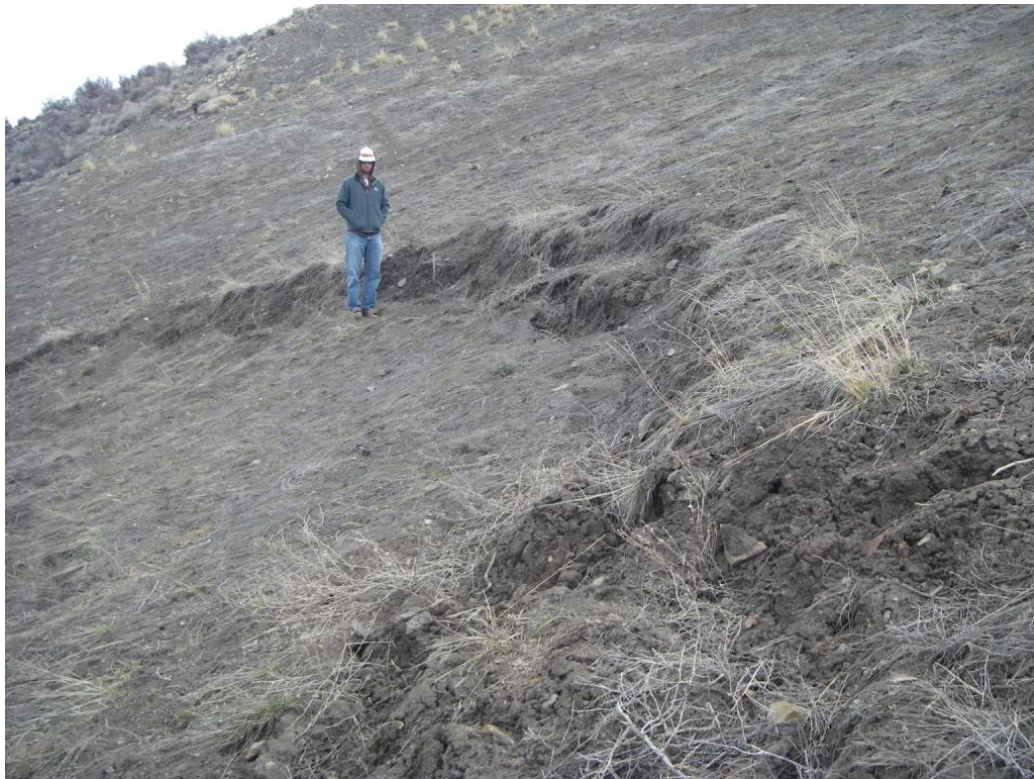
The area above East Taylor Pond was inspected and several small slumps and several rills were observed. The slump near the pond appears to be healing; the scarp is about 2.5 feet high. This area will continue to be monitored closely.

Slump above East Taylor Pond (east side of Taylor Trib Ditch)

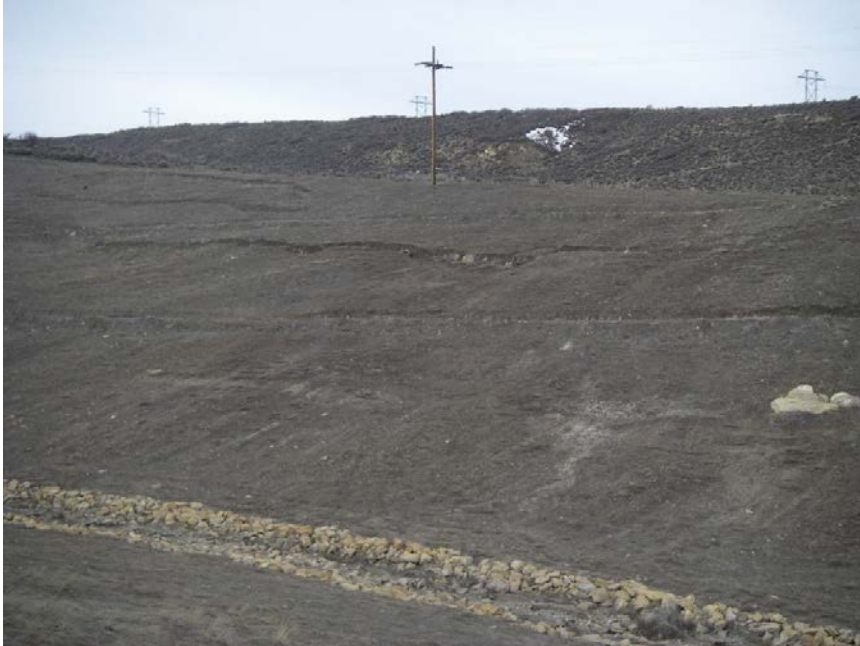
Slumps above East Taylor Pond (west side of Taylor Tributary Ditch)

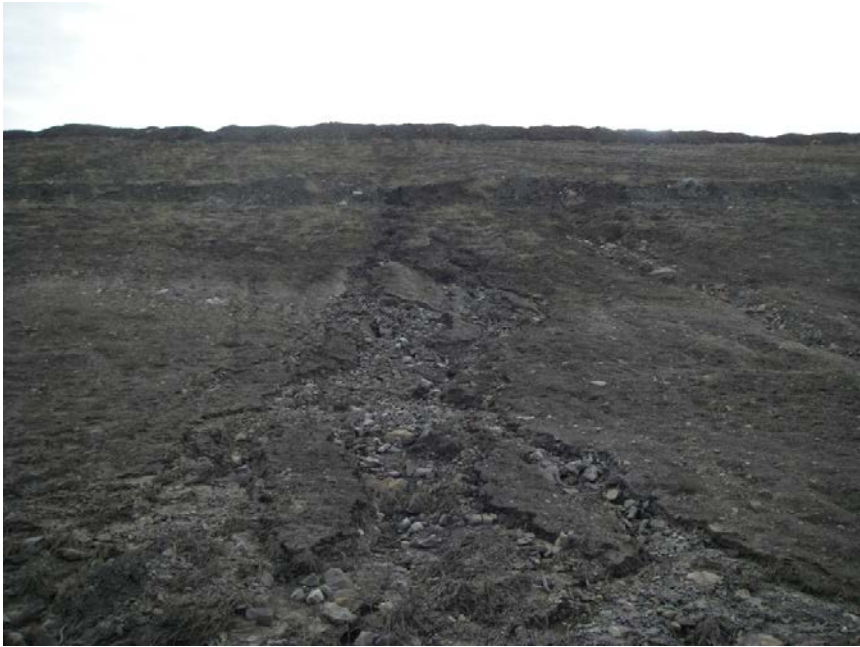
Two contour ditches were found to have blowouts: one above East Taylor Pond near the confluence of Taylor Trib Ditch and East Taylor Ditch and one in the Prospect Ditch drainage. These need to be repaired as soon as practical (avoiding further damage to reclamation).

Blowout of contour ditch above confluence of East Taylor Ditch and Taylor Tributary Ditch

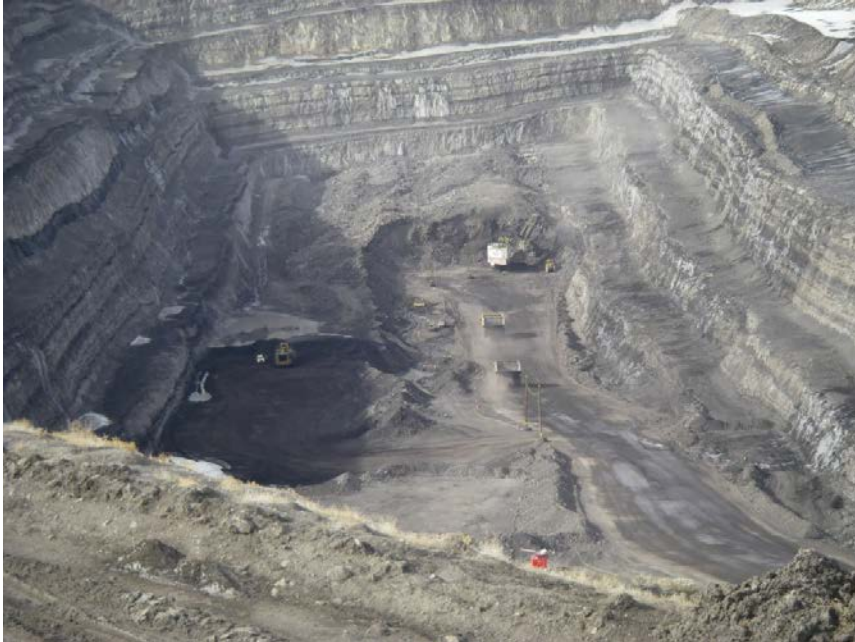
South Taylor Pit (looking southeast)

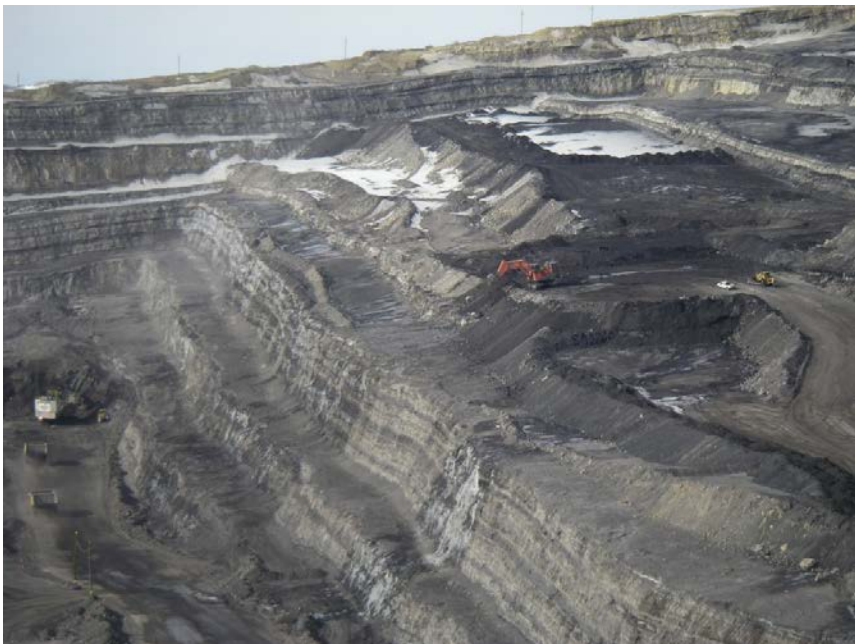
South Taylor Pit (looking south)

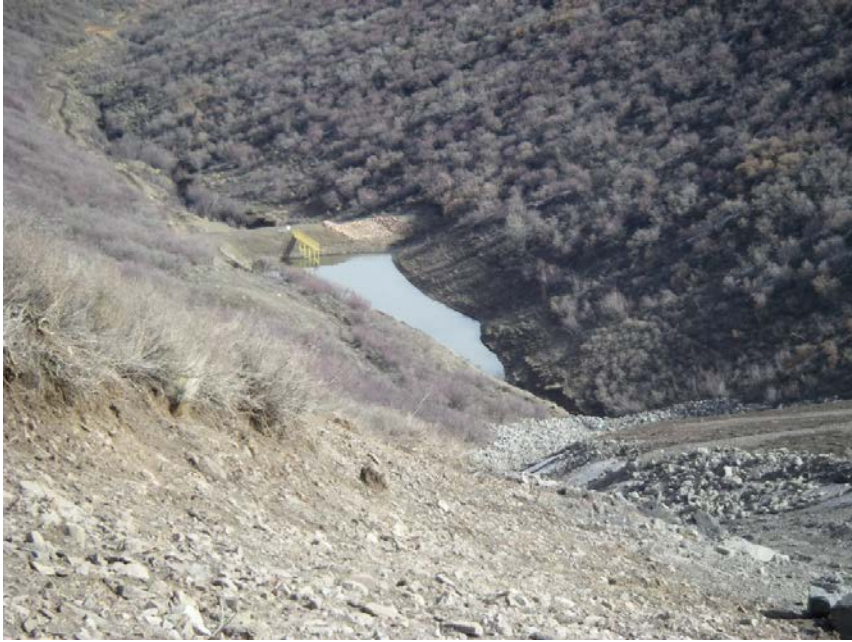
West Taylor Pond

Some observed ponds were discharging: East Taylor, West Taylor (large flow, likely from fill underdrain), Prospect, and Stoker Siding.

- West Taylor – pH of 7.7, flow of 0.09 cfs, electrical conductivity of 2,180 uS/cm, and temp. of 4.2 C.
- East Taylor – pH of 7.8, flow of 0.01 cfs, electrical conductivity of 1,780 uS/cm, and temp. of 2.4 C.

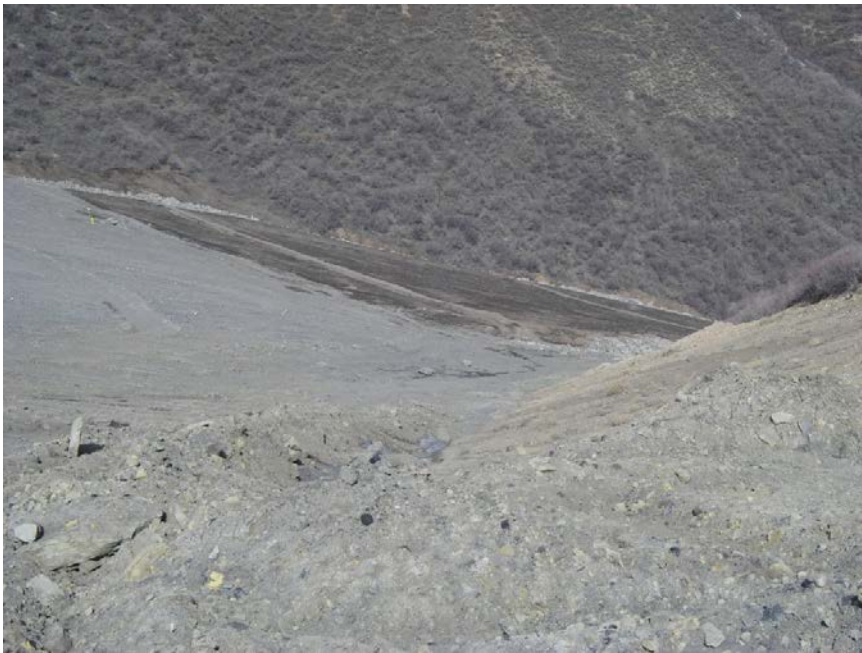
West Taylor Fill was observed from above and below, and no significant problems were seen. Some rills were observed.

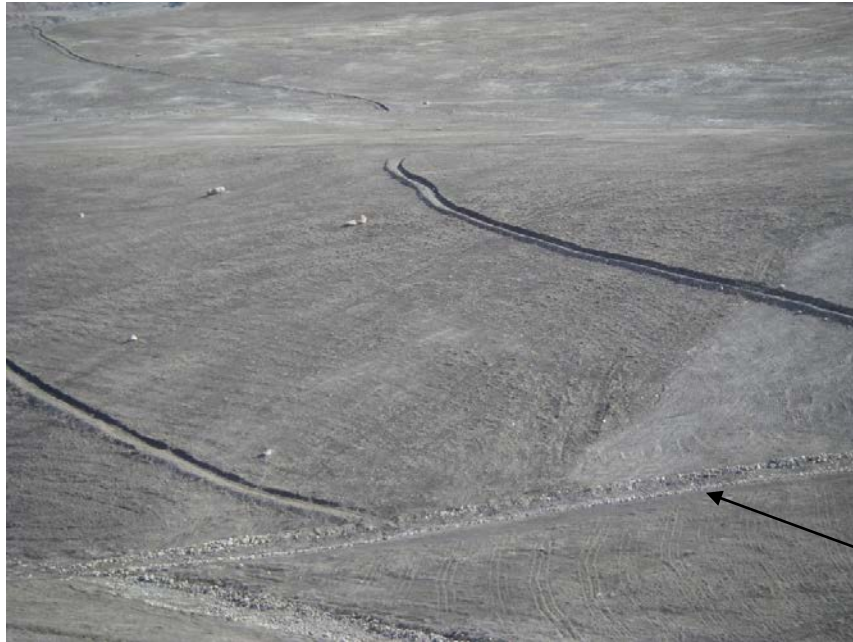
The lower portion of East Taylor Ditch was observed and was found to be stable. The Taylor Ditch was found to be stable. The maintenance at the bottom of the constructed portion of Prospect Ditch (including wattles) was found to be in excellent shape.

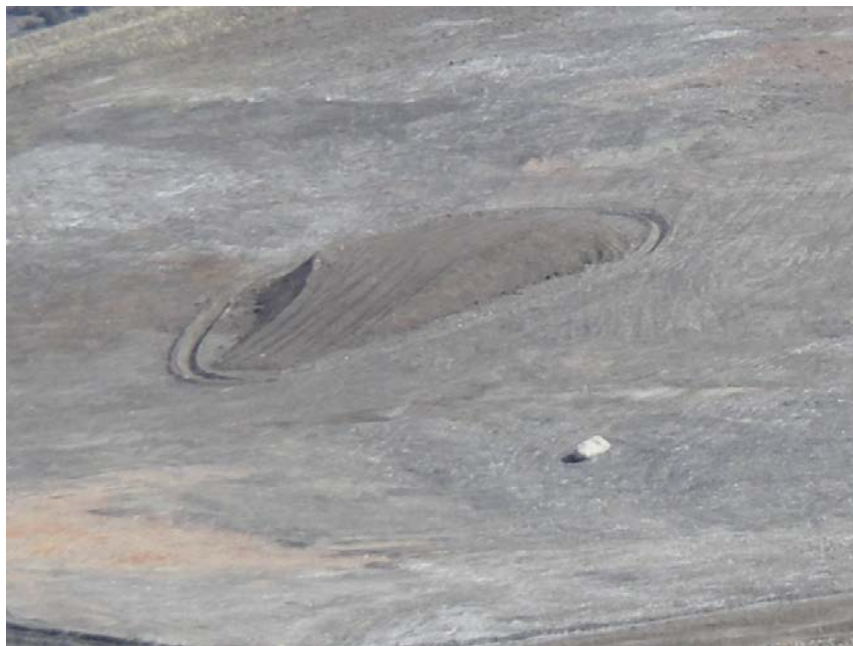
- In the West Pit reclamation, the two large piles below the spoil pile (Hink's Peak) were found to have no problems.
- Pile 15A was inspected from all sides, and no erosion problems were observed, but additional signs should be added. GPS was used to confirm the footprint of the pile; the map is very accurate.
- Pile 16A was inspected from the north and east sides, and no erosion problems were observed, but additional signs should be added.

Topsoil Pile in West Pit reclamation

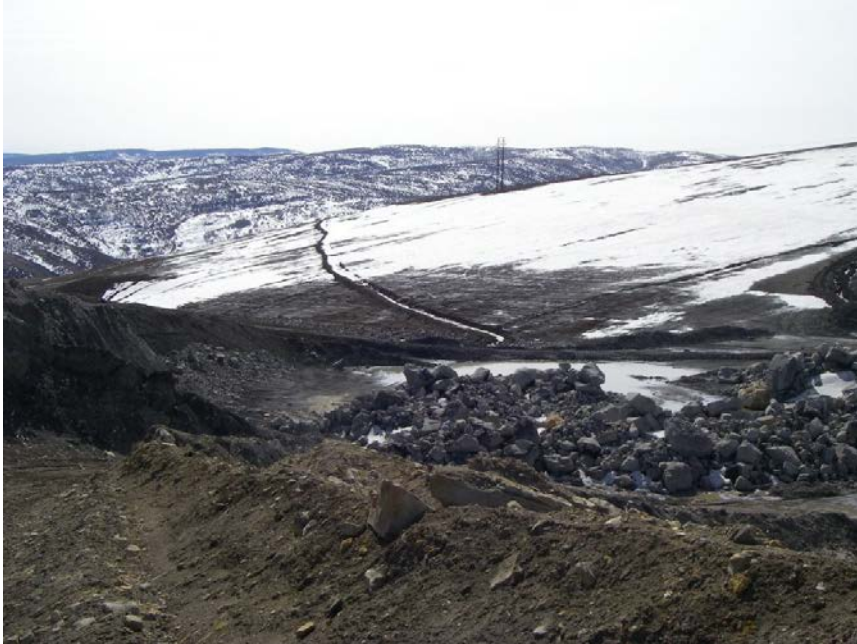
East Pit reclamation was found to be in good shape.

East Pit reclamation, looking southeast

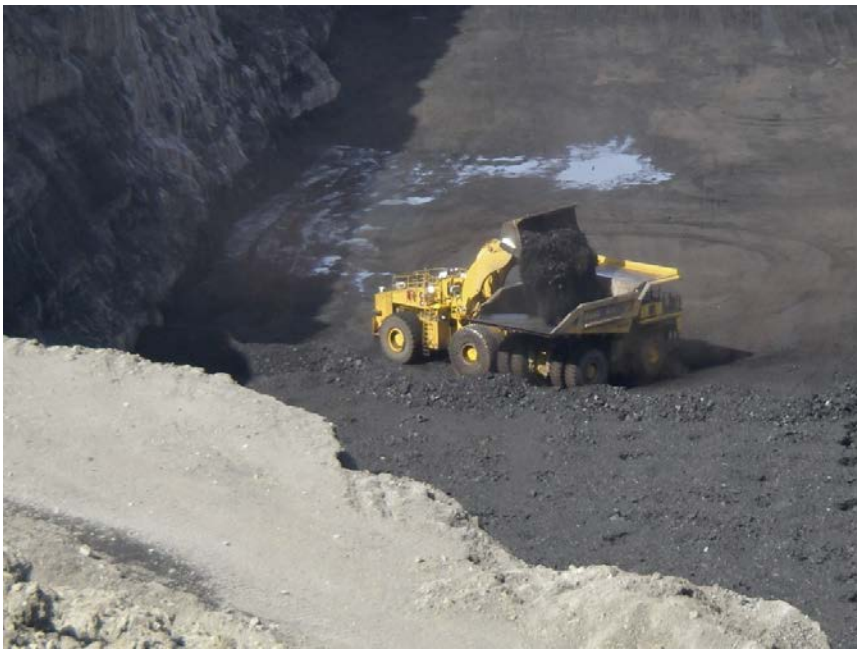
Loading coal in West Pit

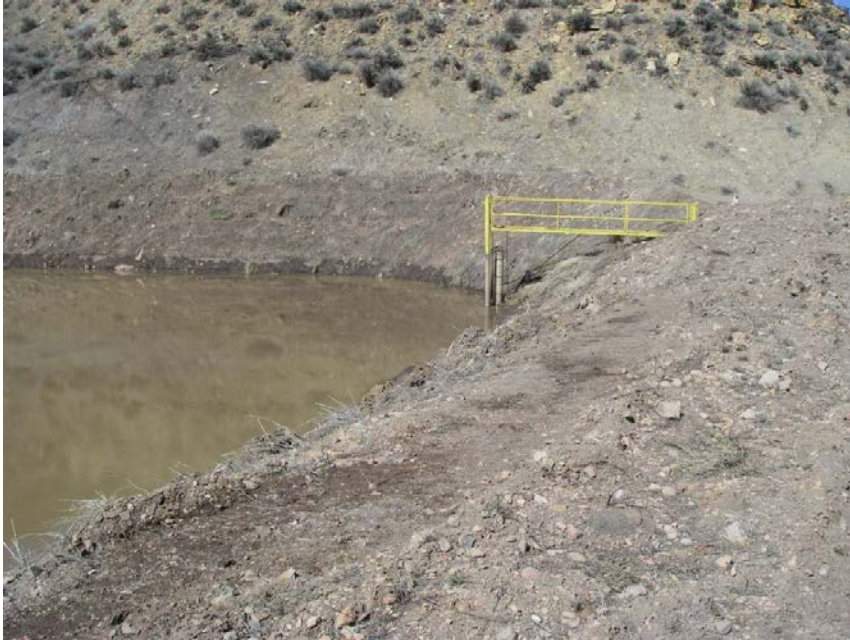
Prospect Pond embankment and primary spillway

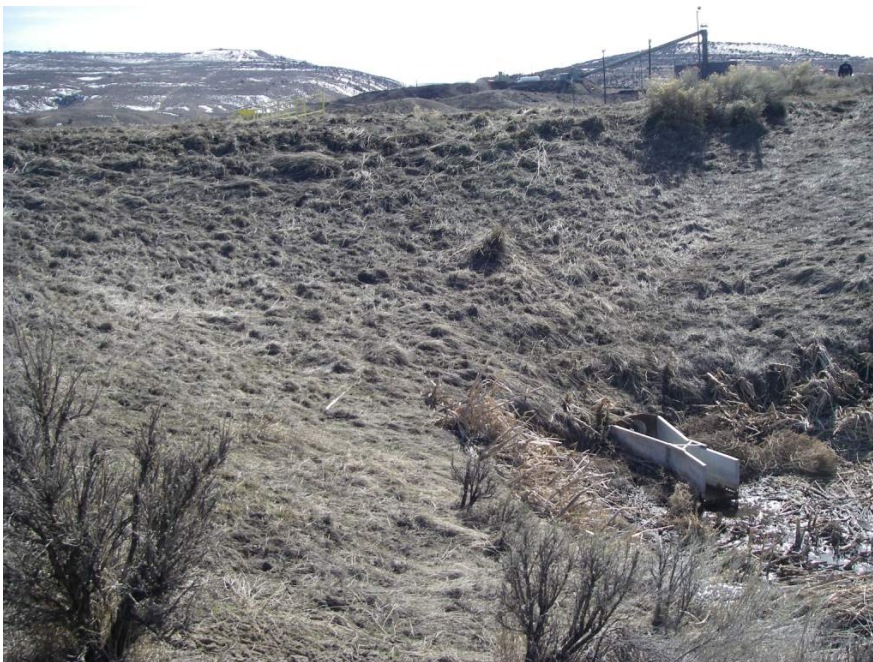
Stoker Siding Pond embankment and flume

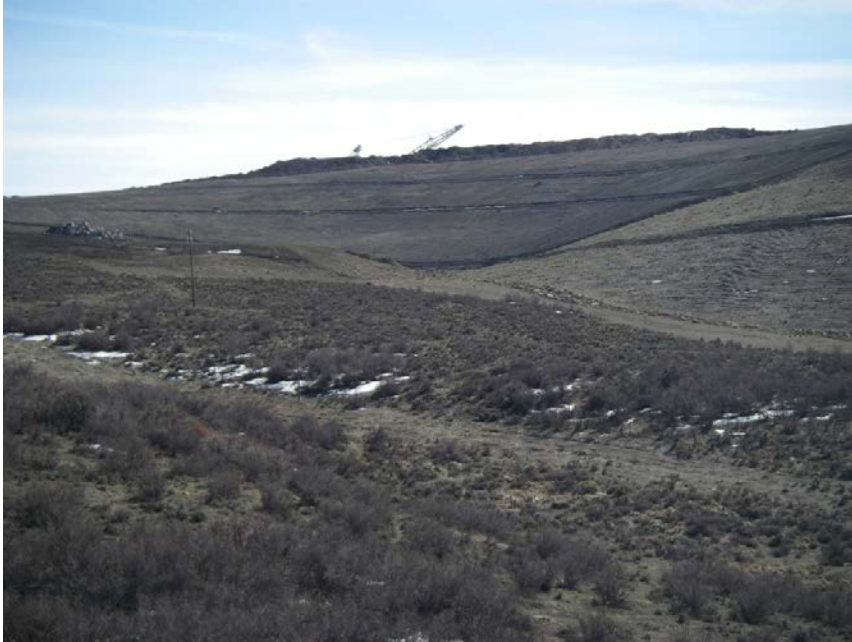
The 102 dragline was idle in the West Pit area. The 103 dragline was casting spoil.

West Pit spoil pile, looking south (idle 102 dragline partially visible)

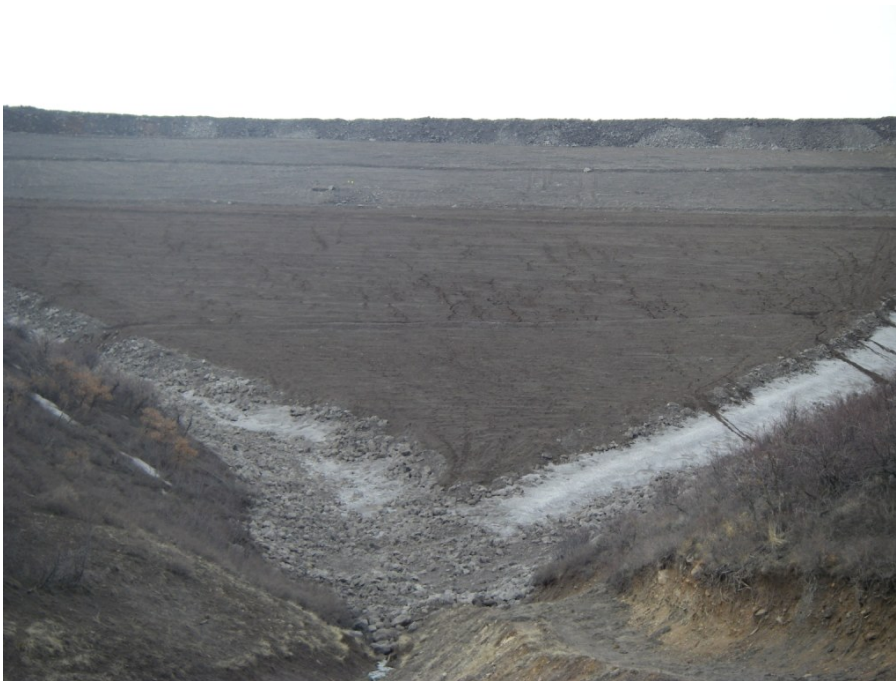
West Taylor Fill – significant number of rills

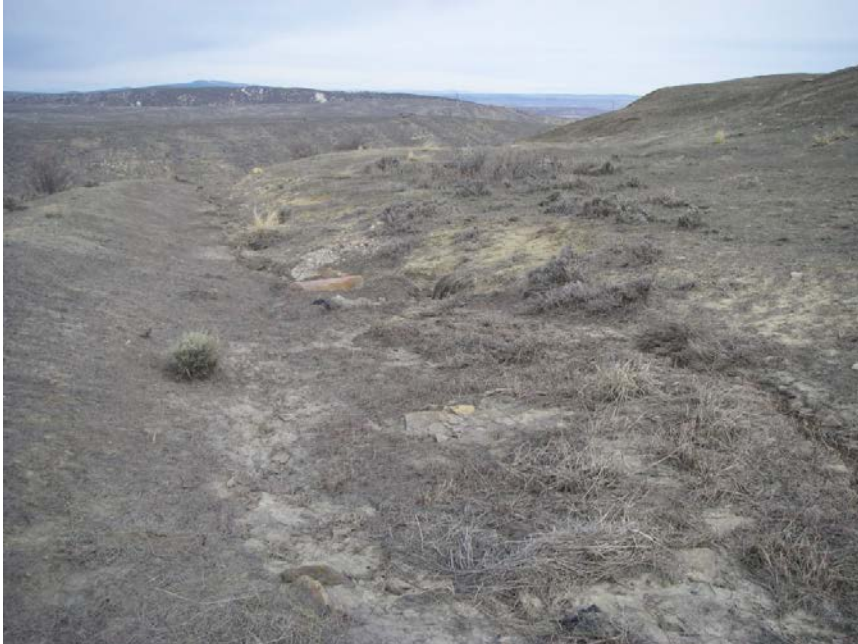
Topsoil Pile 15A – ring ditch on west side

Kurt Blunt and Juan Garcia of Colowyo indicated that the signs would be added soon.

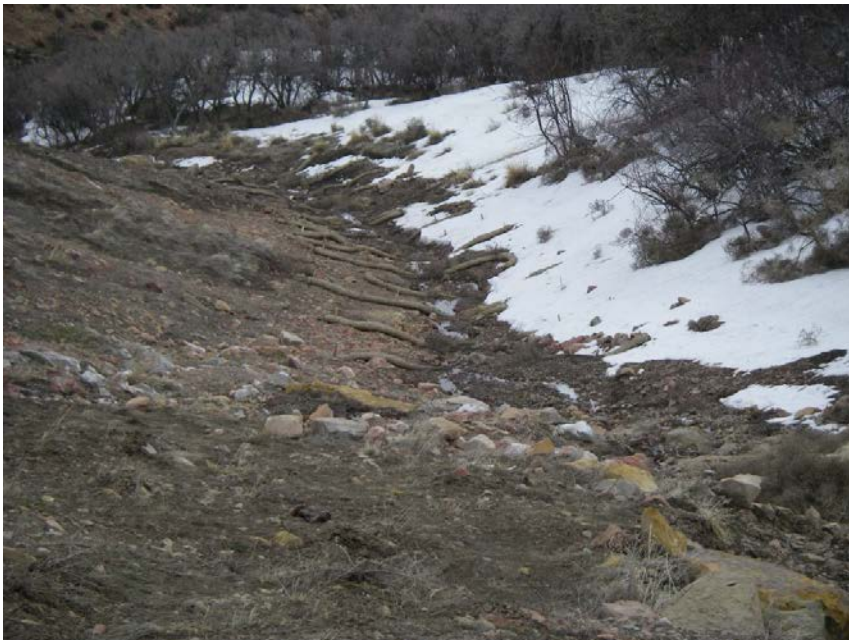
Prospect Ditch – reach of channel where maintenance was performed in 2012
