**COLORADO DIVISION OF RECLAMATION, MINING AND SAFETY
COAL PROGRAM INSPECTION REPORT**

Permit Number: C-1994-082 Mine Name: Yoast Mine Operator: Seneca Coal Company, LLC Operator Address: Mr. Roy Karo 37796 Routt County Road 53 P.O. Box 670 Hayden, CO 81639	County: Routt Operation Type: Surface Permit Status: Permanent Cessation Ownership: Federal
	Operator Representative Present: Roy Karo
Operator Representative Signature: (Field Issuance Only)

Inspection Start Date: March 19, 2013 Inspection Start Time: 14:40 Inspection End Date: March 19, 2013 Inspection End Time: 12:30	Inspection Type: Coal Complete Inspection Inspection Reason: Normal I&E Program Weather: Cloudy
Joint Inspection Agency: None	Joint Inspection Contacts:
Post Inspection Agency: None	Post Inspection Contacts:
Inspector(s): Jared L. Ebert	Inspector's Signature:

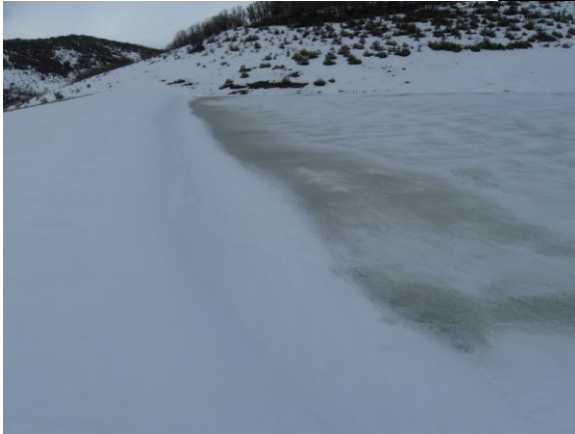
Pond 013 was holding water and was ice covered. The pond was discharging a small amount of water. The embankment was snow covered but appeared stable. The primary spillway was clear of debris and functional. The emergency spillway was snow covered.

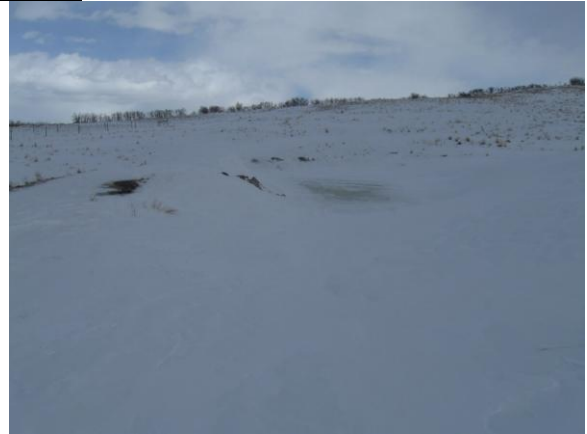
Stock tank ST-01

Stock tank ST-1 was holding water, the embankment was snow covered and appeared stable.

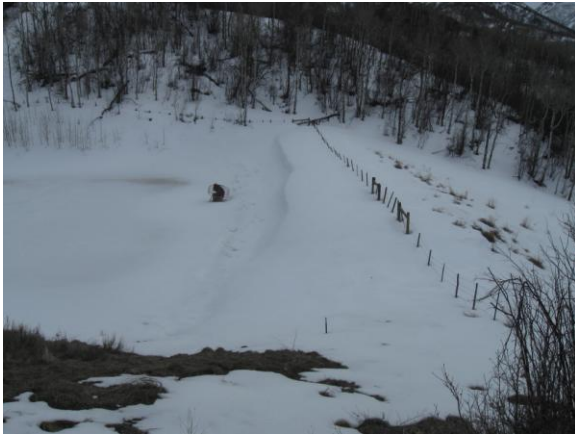
Pond 014 was holding water and was snow covered. The embankment was snow covered but appeared stable. The primary spillway was clear of debris and functional. The emergency spillway was snow covered.

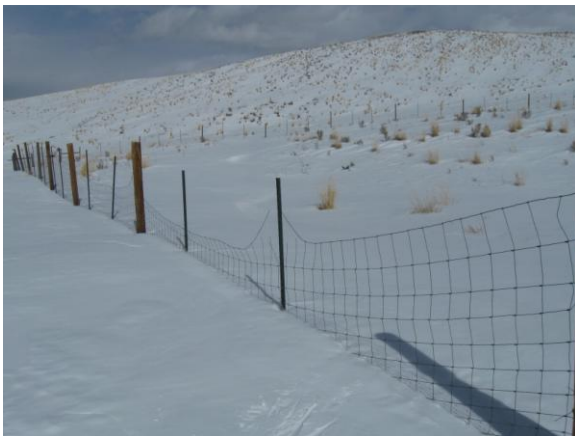
The fence around shrub plot SP05-1 was damaged on the west side and will likely need to be repaired in the spring.

Shrub Plot SP05-1, fence damage

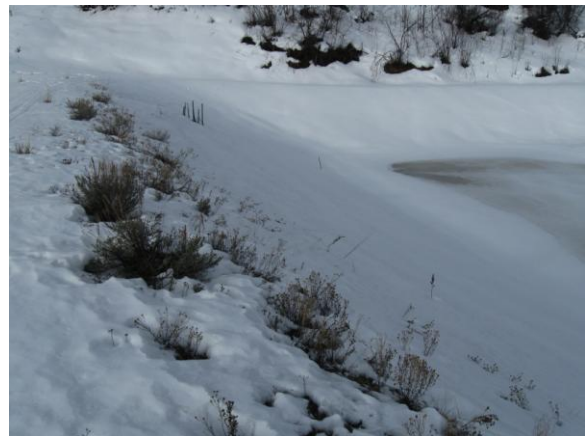
Pond 011 was holding water and was ice covered. The pond was not discharging at the time of the inspection. The primary and emergency spillway was snow and ice covered. The embankment was also snow covered but appeared stable.

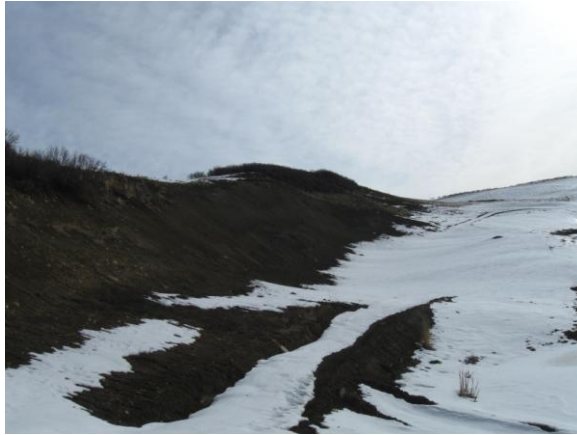
The slide adjacent to Pond 012 was observed, overall the area has not changed since the last inspection, some minor rilling was observed likely due to snow melt.

Pond 012 slide area

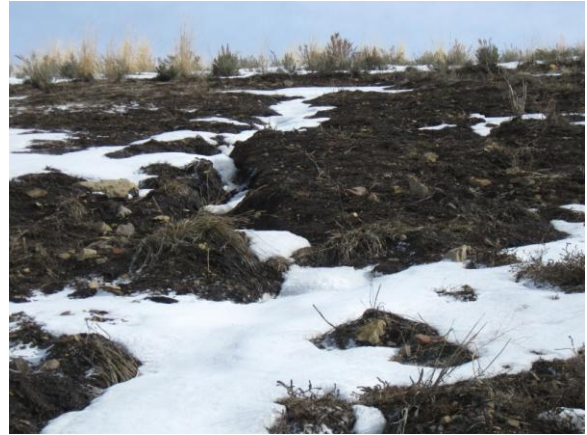
The hillside adjacent to the intersection of YPM-6-2 and YPM-7 has several gullies forming that will need to be stabilized and repaired when the area is accessible.

Rills above the intersection of YPM-6-2 and YPM-7

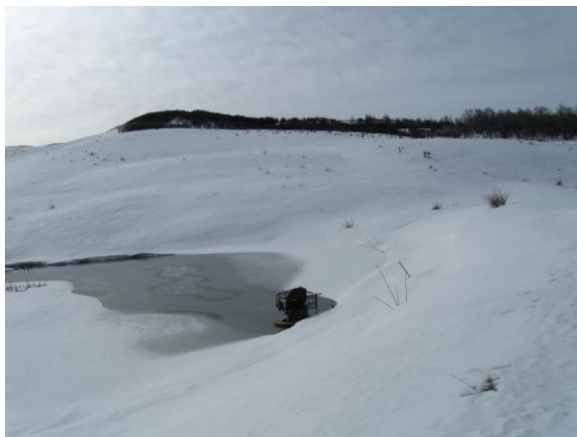
Pond 012 was holding water and was discharging. The primary spillway was clear and functional. The embankment was snow covered and appeared stable.

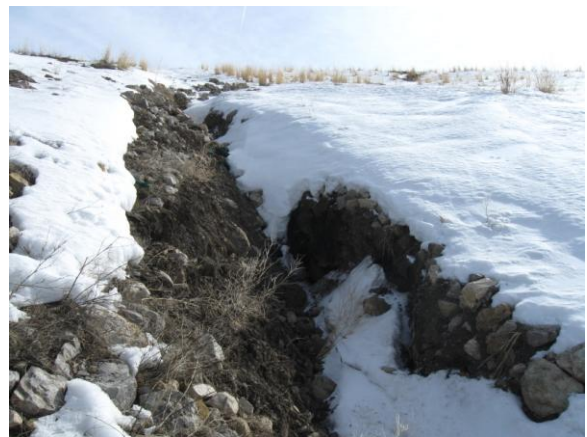
Drainage YPM-7

The majority of YPM-7 was snow covered; however several portions of the channel were visible and the sidewall of the channel is cutting 3 to 4 feet in places and will need to be monitored and repaired when the area is accessible.

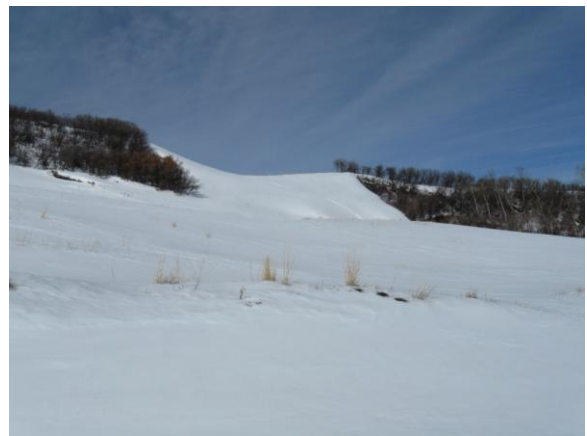
The neck pit slide area was observed, this area is covered with a significant snow drift.

Neck pit slide area.

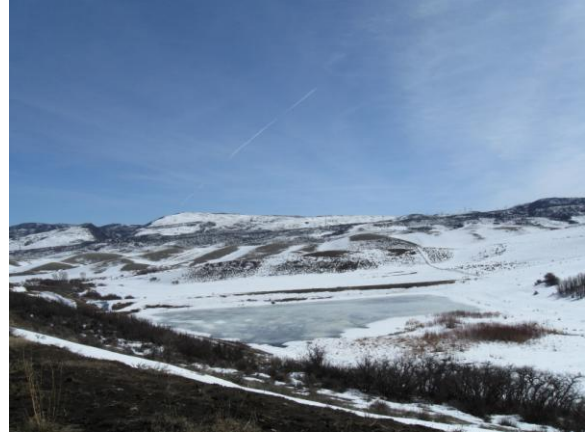
Pond 010 was holding water and was ice covered. The pond was discharging at the time of the inspection. The embankment was stable and snow covered. The primary spillway was clear and functional. The emergency spillway was snow covered.
