COLORADO DIVISION OF RECLAMATION, MINING AND SAFETY
MINERALS PROGRAM INSPECTION REPORT
PHONE: (303) 866-3567

MINE NAME: Revenue Mine	MINE/PROSPECTING ID#: M-2012-032	MINERAL: Lead, silver and gold	COUNTY: Ouray
INSPECTION TYPE: Monitoring	INSPECTOR(S): Bob Oswald	INSP. DATE: March 1, 2013	INSP. TIME: 10:20
OPERATOR: Star Mine Operations, LLC	OPERATOR REPRESENTATIVE: Rory Williams	TYPE OF OPERATION: 112d-1 - Designated Mining Operation

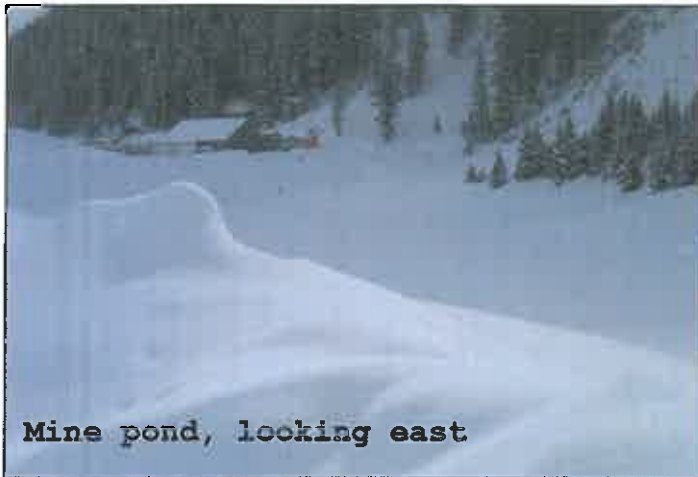
Mine pond, looking east

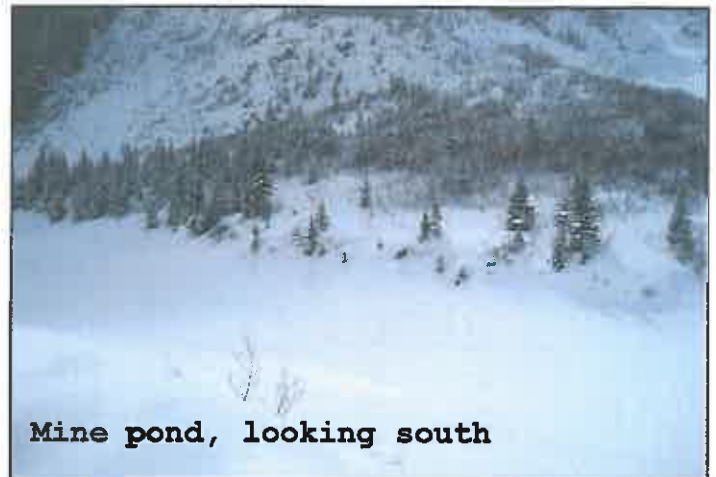
Mine pond, looking south

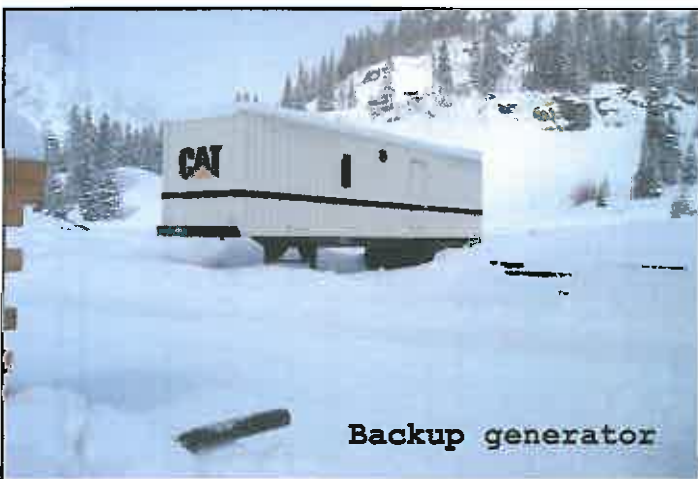
Backup generator

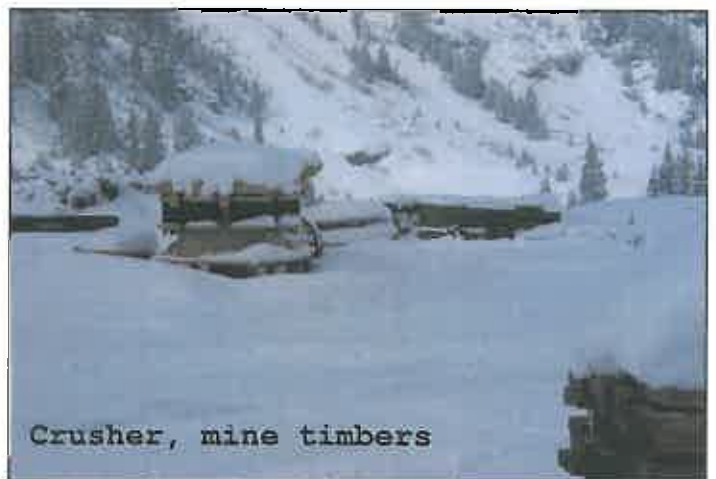
Crusher, mine timbers

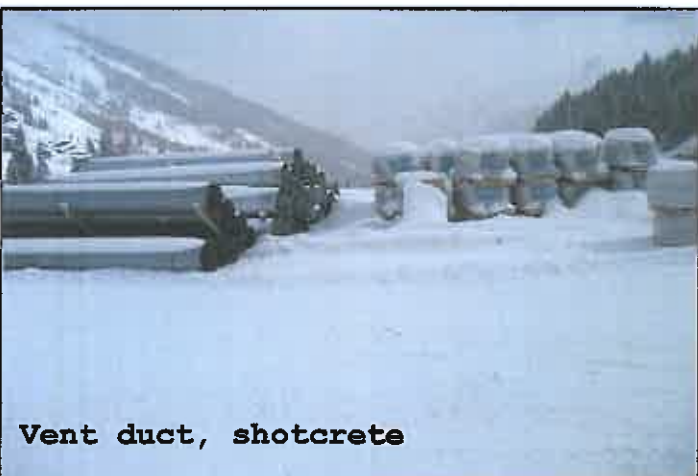
Vent duct, shotcrete

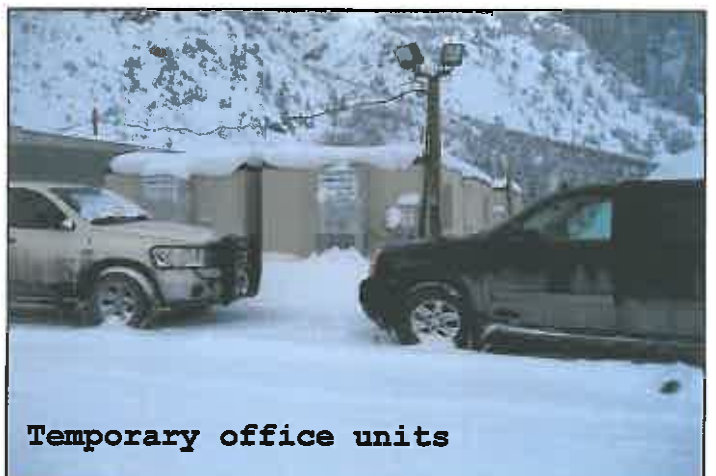
Temporary office units

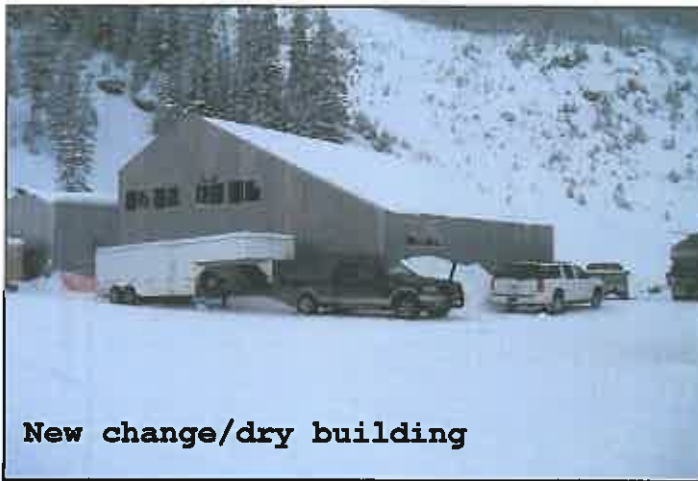
New change/dry building

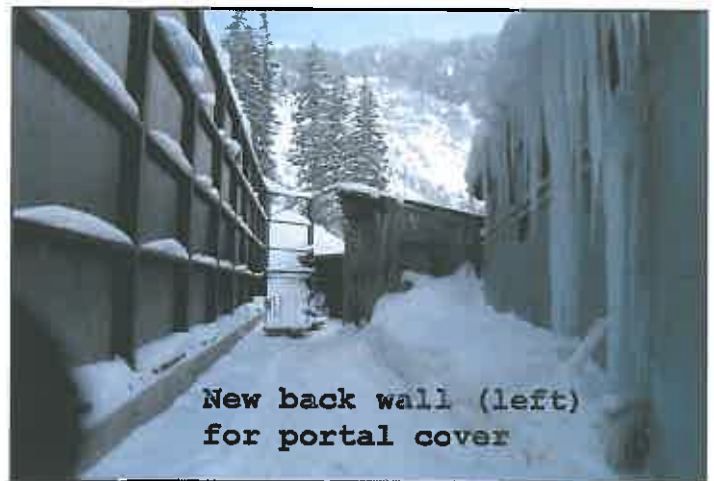
New back wall (left)
for portal cover

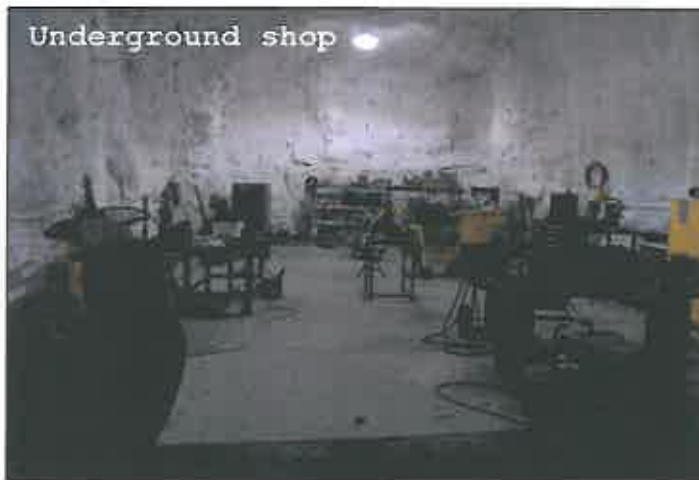
Underground shop

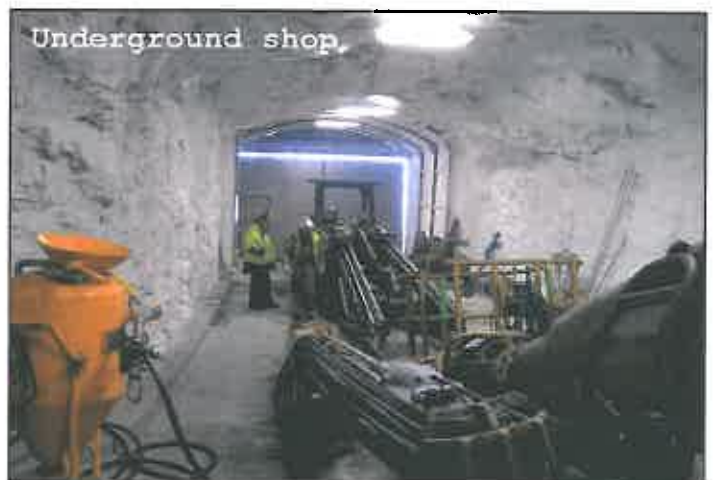
Underground shop

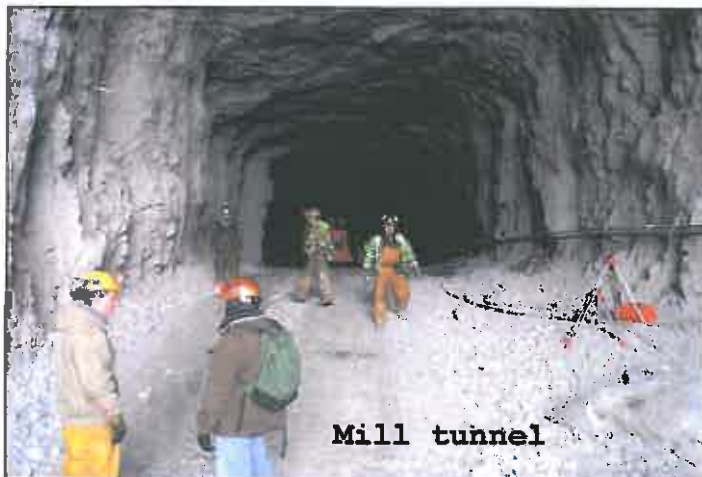
Mill tunnel

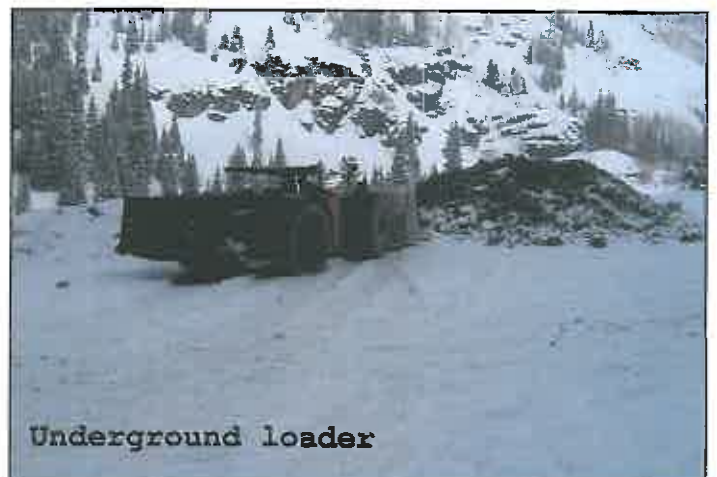
Underground loader
