RE: Response to Problems Cited Inspection Report February 4, 2013
Costilla Pit 110c Construction Limited Impact File M-1987-040

SUBJECT: Response to Problems Cited Inspection Report February 4, 2013
Costilla Pit 110c Construction Limited Impact File M-1987-040

COSTILLA PIT

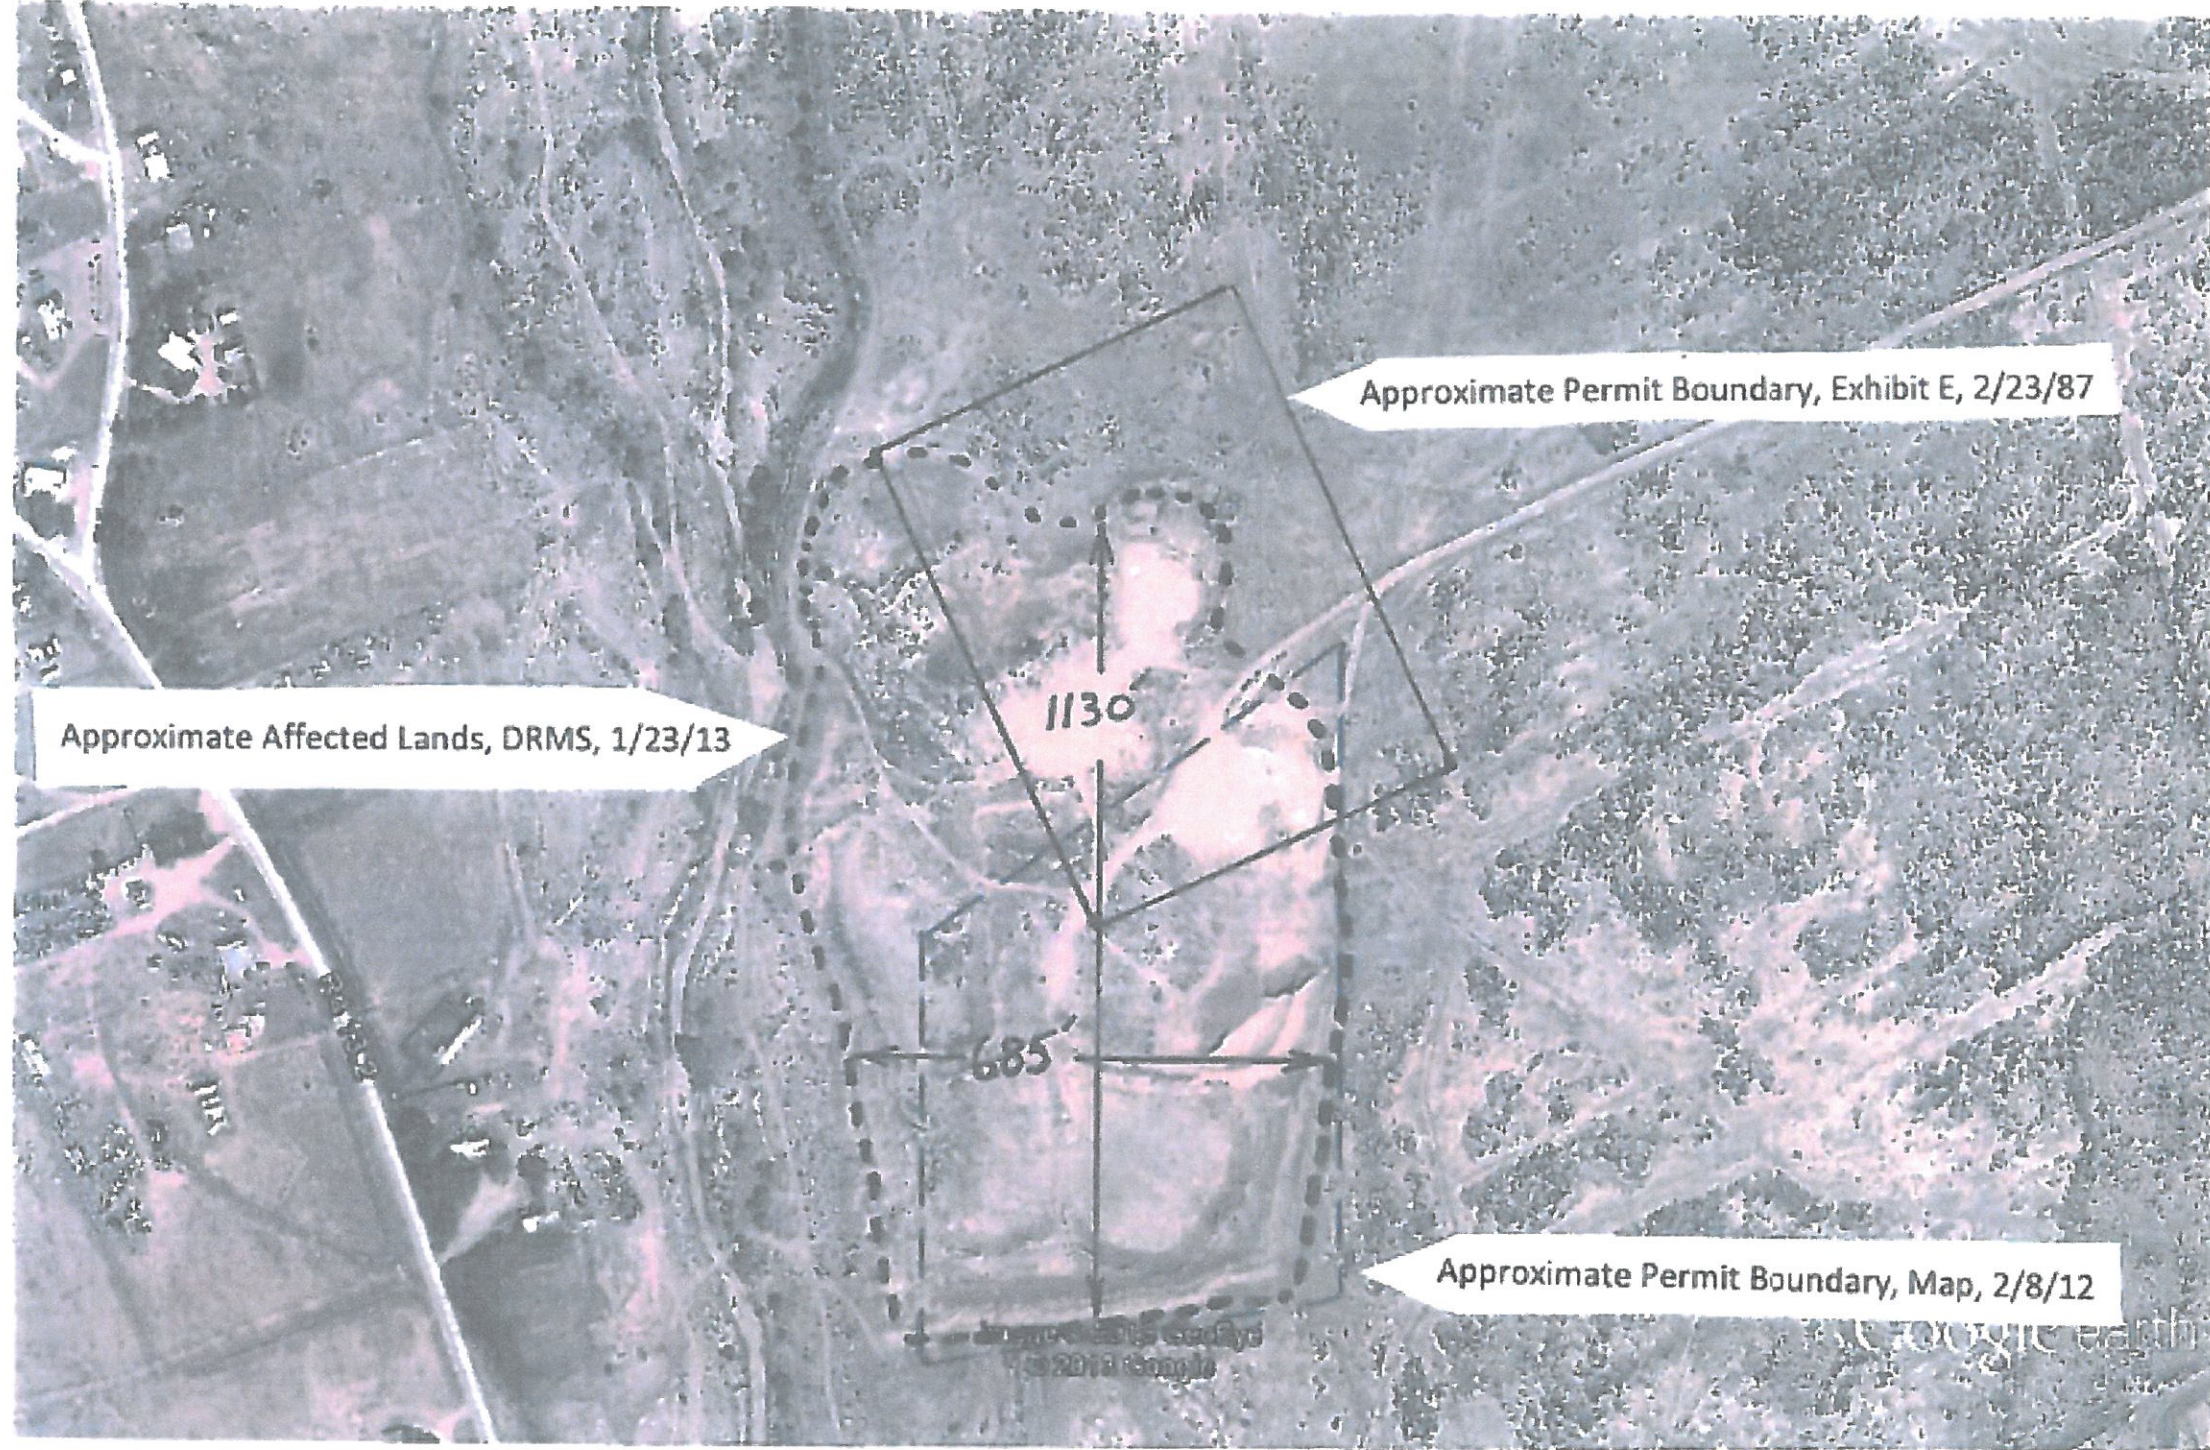
DIVISION OF RECLAMATION, MINING and SAFETY MAP
SHOWING THE IMAGERY OF
THE DRMS INSPECTION 1/23/13
OBSERVATIONS BY WHE

Imagery Date 6/10/12
Castilla Pit M-1987-040
DRMS inspection 1/23/13
WHE observations

$$\text{Affected Land} \approx \frac{1130' \times 685'}{43560 \text{ sf/ac}} \approx 17.8 \text{ acres}$$

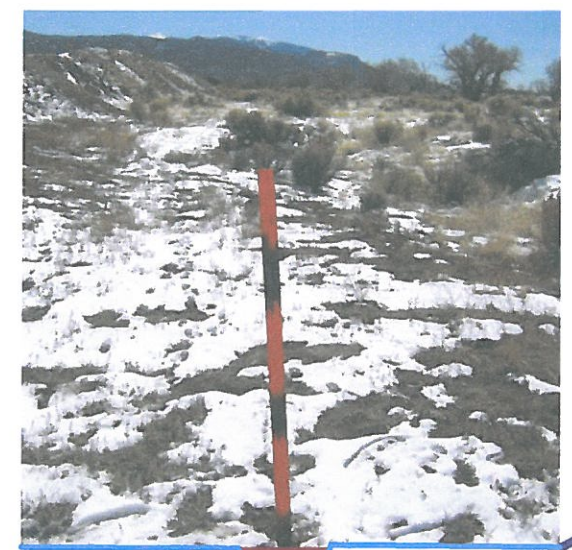
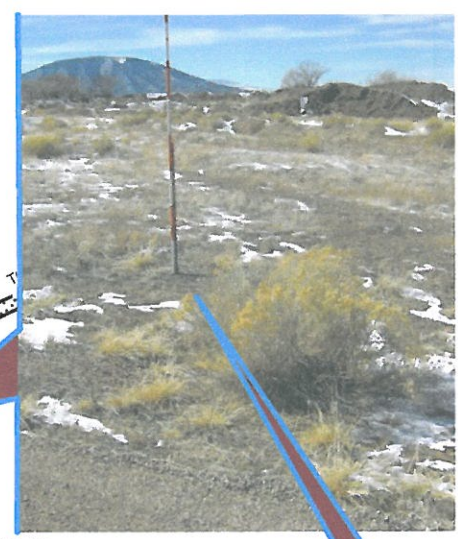
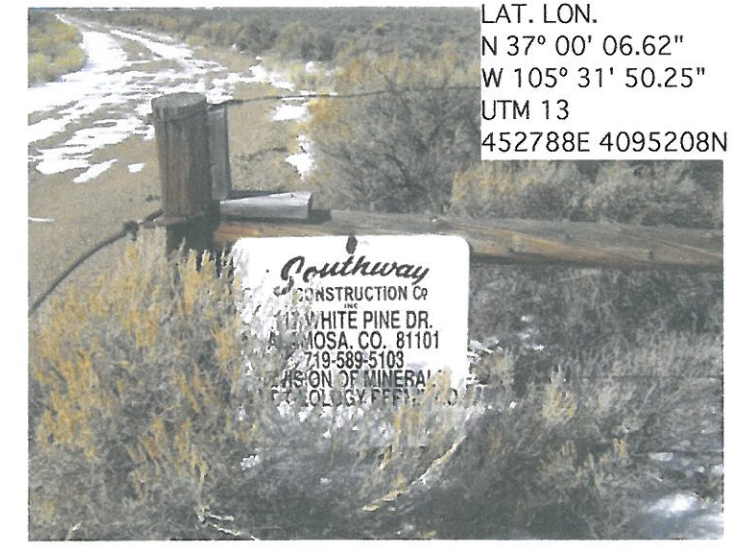
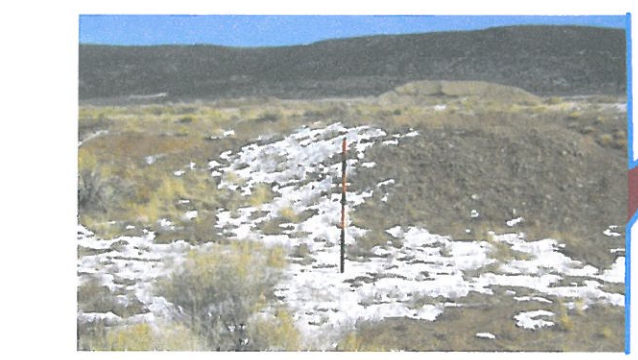
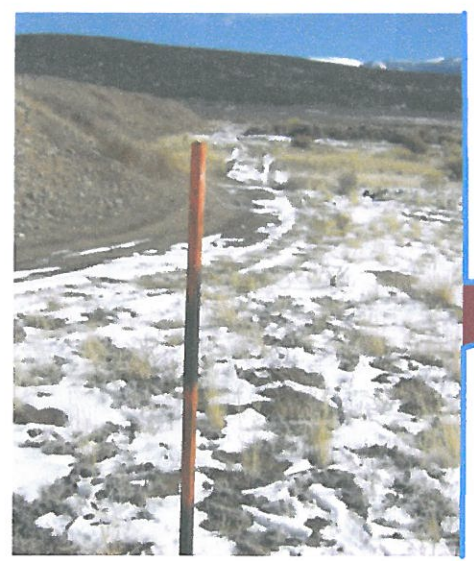
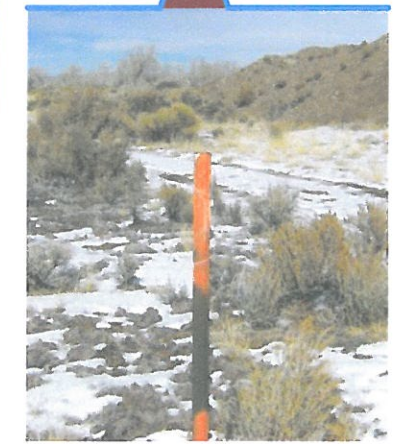
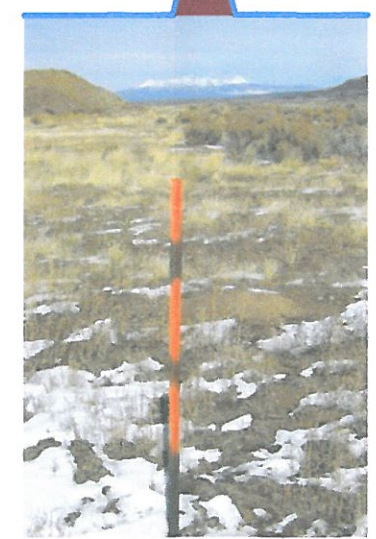
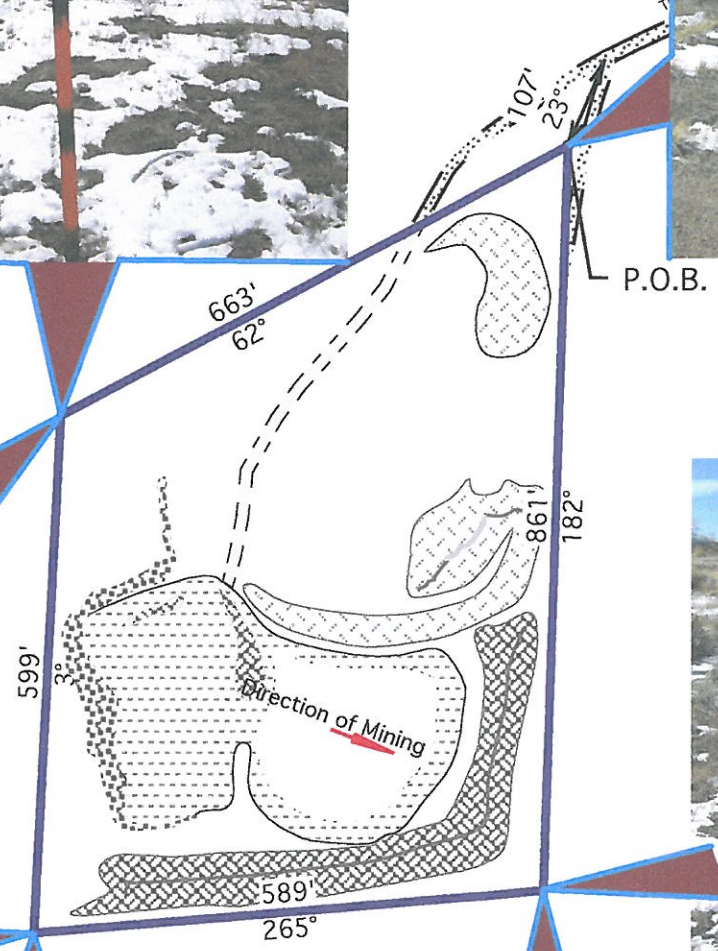
COSTILLA PIT		CORRECTIVE ACTION MAP & PHOTOS	
CLIENT: SOUTHWAY CONSTRUCTION COMPANY, INC.		PERMIT FILE NUMBER M-1987-040	
CONSULTANT: L J DEVELOPMENT, INC.		PREPARED BY: <i>Joseph P. Haglund</i>	
PHOTOGRAPHIC EVIDENCE OF NEWLY PLACED MARKERS		DATE: FEBRUARY 19, 2013

MARKERS THAT THE DELINEATE PERMIT BOUNDARY

The second problem cited was the inspection topic of Signs and Markers. The problem noted was that the affected area boundary markers were missing or incorrectly placed. We have corrected this situation by placing steel tee posts to delineate the permit boundary. A map with the permit description that can be used in the future to establish the boundary has been enclosed with this correspondence please see Exhibit E Mining Plan. Additionally we have enclosed a labeled CORRECTIVE ACTION MAP & PHOTOS that provides the Photographic Evidence as required by the Division of Reclamation, Mining and Safety.
