**COLORADO DIVISION OF RECLAMATION, MINING AND SAFETY
COAL PROGRAM INSPECTION REPORT**

Permit Number: C-1982-057 Mine Name: Seneca II-W Mine Operator: Seneca Coal Company, LLC Operator Address: Mr. Roy Karo 37796 Routt County Road 53 P.O. Box 670 Hayden, CO 81639	County: Routt Operation Type: Surface Permit Status: Permanent Cessation Ownership: Federal
	Operator Representative Present: Roy Karo
Operator Representative Signature: (Field Issuance Only)

Inspection Start Date: March 18, 2013 Inspection Start Time: 12:30 Inspection End Date: March 20, 2013 Inspection End Time: 09:30	Inspection Type: Coal Complete Inspection Inspection Reason: Normal I&E Program Weather: Clear
Joint Inspection Agency: None	Joint Inspection Contacts:
Post Inspection Agency: None	Post Inspection Contacts:
Inspector(s): Jared L. Ebert	Inspector's Signature:

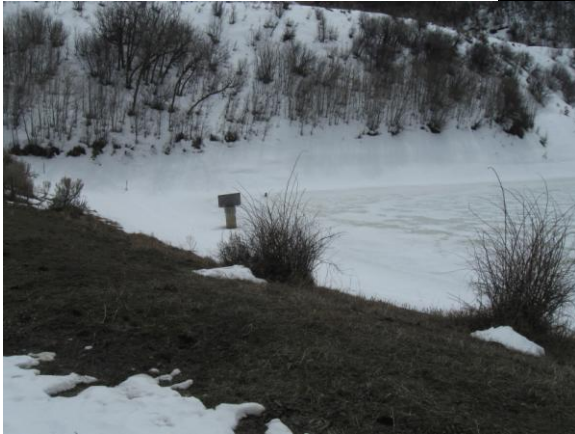
Pond 009 was holding water and was ice covered. The primary spillway was clear of debris and functional. The emergency spillway was snow covered. The embankment was snow covered but appeared stable.

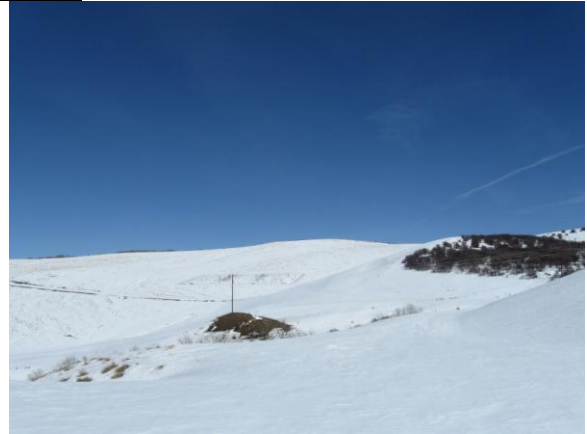
Road A near the Pit Ramp Slide looking into the upper end of 006 Gulch

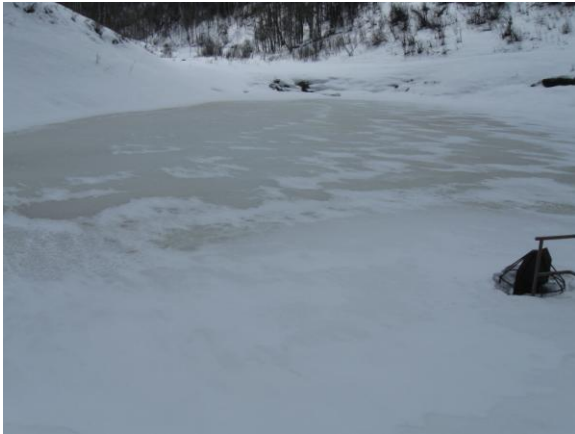
Pond 015 was holding water and was discharging. The primary spillway was partially frozen but was still functional. The emergency spillway was snow covered. The embankment was snow covered but appeared stable.

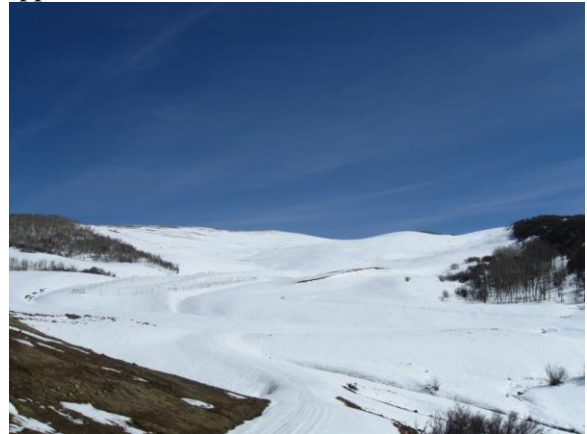
The PM-2, PM-3, PM-6, drainage basins were visible from the Pond 016 area. The drainages and basins were snow covered but they appeared stable.

PM-2 and 3 Drainage Basins into Pond 016

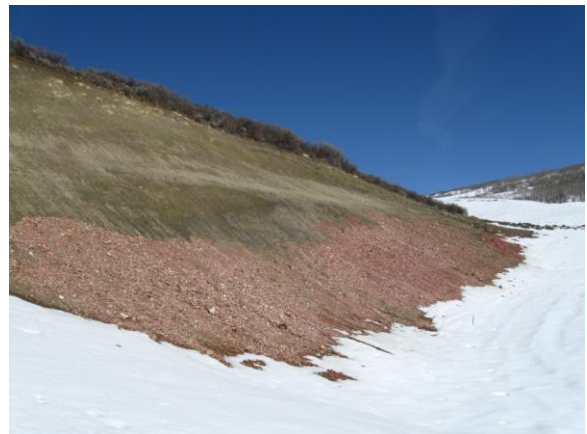
Pond 016 Slide Area

The Pond 016 slide area was observed. The rock mulch that was applied to the graded area was exposed and appears to have stayed in place after snow has melted from the area. Minor rilling was observed from the snow melt in this area.

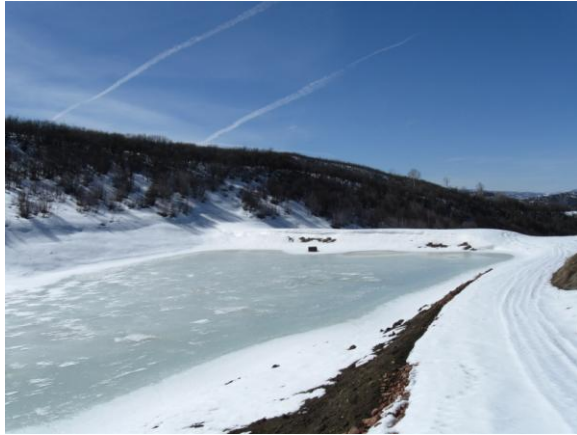
Pond 016 was holding water and discharging. The primary spillway was partially covered with snow but was functional. The embankment was snow covered but appeared stable. The emergency spillway was also snow covered.

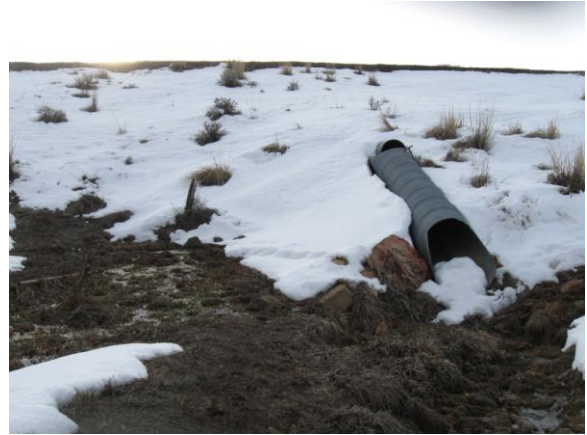
Pond 005 was holding water but was not discharging from the primary spillway. There is a seep adjacent to the bottom of the primary spillway culvert at the base of the embankment. This seep was flowing and the water was discharging from the flume.

Pond 005 primary spillway at the base of the embankment.

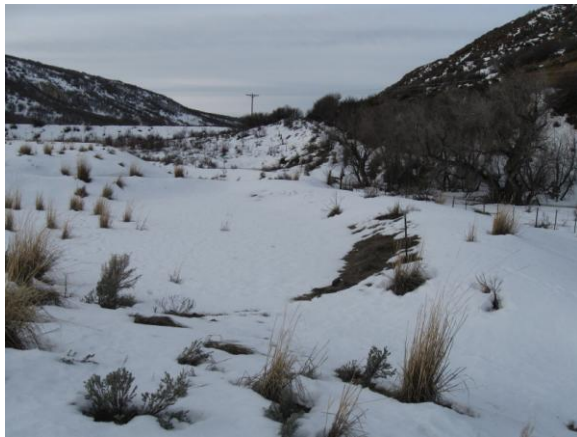
Stock Tank T-24

Stock tank T-24 was snow covered but the embankment appeared stable.

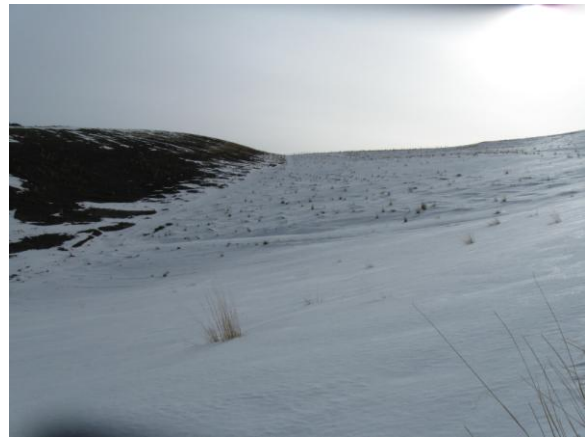
Drainage 005-E-1

Drainages 005-E-1 and 005 Gulch were snow covered. Portions of these drainage basins were melted and some rills were visible.

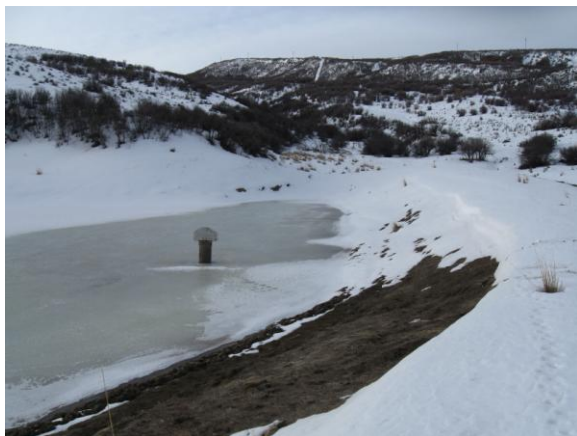
The Pond 005 area appears to be heavily used by deer, elk and other wildlife.

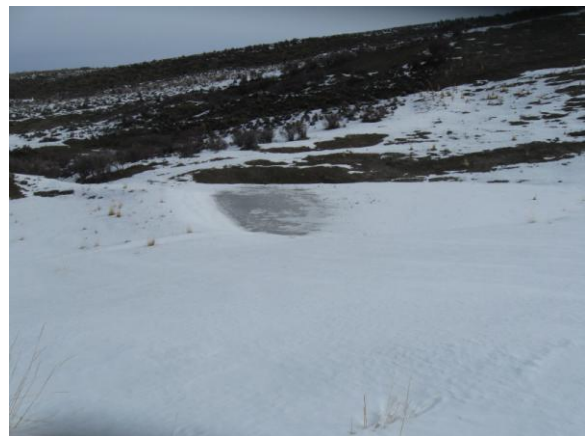
Stock Tank T-20

Stock tank T-20 was holding water and the embankment was snow covered but appeared stable.

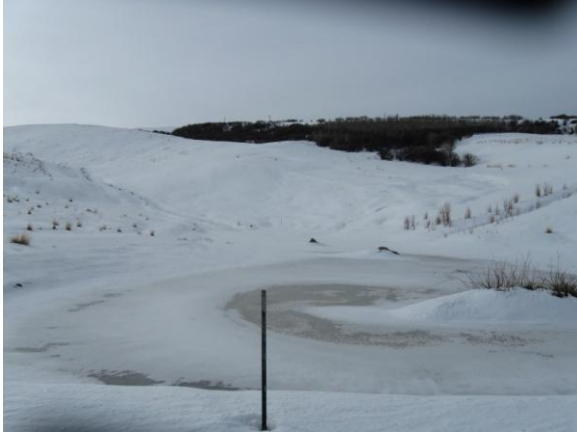
Stock Tank T-18, and 005 Gulch

Stock Tank T-18 was holding water, the embankment was snow covered but appeared stable.
