## COLORADO DIVISION OF RECLAMATION, MINING AND SAFETY COAL PROGRAM INSPECTION REPORT

<b>Permit Number:</b> C-2009-087 <b>Mine Name:</b> Peabody Sage Creek Mine <b>Operator:</b> Peabody Sage Creek Mining LLC <b>Operator Address:</b> Mr B. Scott Cowman P.O. Box 250 36600 Routt County Road 27 Hayden, CO 81639	<b>County:</b> Routt <b>Operation Type:</b> Underground <b>Permit Status:</b> Active <b>Ownership:</b> Federal
<b>Operator Representative Present:</b>	
<b>Operator Representative Signature: (Field Issuance Only)</b>

<b>Inspection Start Date:</b> March 18, 2013 <b>Inspection Start Time:</b> 12:00 <b>Inspection End Date:</b> March 18, 2013 <b>Inspection End Time:</b> 14:30	<b>Inspection Type:</b> Coal Partial Inspection <b>Inspection Reason:</b> Normal I&E Program <b>Weather:</b> Cloudy
<b>Joint Inspection Agency:</b>  None	<b>Joint Inspection Contacts:</b>
<b>Post Inspection Agency:</b>  None	<b>Post Inspection Contacts:</b>
<b>Inspector(s):</b>  Leigh D. Simmons  Jason D. Musick	<b>Inspector's Signature:</b>

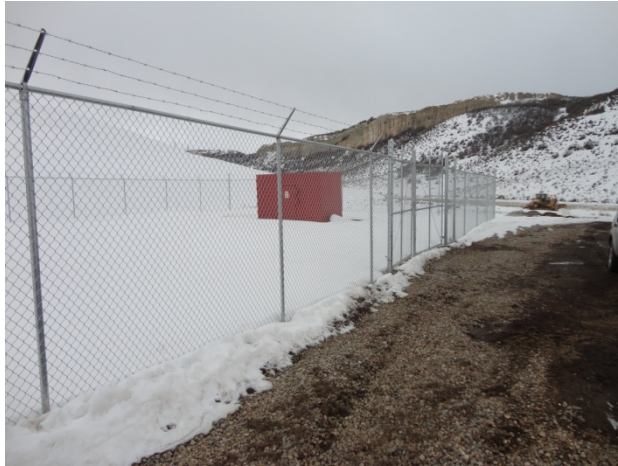
Photo 1: Explosives area

The explosives storage area was snow covered. The chain link fence was intact, with the gate locked (see photo 1).

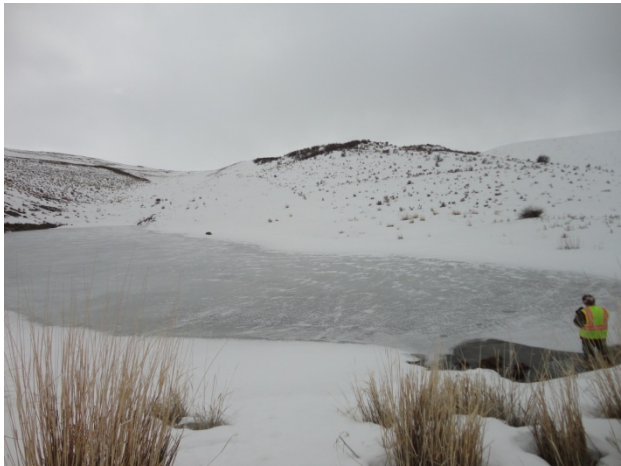
Photo 2: Pecoco Pond

**Pecoco Pond** was frozen on the surface, but there was a small flow into the Upper Sump through the primary spillway. The embankment and emergency spillway were snow-covered but appeared stable (see photo 2).

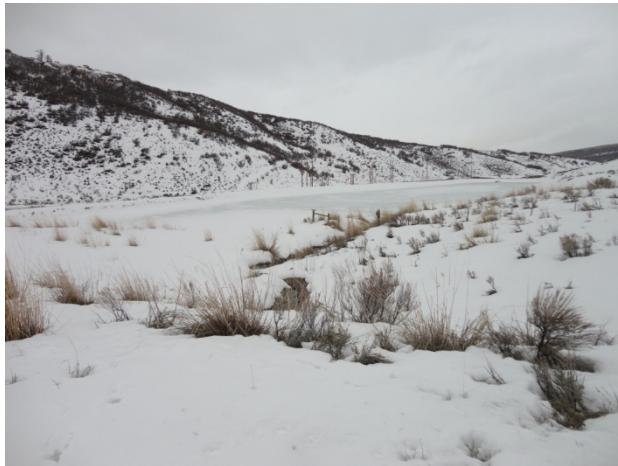
Photo 3: Upper Sump

The **Upper Sump** was similarly frozen and snow-covered (see photo 3). No problems were observed. A small flow was discharging through the primary spillway. Flow from the Upper Sump is conveyed under Road C through culvert SC-16, then back under Road B through culvert SC-19, to the Lower Sump. The culverts had been buried by snow but were inspected and found to be clear (see photos 4&5).

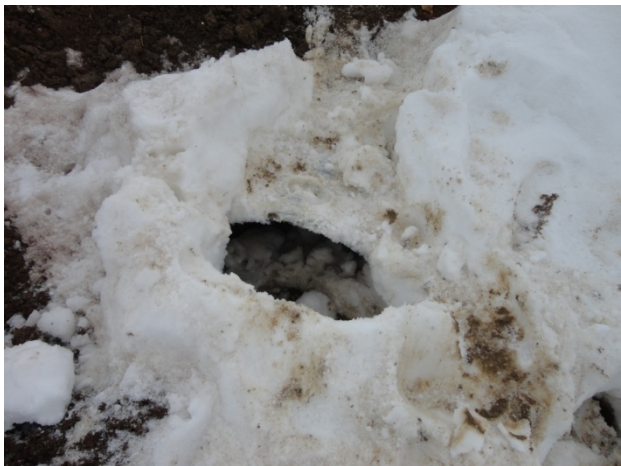
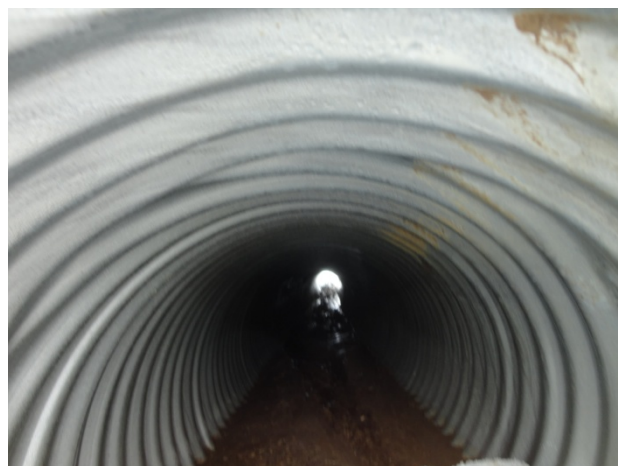
Photo 4: Culvert SC-16 buried

Photo 5: Culvert SC-16 flowing

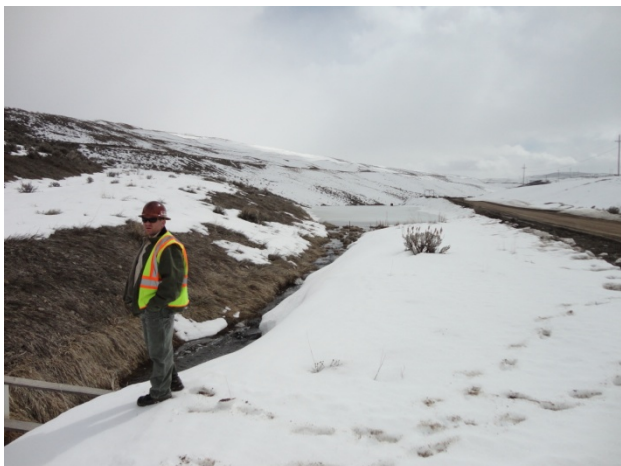
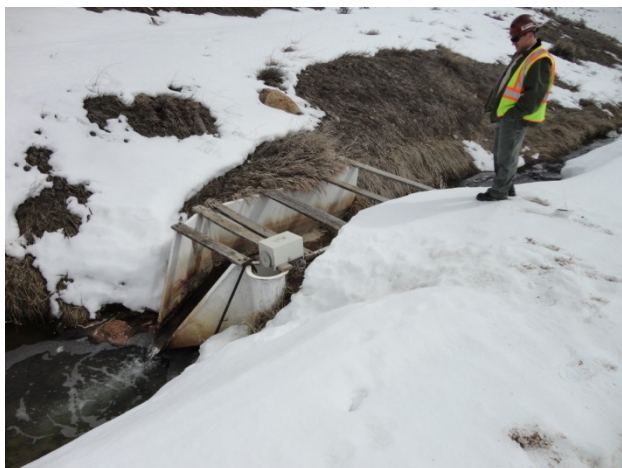
**Pond 2** was holding water and mostly frozen on the surface. The combined primary/emergency spillway was discharging water through culvert 9A, beneath Road B, to the wetland area above the confluence of Little Grassy Creek and Grassy Creek (see photos 6&7). The NPDES point at the outlet of the pond 2 combined spillway is subject to a numerical limit for Selenium. Exceedences of this limit have been recorded within the last two years, although recent discharge monitoring reports have shown Selenium levels back below the limit. The values of the numerical limit; the extent to which disturbance at Sage Creek Mine has elevated background Selenium levels; and possible mitigation strategies are the subject of ongoing debate between Mr Cowman, on behalf of Peabody Sage Creek Mining, and the Colorado Water Quality Control Division. DRMS asks to be kept fully informed as the situation develops.

Photo 6: Pond 2

Photo 7: Pond 2 discharge

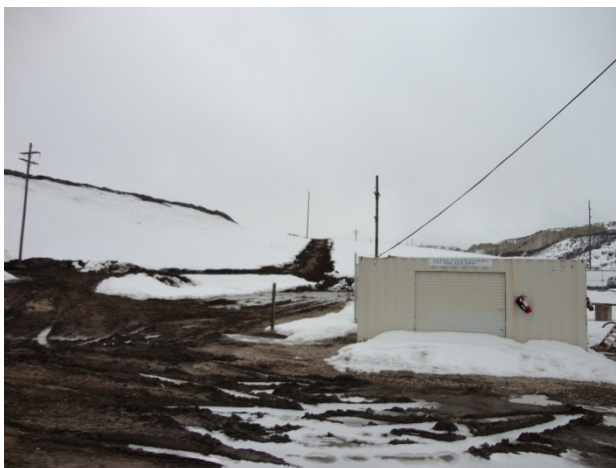
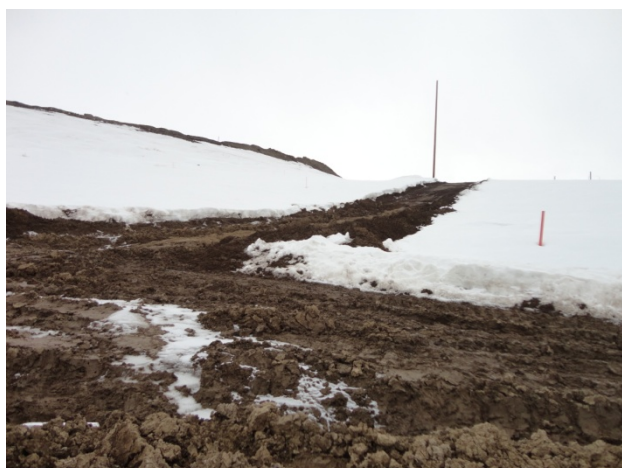
- Culverts 53A and 64A were clear;
- Culvert SC 18 was clear and undamaged despite the recent disturbance caused by the project to erect the power poles;
- The power pole project has created a muddy mess and compromised the ditch across the area (see photos 8&9). **Ditch FA-D1 should be re-established;**
- A breach had been made in the ditch on the east side of Road B in order to drain the road through a culvert to the north of culvert 9A (see photos 10&11). **The roadside ditch should be re-established, or if that is found to be ineffective, the surface water scheme should be re-designed and the permit revised.**

Photo 8: Power pole disturbance

Photo 9: Power pole disturbance (2)

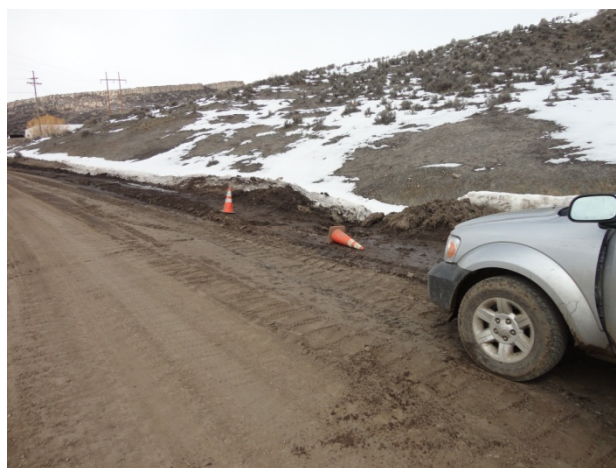
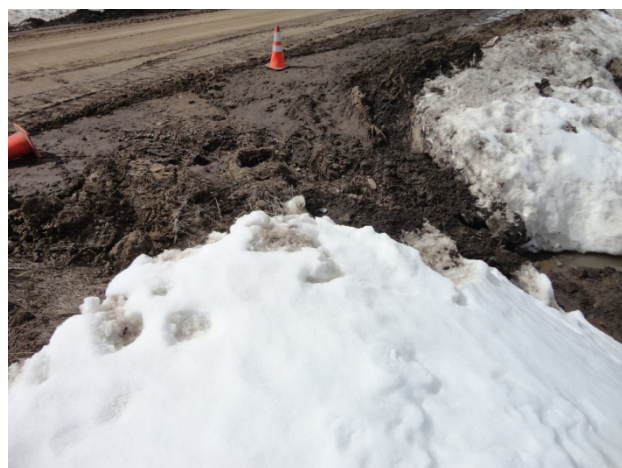
Photo 10: Breach in roadside ditch

Photo 11: Breach in roadside ditch (2)

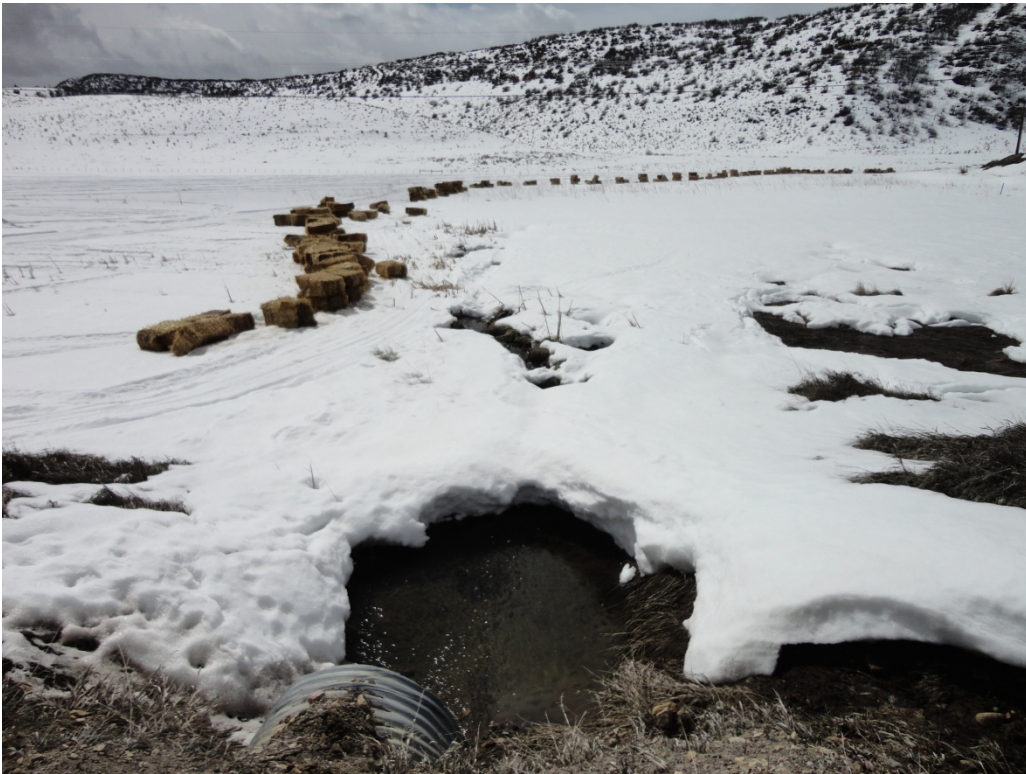
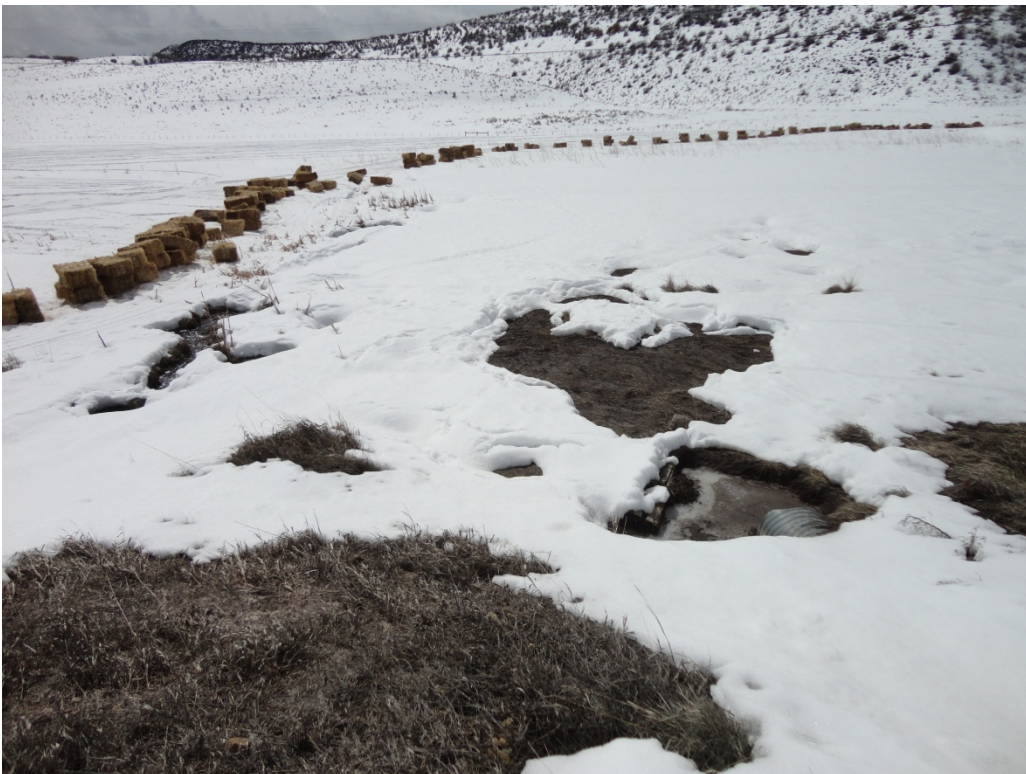
A culvert just to the north of culvert 9A was conveying water underneath Road B to the wetlands. The culvert is not currently identified on map 2.05.3 M4 Drainage and Sediment Control Plan (see photos 12&13). **The culvert should be identified and the permit updated as necessary.**

Photo 12: Culvert 9A, and Little Grassy Creek wetland

Photo 13: Unidentified culvert just north of 9A, and Little Grassy Creek wetland
