# COLORADO DIVISION OF RECLAMATION, MINING AND SAFETY COAL PROGRAM INSPECTION REPORT

<b>Permit Number:</b> C-1982-056 <b>Mine Name:</b> Foidel Creek Mine <b>Operator:</b> Twentymile Coal, LLC <b>Operator Address:</b> Mr Jerry Nettleton 29515 Routt County Road No. 27 Oak Creek, CO 80467	<b>County:</b> Routt <b>Operation Type:</b> Underground <b>Permit Status:</b> Active <b>Ownership:</b> Federal
	<b>Operator Representative Present:</b>  Brian Watterson
<b>Operator Representative Signature: (Field Issuance Only)</b>

<b>Inspection Start Date:</b> March 19, 2013 <b>Inspection Start Time:</b> 08:00 <b>Inspection End Date:</b> March 19, 2013 <b>Inspection End Time:</b> 16:00		<b>Inspection Type:</b> Coal Partial Inspection <b>Inspection Reason:</b> Normal I&E Program <b>Weather:</b> Clear	
<b>Joint Inspection Agency:</b>  None		<b>Joint Inspection Contacts:</b>  	
<b>Post Inspection Agency:</b>  None		<b>Post Inspection Contacts:</b>  	
<b>Inspector(s):</b>  Leigh D. Simmons  Jason D. Musick	<b>Inspector's Signature:</b>

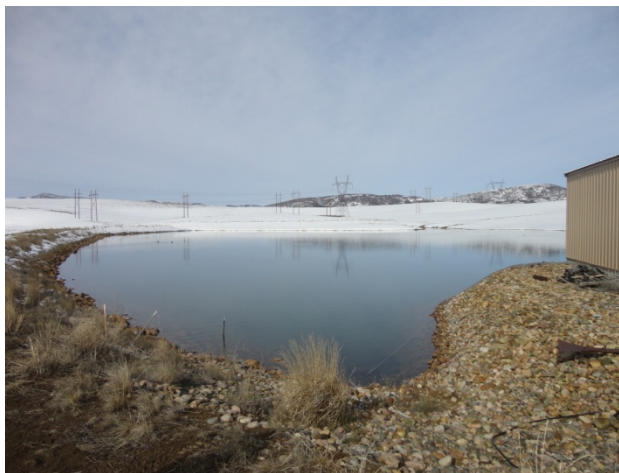
dust control. The embankments of this impoundment were stable, (see photos 1&2).

Photo 1: 6-Main North impoundment

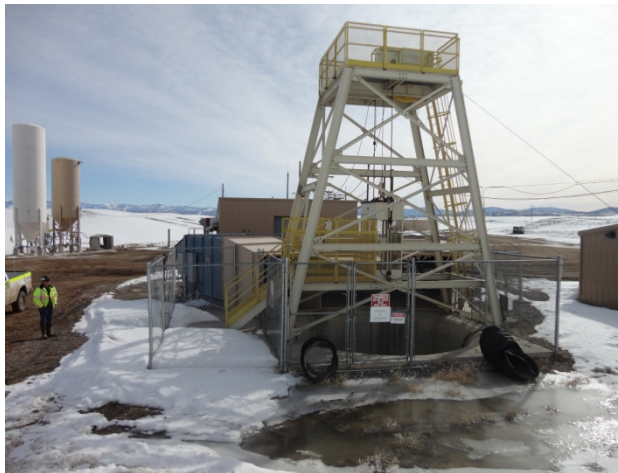
Photo 2: 6-Main North ventilation shaft

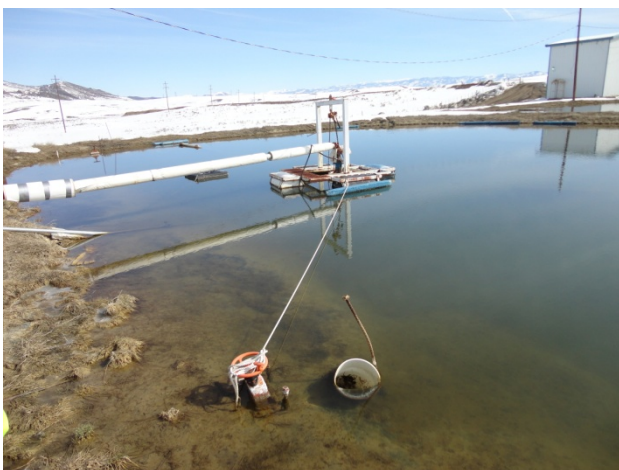
The Fish Creek Borehole dewater the old workings of the Western Mining District (the oldest part of the mine). The water used to be treated with sodium hydroxide to raise the pH sufficiently to precipitate metals, before discharging to Fish Creek. The current scheme has the mine water treated by electro-coagulation before passing through a series of three baffled ponds with the aim of removing Iron and Manganese so that the water can be used for dust control without causing scaling of the equipment. Discharge to Fish Creek is avoided; overflow from the third pond runs back into the mine workings. The ponds were full, the embankments were sound but the baffles appeared to be in need of maintenance, (see photo 3).

Photo 3: Overflow from third pond at Fish Creek Borehole

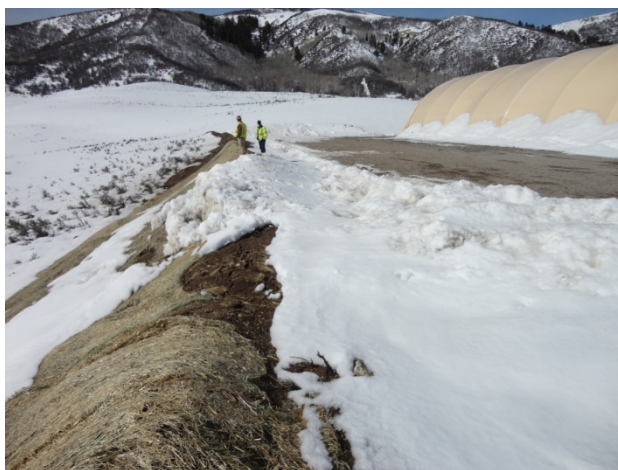
The 16-Left Utility borehole pad is permitted as an SAE. The pad was generally in good shape; however a slump had occurred in the berm on the south side, possibly as a result of snow-plowing, (see photo 4). **The berm on the outside of the pad should be re-built.** Also on this pad was an uncovered pail for the disposal of oil-soaked diapers, (see photo 5). **The pail should be covered.**

Photo 4: Slump in berm at the 16-Left Utility borehole pad SAE

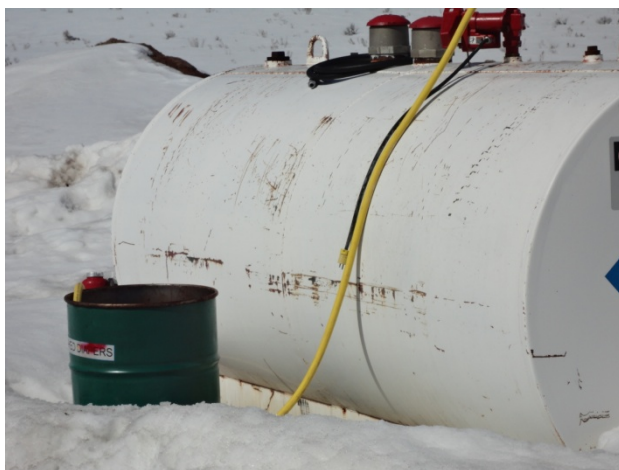
Photo 5: Uncovered pail at the 16-Left Utility borehole pad SAE

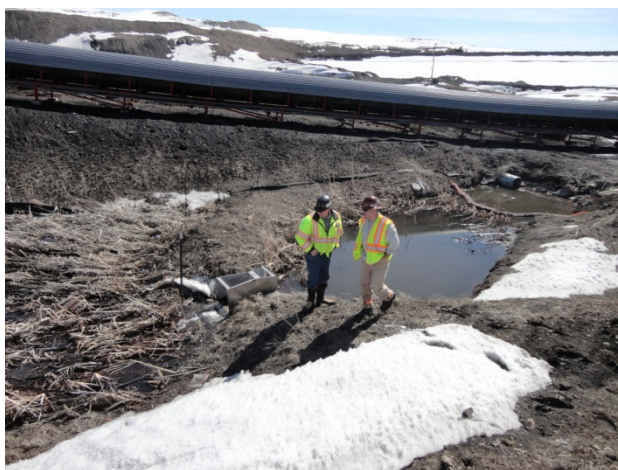
Photo 6: Discharge from pond D

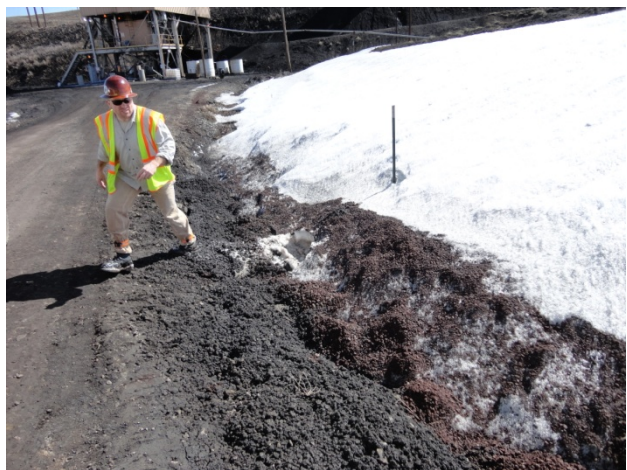
The unidentified culvert(s) east of pond C were covered with snow at the inlet side. On the outlet side there was some evidence of erosion through the berm on the road-side (see photos 7&8). **Maintenance is needed in this area.**

Photo 7: Covered culverts near pond C

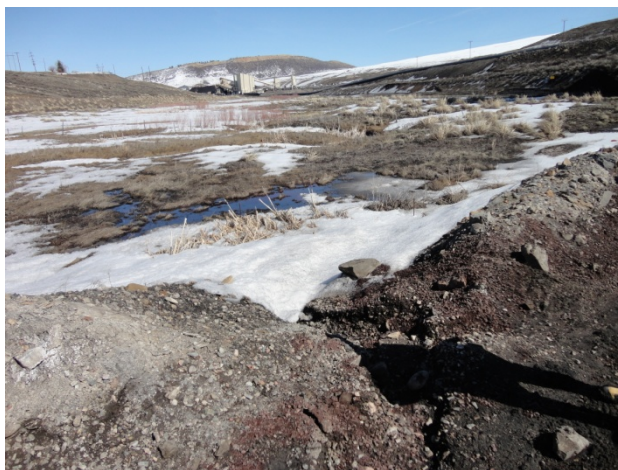
Photo 8: Erosion near pond C

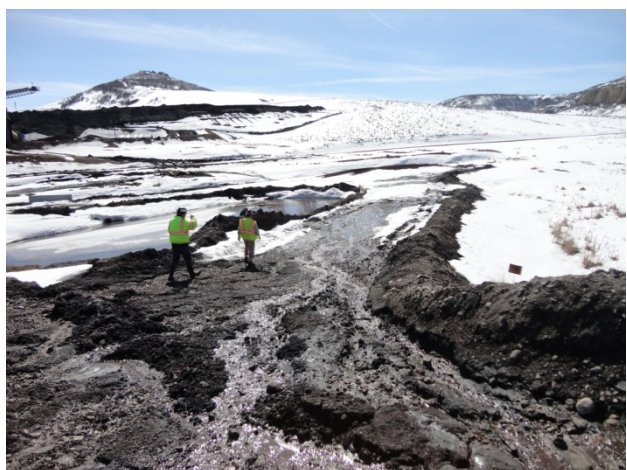
Within the facilities area, "the pit" and ponds D, E, C, B and A were inspected. The embankments of all appeared to be stable. The Pit is not permitted as a sediment pond and is incised rather than impounded by embankments. It receives road run-off and the outflow of the down drain under the RDA. The pit discharges to pond D, which was observed to be discharging through its NPDES monitoring point, (see photo 6). Ponds E and C were not discharging. Pond B could have been discharging, but the outlet was blocked by snow/ice and a definitive observation could not be made (see photos 9&10). **The outlet to pond B should be cleared.**

Photo 9: Muddy road near pond B

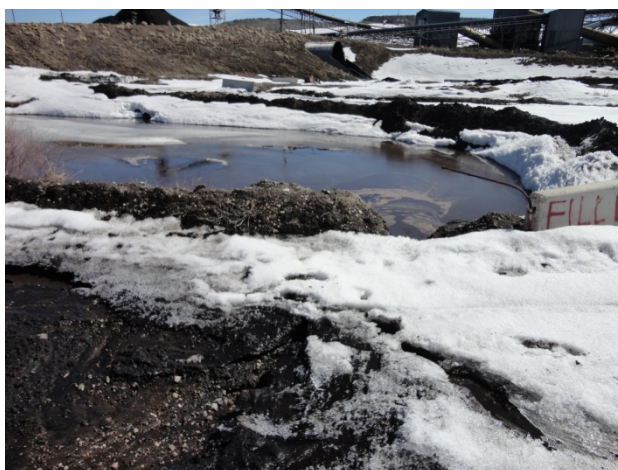
Photo 10: Pond B

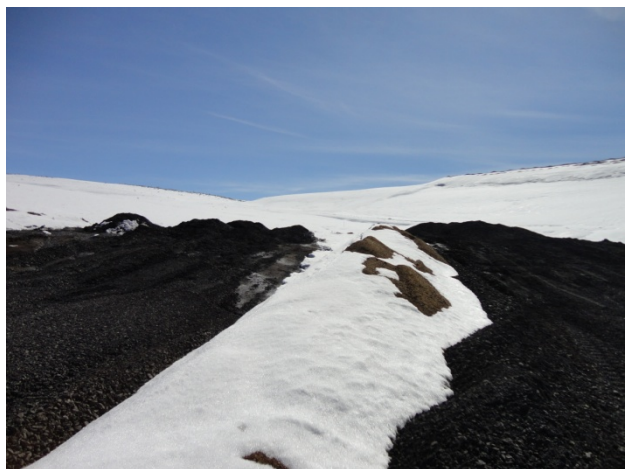
The RDA, as permitted, is sufficient to see Foidel Creek Mine to the end of its life, and also to take the first few years worth of refuse from the Peabody Sage Creek Mine when it begins production. Refuse was being deposited on the second lift. The pile was stable and the down drain was inspected, with no problems observed, (see photos 11&12).

Photo 11: RDA down drain

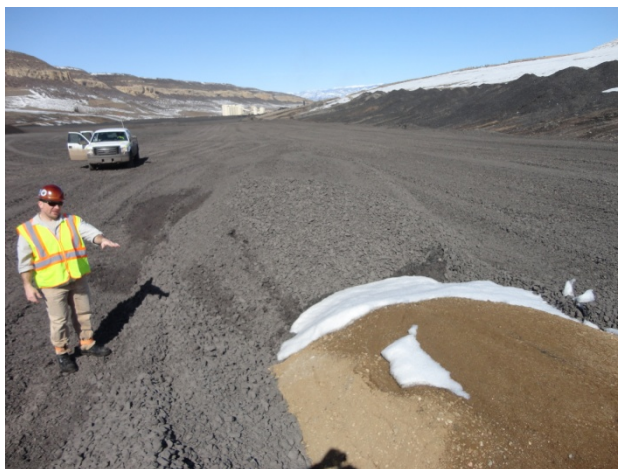
Photo 12: RDA
