**COLORADO DIVISION OF RECLAMATION, MINING AND SAFETY
COAL PROGRAM INSPECTION REPORT**

Permit Number: C-1981-010 Mine Name: Trapper Mine Operator: Trapper Mining, Inc. Operator Address: Mr Forrest V Luke P.O. Box 187 Craig, CO 81626	County: Moffat Operation Type: Surface Permit Status: Active Ownership: Federal
	Operator Representative Present: Graham Roberts
Operator Representative Signature: (Field Issuance Only)

Inspection Start Date: March 20, 2013 Inspection Start Time: 10:30 Inspection End Date: March 20, 2013 Inspection End Time: 17:30		Inspection Type: Coal Complete Inspection Inspection Reason: Normal I&E Program Weather: Cloudy	
Joint Inspection Agency: None		Joint Inspection Contacts:	
Post Inspection Agency: None		Post Inspection Contacts:	
Inspector(s): Jared L. Ebert	Inspector's Signature:

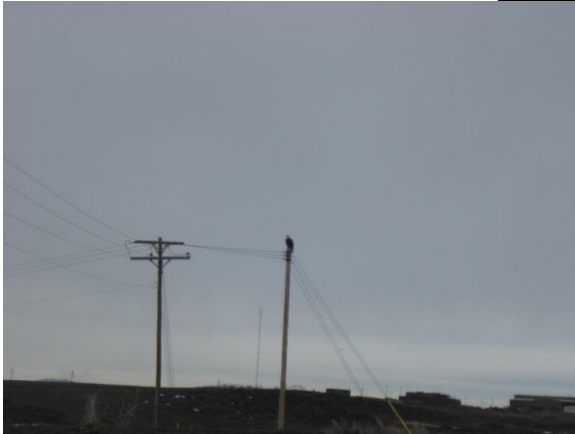
Several Bald Eagles were observed on the power poles near Coyote and Far East Buzzard Pond.

Bald Eagle near Far East Buzzard Pond entrance

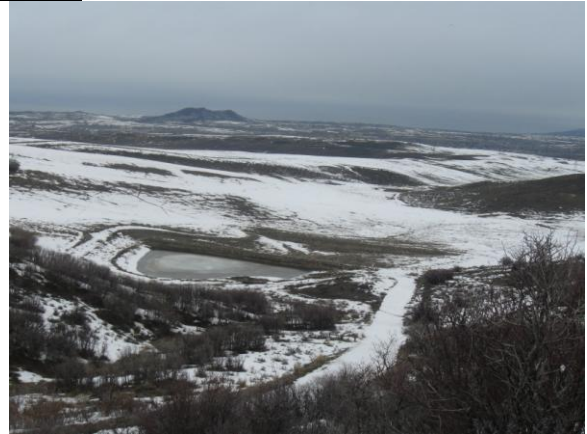
Grouse Ponds

Grouse and Sage Ponds were inaccessible but were visible from the ridge above the ponds. Grouse No. 1 pond was holding water and the spillway appeared clear and functional. Grouse No. 2 was dry and not discharging, the primary and emergency spillway appeared clear and functional. Both Sage Ponds were dry and not discharging. The Sage Ponds primary and emergency spillways appeared clear and functional.

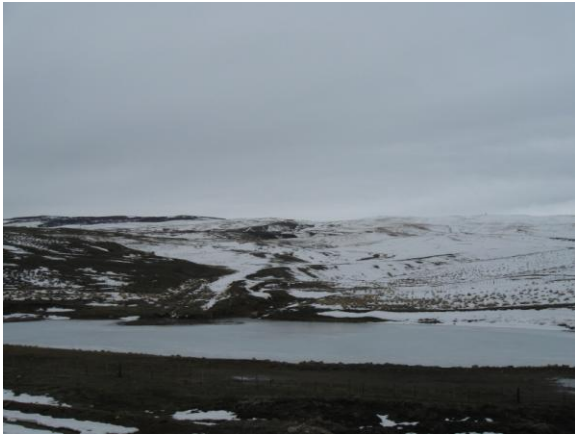
No Name Pond 2 was holding water and was ice covered. It appears this pond was cleaned last fall. The primary and emergency spillway was partially covered with snow.

No Name Pond No. 2 from road looking south toward D Pit.

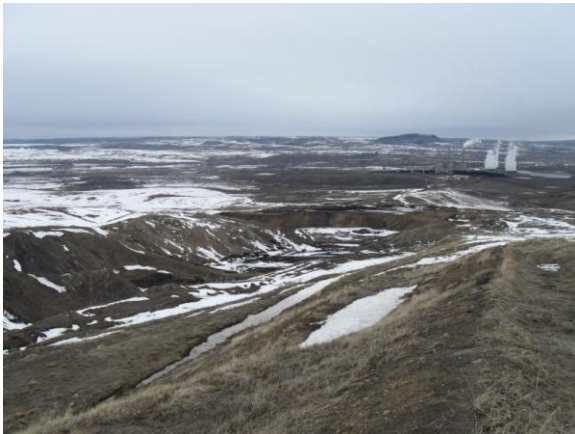
D Pit was observed, this pit is inactive and no problems were noted. The road to the top of the pit to Ute Pond was snow covered and inaccessible.

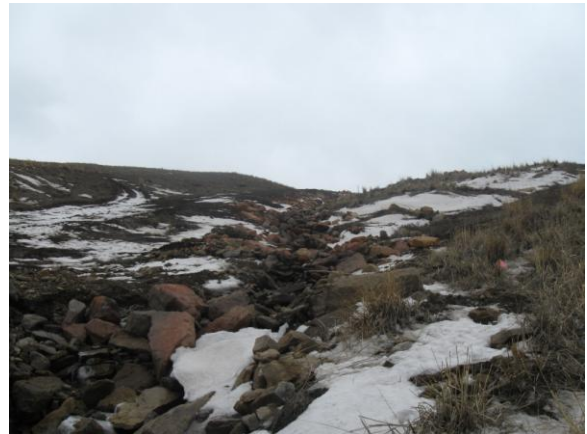
Oak gulch drainage

The Oak Gulch drainage was visible from the access road to the Oak Gulch Ponds. It appears a number of check dams have been constructed in this drainage. The lower end of drainage appeared stable and functional.

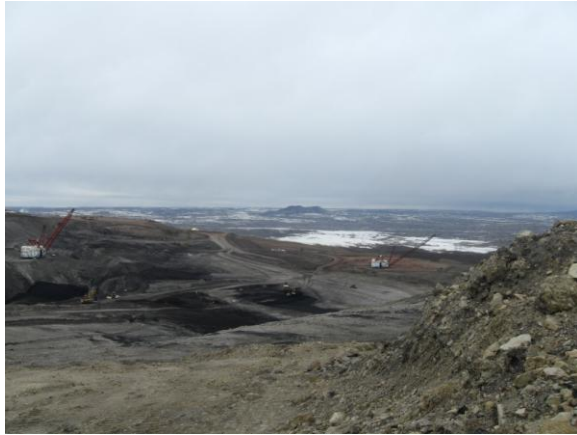
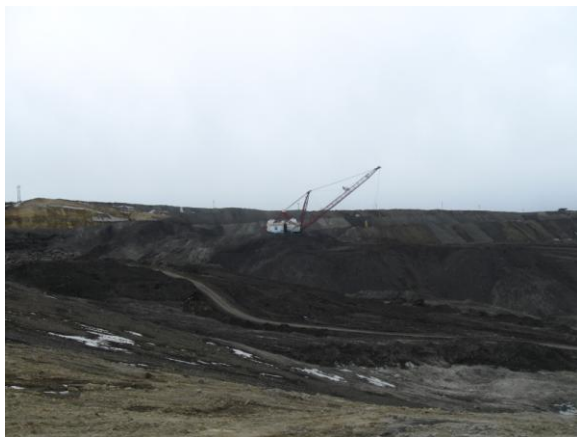
Active mine area

personnel at the mine office and there was little activity in the active mine area. Two truck and shovel crews were running at the time of the inspection and spoil was actively being backfilled behind the active pit area. It did not appear a blast pattern was being drilled and it did not appear TMI conducted blasting operations during the inspection.

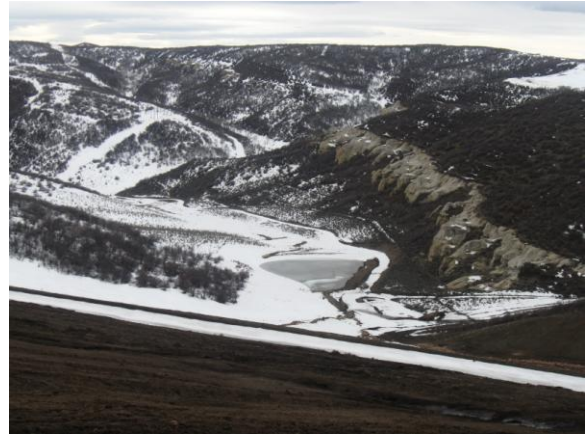
Horse Gulch Pond was inaccessible but the pond was visible from the top of the fill. The pond was holding water and was ice covered. It did not appear that the pond was discharging.

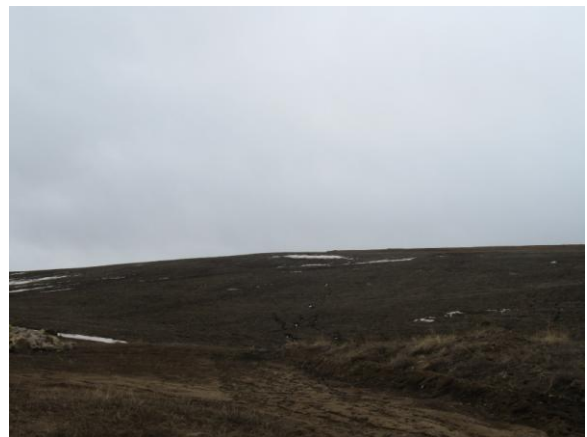
Parcel A-B-10 was observed, this parcel was devoid of snow and several large rills and gullies were observed that will need to be repaired.

Rilling in Parcel A-B-10

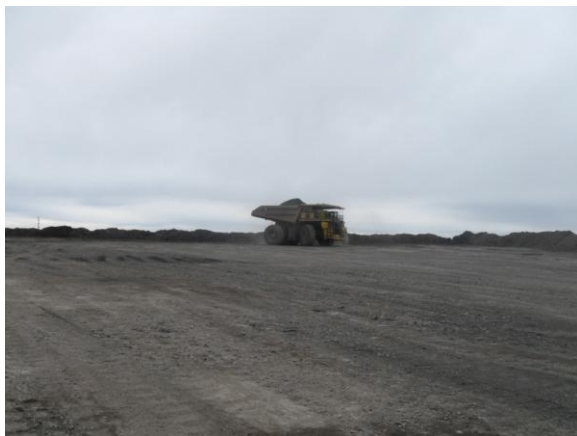
The Operator was actively backfilling spoil behind the Horse Gulch fill area. The upper level of the Horse Gulch Fill was devoid of snow. The lower levels of the fill and south drainage were covered in snow. The north drainage was clear and of snow and appeared functional. The fill seemed stable and only minor rilling was observed on the top level.

Backfilling behind active pit area
