**COLORADO DIVISION OF RECLAMATION, MINING AND SAFETY
COAL PROGRAM INSPECTION REPORT**

Permit Number: C-1981-020 Mine Name: Munger Canyon Mine Operator: CAM Mining, LLC Operator Address: Mr. Gary Isaac P.O. Box 98 Loma, CO 81524	County: Garfield, Mesa Operation Type: Underground Permit Status: Permanent Cessation Ownership: Federal
	Operator Representative Present: None
Operator Representative Signature: (Field Issuance Only)

Inspection Start Date: March 26, 2013 Inspection Start Time: 13:00 Inspection End Date: March 26, 2013 Inspection End Time: 15:10	Inspection Type: Coal Complete Inspection Inspection Reason: Normal I&E Program Weather: Clear
Joint Inspection Agency: None	Joint Inspection Contacts:
Post Inspection Agency: None	Post Inspection Contacts:
Inspector(s): Michael P. Boulay	Inspector's Signature: <i>Michael P. Boulay</i> Signature Date: 3/27/13

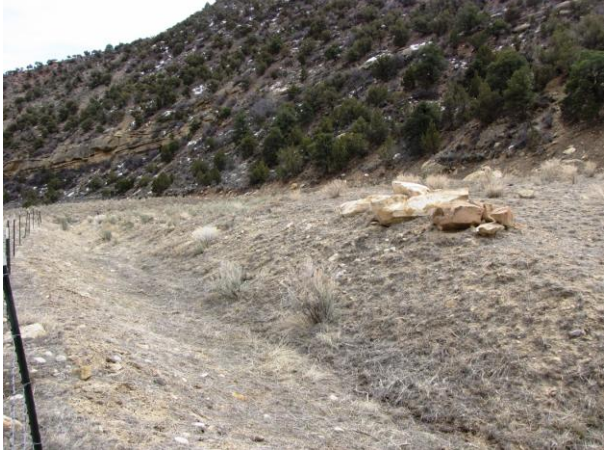
Photo No. 1 - Waste disposal and cover soil stockpile site.

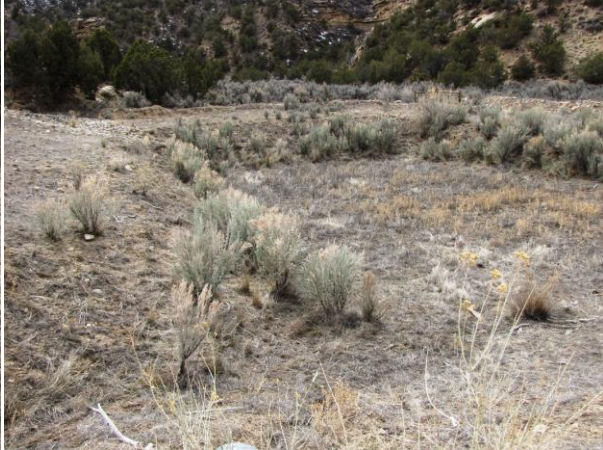
East Salt Creek and Munger Creek were not flowing and were only damp along the channel bottoms. The road into the mine site was mostly dry and stable and appeared to be in good condition. Ditches and culverts associated with the reclaimed waste disposal site, cover soil stockpile site, and the topsoil stockpile locations were in good condition and maintained (see Photograph No. 1). The sediment pond was not retaining water. The inlet and discharge structures were stable. The Sediment Pond is shown in Photograph No. 2. No problems were noted.

Photo No. 2 - Sediment Pond.

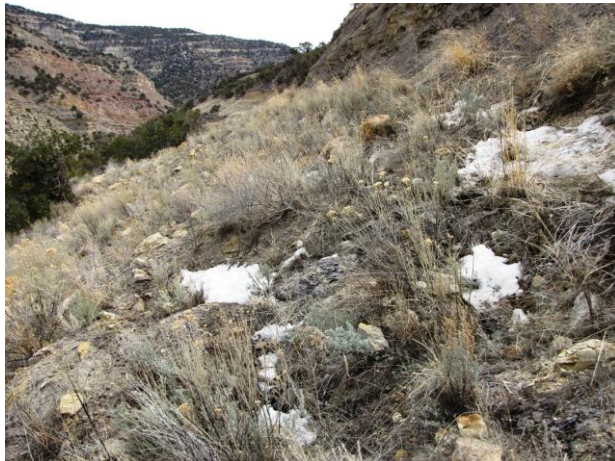
The reclaimed portal bench access road was inspected up to a point to where it became slick to walk on from snow melt. A portion of the reclaimed access road is shown in Photograph No. 3. The reclamation looks very good and there has been minimal erosion since the reclamation was completed in 2007. Rock lined drainage channels are in good condition (see Photograph No. 4).

Photo No. 3 - Reclaimed portal access.

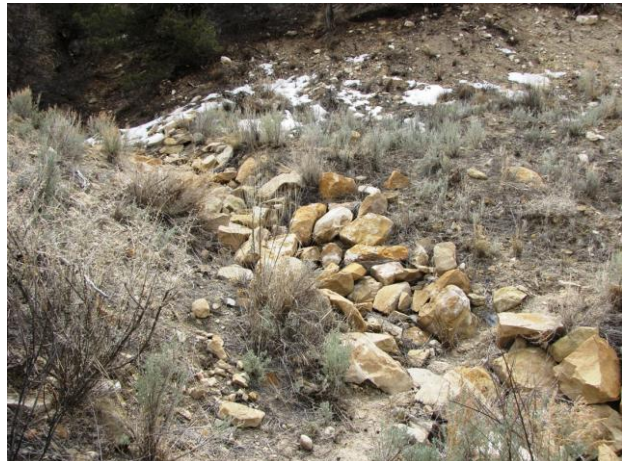
Photo No. 4 - Riprap drainage.
