COLORADO DIVISION OF RECLAMATION, MINING AND SAFETY COAL PROGRAM INSPECTION REPORT

Permit Number: C-1981-044 Mine Name: Williams Fork Mines Operator: Moffat County Mining, LLC Operator Address: Mr Jason Davis 29515 Routt County Road #27 Oak Creek, CO 80467	County: Moffat Operation Type: Underground Permit Status: Active Ownership: Federal
Operator Representative Present: Brian Watterson	
Operator Representative Signature: (Field Issuance Only)

Inspection Start Date: February 19, 2013 Inspection Start Time: 14:00 Inspection End Date: February 19, 2013 Inspection End Time: 16:00	Inspection Type: Coal Partial Inspection Inspection Reason: Normal I&E Program Weather: Cloudy
Joint Inspection Agency: None	Joint Inspection Contacts:
Post Inspection Agency: None	Post Inspection Contacts:
Inspector(s): Leigh D. Simmons Daniel I. Hernandez	Inspector's Signature:

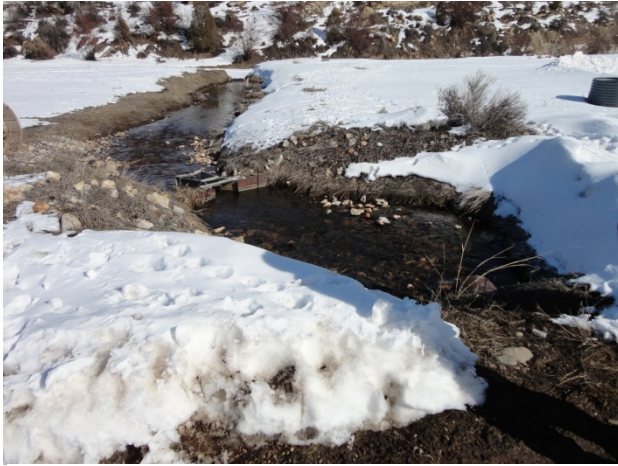
Photo 1: CDPS 003

A mine de-watering pump was discharging water into pond 5-P6 (the center of three ponds). Water appeared to circulate to ponds 5-P5 and 5-P7, as described in drawing number DWG. IV-33, before discharging at the monitoring point, CDPS 003 (sometimes still referred to as NPDES 003). Discharge was clear and colorless. The embankments of the three ponds were sound, with no sign of rodents.

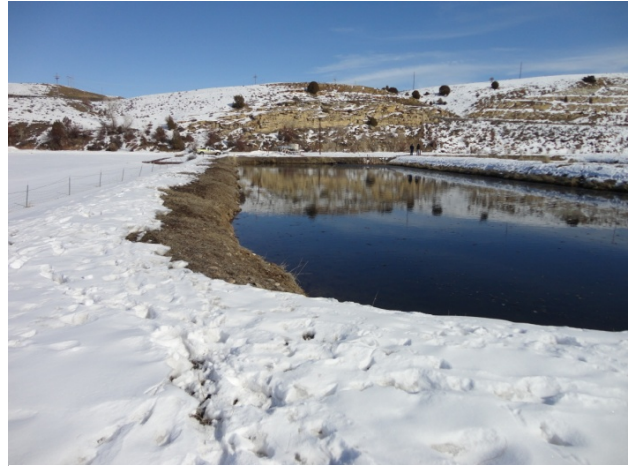
Photo 2: Pond 5P-5, looking west

An additional white pipe (not shown on DWG. IV-33) was laid across the eastern embankments of the three ponds. Its purpose was not clear although it appeared to be discharging water, possibly through a split, into pond 5-P5.

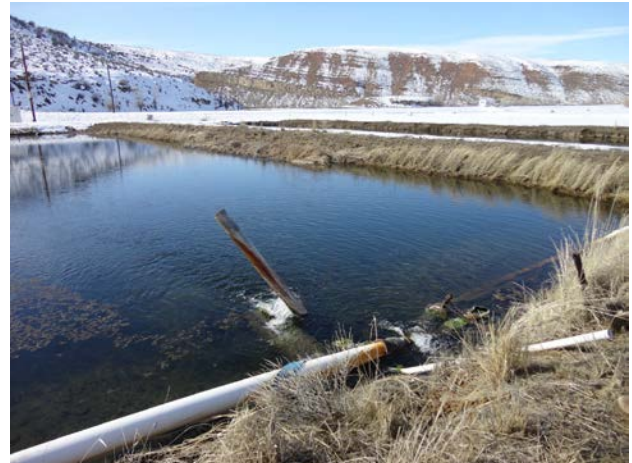
Photo 4: Pond 5P-6, showing inflow and unidentified white pipe

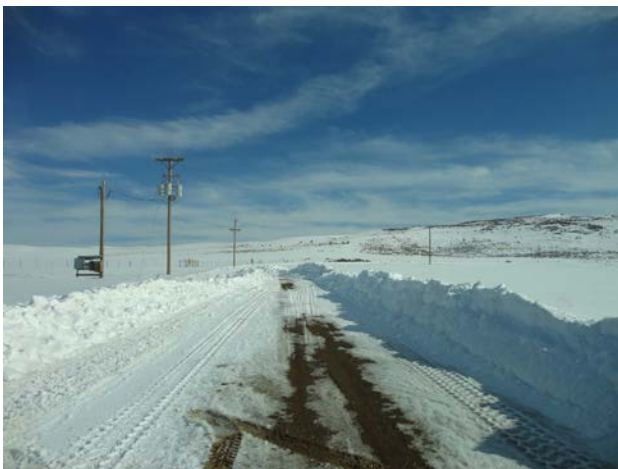
Most roads were snow covered and impassable, however the haul road to the main facilities area had been plowed and was in good condition.

Photo 5: Plowed haul road

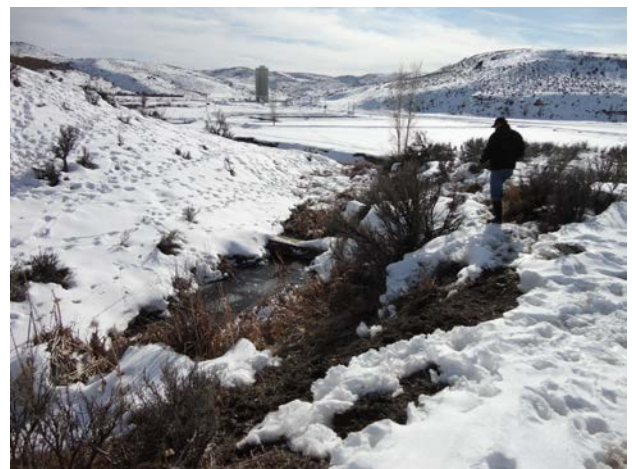
Photo 6: CDPS 022

The monitoring point, CDPS 022, to the north-east of the 5-P ponds (across the Williams Fork River), at the v-notch weir had a tiny trickle of liquid water under the ice. According to the most recent Annual Hydrology Report this is designated as a “spoil spring”. On inspection, it seems unlikely that water infiltrating the backfilled surface mine could discharge at this point due to the distance from the pit to the spring and the topography between them; it may be advisable to review the designation of the “spoil spring” in the CDPHE permit (CO 0034142).

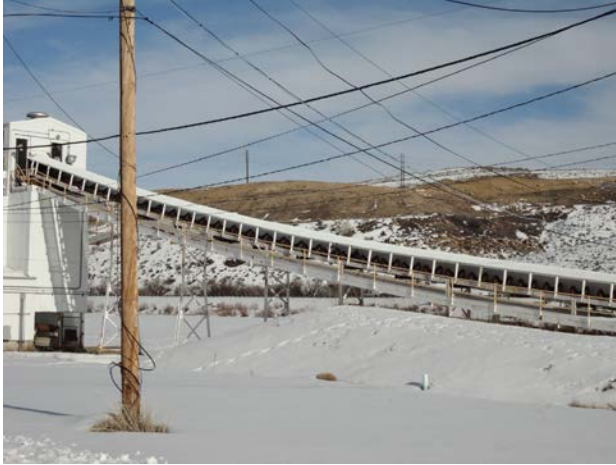
Puffs of smoke from a smouldering underground coal seam within a historic abandoned mine were just visible on the horizon made by the outcrop across the Williams Fork River, to the north east of the facilities area. Personnel from the Division's Inactive Mines program are planning to work on this during 2013.

Photo 7: View of site of underground coal seam fire from facilities area
