**COLORADO DIVISION OF RECLAMATION, MINING AND SAFETY**  
**MINERALS PROGRAM INSPECTION REPORT**  
**PHONE: (303) 866-3567**

<b>MINE NAME:</b> Delta Paving Gravel Pit	<b>MINE/PROSPECTING ID#:</b> M-1998-105	<b>MINERAL:</b> Gravel	<b>COUNTY:</b> Delta
<b>INSPECTION TYPE:</b> Monitoring	<b>INSPECTOR(S):</b> Dustin M. Czaplá	<b>INSP. DATE:</b> March 20, 2013	<b>INSP. TIME:</b> 12:30
<b>OPERATOR:</b> Grand Junction Pipe & Supply Co.	<b>OPERATOR REPRESENTATIVE:</b> Ivan Geer	<b>TYPE OF OPERATION:</b> 112c - Construction Regular Operation

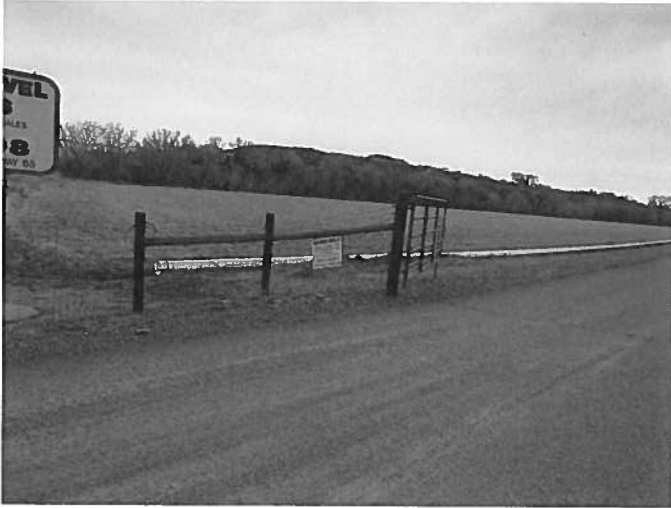
Adequate mine identification signage was noted at the entrance to the site.

Figure 1: Mine identification sign was located at the entrance to the site.

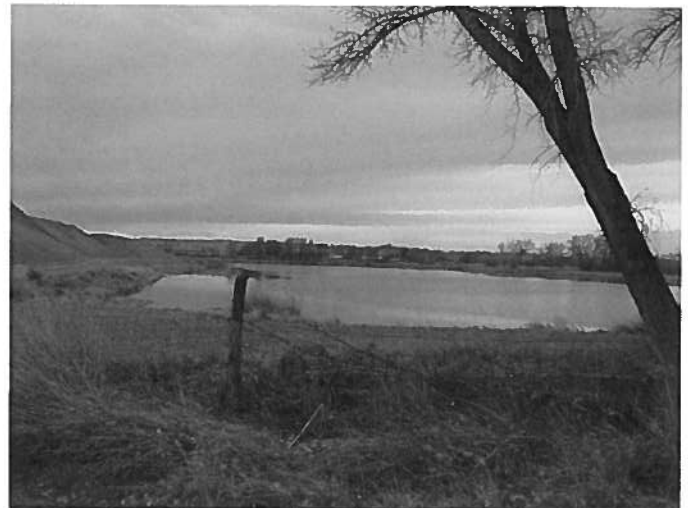
Figure 2: View from the north side of the pond, facing south.

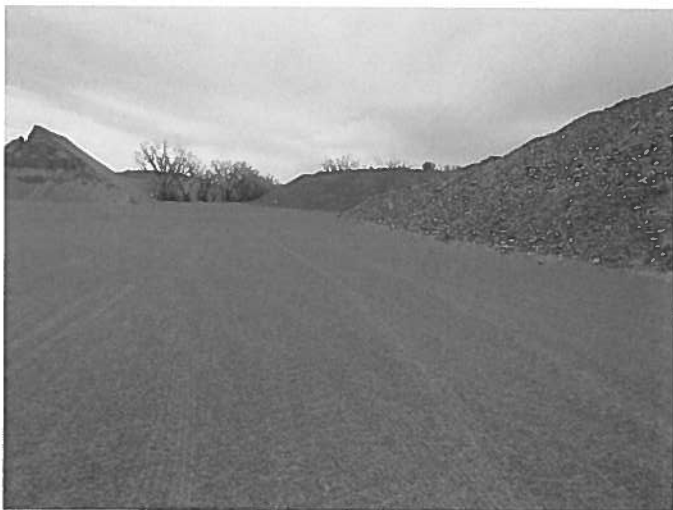
A stockpile area is located east of the mined pond. According to the operator's most recent annual report, this area includes 16.7 acres. Large stockpiles of various material sizes were located in this area. It appeared that at least several years worth of material was stockpiled and that further mining at the site would not be necessary in the near future. Topsoil was stockpiled on the southwest side of the pond.

Figure 3: Stockpile area located on the east side of the pond.

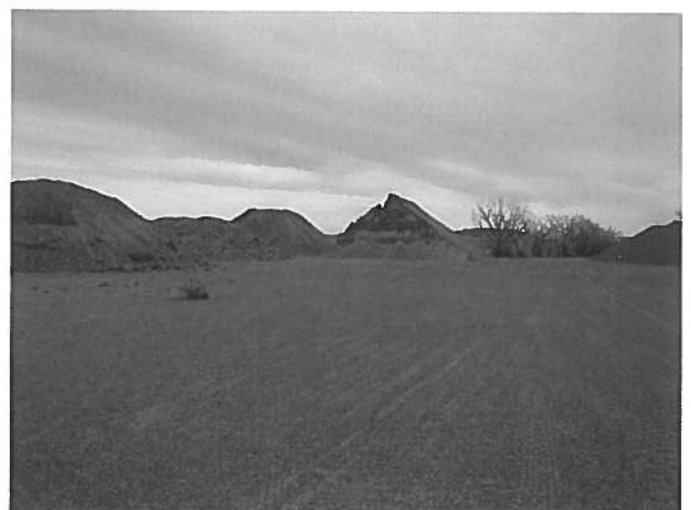
Figure 4: Stockpile area located on the east side of the pond.

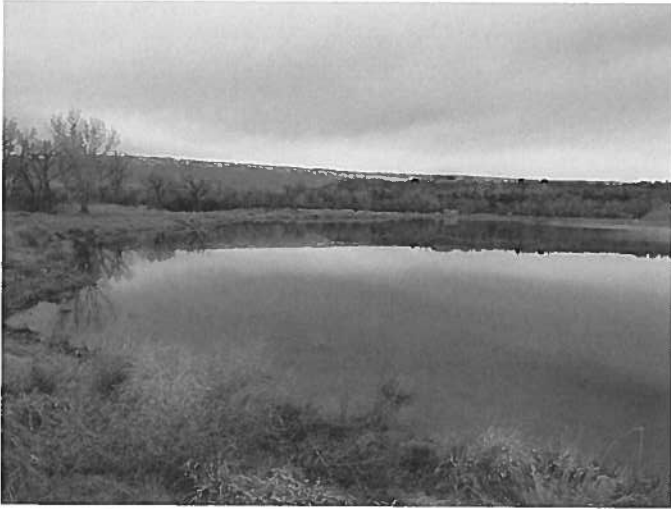
Figure 5: View from the southwest corner of the pond, facing north.

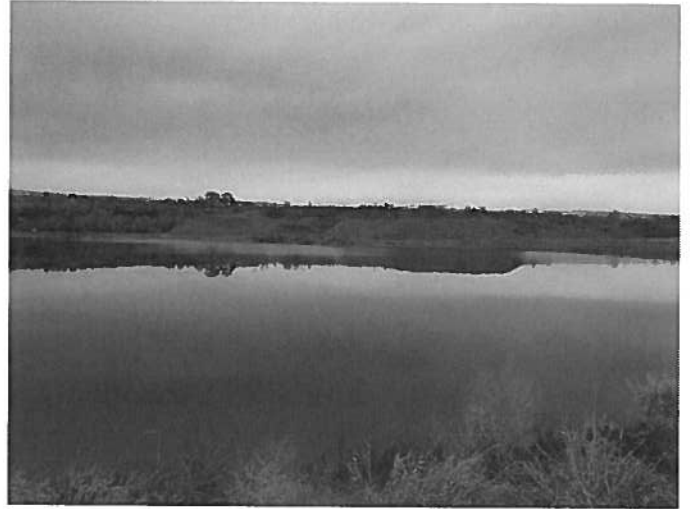
Figure 6: View from the southwest corner of the pond, facing northeast.

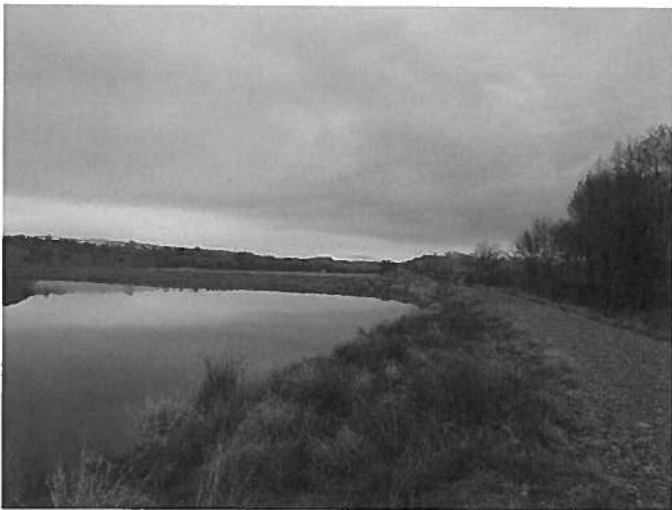
Figure 7: View from the southwest corner of the pond, facing east.

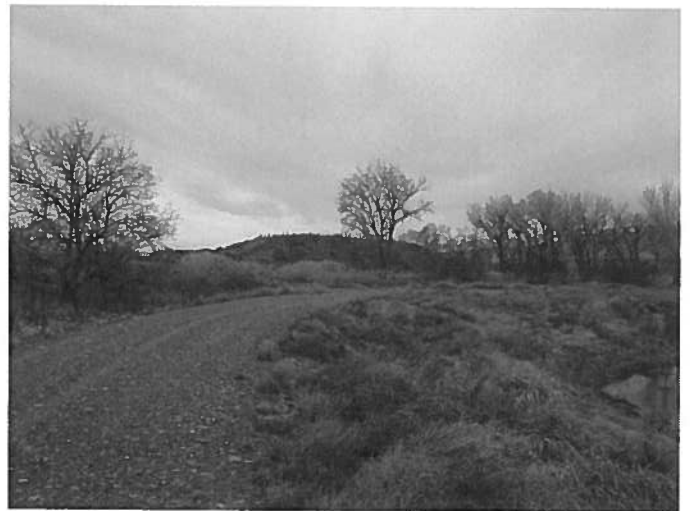
Figure 8: Topsoil stockpile located on the southwest side of the pond.
