**COLORADO DIVISION OF RECLAMATION, MINING AND SAFETY
COAL PROGRAM INSPECTION REPORT**

Permit Number: C-1981-018 Mine Name: Deserado Mine Operator: Blue Mountain Energy, Inc Operator Address: Mr Scott Wanstedt 3607 County Road 65 Rangely, CO 81648	County: Rio Blanco Operation Type: Underground Permit Status: Active Ownership: Federal
	Operator Representative Present: Scott Wanstedt
Operator Representative Signature: (Field Issuance Only)

Inspection Start Date: March 27, 2013 Inspection Start Time: 09:20 Inspection End Date: March 27, 2013 Inspection End Time: 15:00	Inspection Type: OSM Oversight Inspection Inspection Reason: OSM Oversight Inspection Weather: Clear
Joint Inspection Agency: OSM	Joint Inspection Contacts: Christine Belka
Post Inspection Agency: None	Post Inspection Contacts: None
Inspector(s): Zach T. Trujillo	Inspector's Signature:

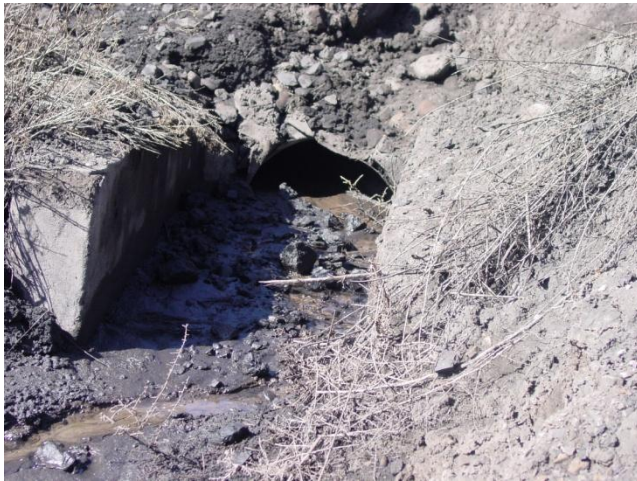
Multiple culverts within the facility area need to be cleaned out. The culvert below the mine portal entry and culverts in the same ditch line are roughly 50% full of sediment. Two culverts south of the refuse bin and truck loadout are approximately 75% full of sediment. Additionally, the ditch line south of the rotary breaker needs to be reestablished. Sediment has accumulated within the ditch and is nearly flush with the facility bench.

Culvert south of refuse bin and truck loadout.

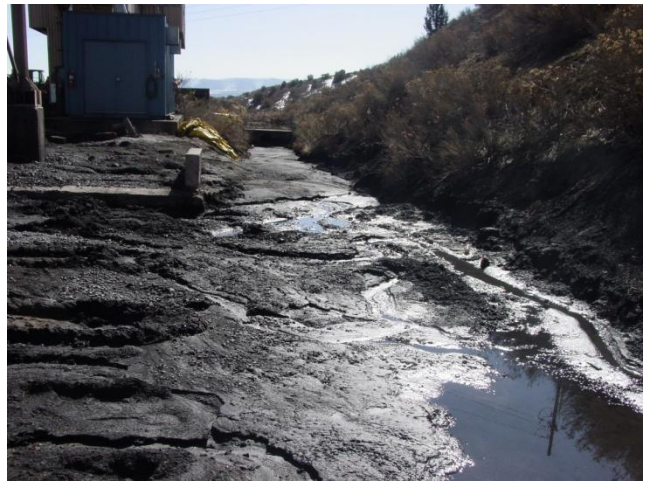
Ditch in need of reestablishment.

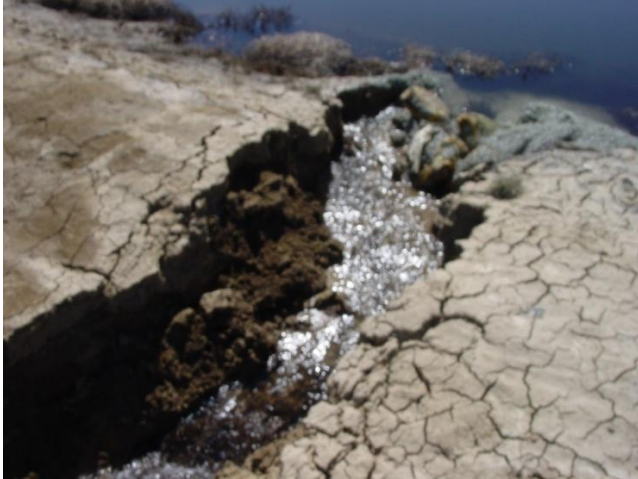
Cutting between Dewatering Ponds 3 and 4.

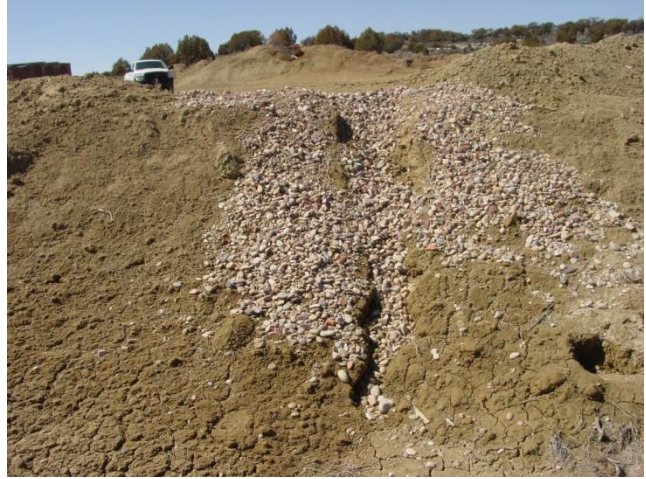
No signs of erosion were observed except within the 10L Vent Shaft SAE. 10L Vent Shaft SAE is a constructed pad with berms and a rock check dam as its primary sediment control. Recent snow melt appears to have created cutting below the rock check. It also appears BME has attempted to mitigate future cutting by filling the section with additional gravel. Additional monitoring and maintenance will be needed to ensure cutting doesn't continue.

Cutting below rock check dam of Vent Shaft 10L.

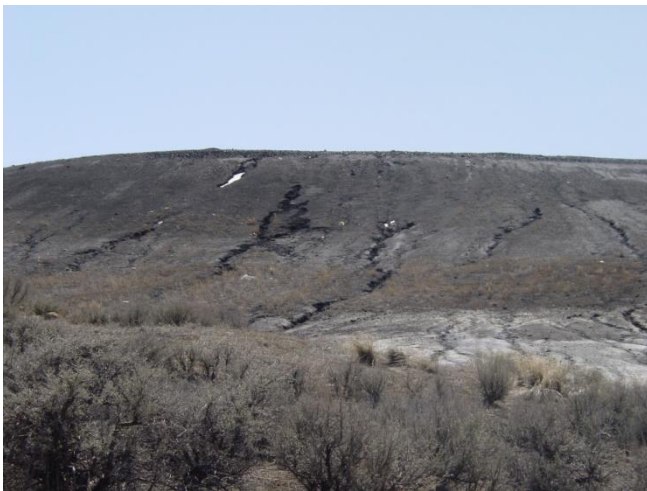
Refuse Pile 2/3/4.

Refuse Pile 2/3/4 and 5A have rills and gullies forming on the northern slope of the piles.

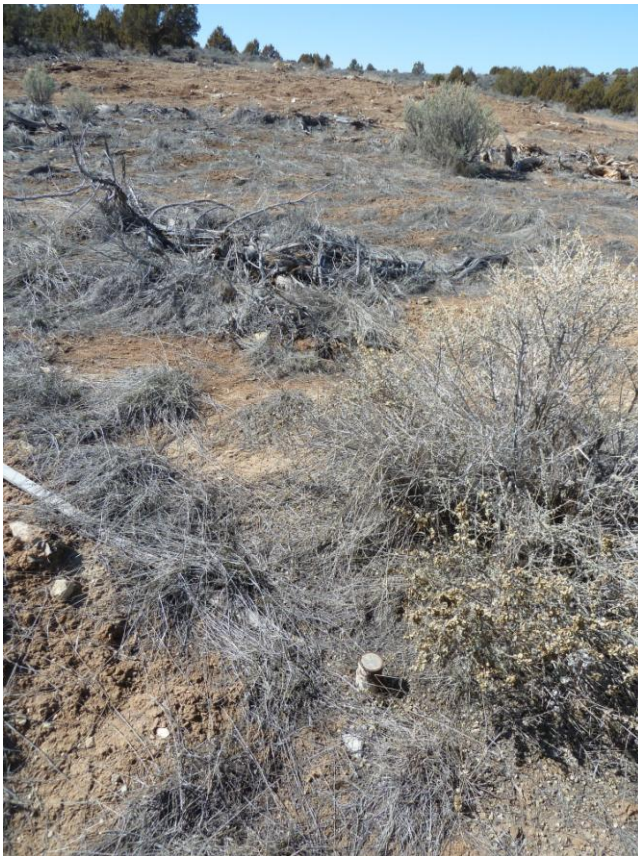
Multiple reclaimed nitrogen injection holes and degas boreholes were inspected. Vegetative growth was observed on reclaimed pads that are roughly 3+ years old. Additional pads have been regraded and seeded within the previous year.

Reclaimed degas borehole and nitrogen injection borehole pads.

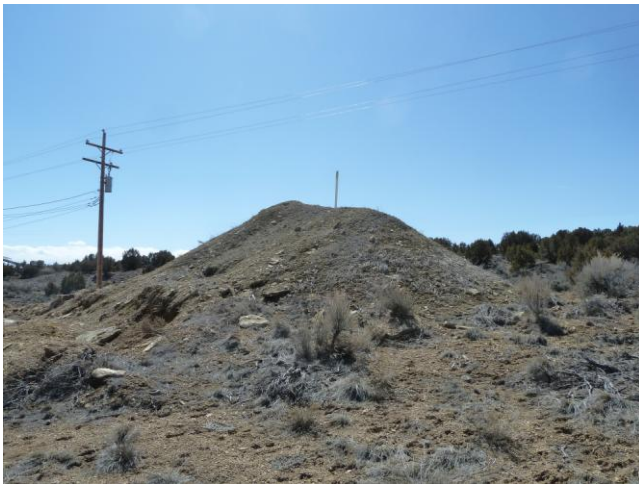
All topsoil piles inspected were clearly marked and stable. Multiple piles throughout the site were in need of being reseeded for erosion control. Most notably the pile south of the train loadout and above the cement pumping station.

Topsoil pile above cement station.
