## COLORADO DIVISION OF RECLAMATION, MINING AND SAFETY COAL PROGRAM INSPECTION REPORT

<b>Permit Number:</b> C-1981-035 <b>Mine Name:</b> King Coal Mine <b>Operator:</b> GCC Energy, LLC <b>Operator Address:</b> Mr. Tom Bird 6473 County Road 120 Hesperus, CO 81326	<b>County:</b> La Plata <b>Operation Type:</b> Underground <b>Permit Status:</b> Active <b>Ownership:</b> Federal
<b>Operator Representative Present:</b>  Wade Wymore	
<b>Operator Representative Signature: (Field Issuance Only)</b>  This report was issued electronically from the Division's Durango Field Office.

<b>Inspection Start Date:</b> March 26, 2013 <b>Inspection Start Time:</b> 10:45 <b>Inspection End Date:</b> March 26, 2013 <b>Inspection End Time:</b> 14:10	<b>Inspection Type:</b> Coal Partial Inspection <b>Inspection Reason:</b> Normal I&E Program <b>Weather:</b> Cloudy
<b>Joint Inspection Agency:</b>  None	<b>Joint Inspection Contacts:</b>
<b>Post Inspection Agency:</b>  None	<b>Post Inspection Contacts:</b>
<b>Inspector(s):</b>  Marcia L. Talvitie, P.E.	<b>Inspector's Signature:</b>

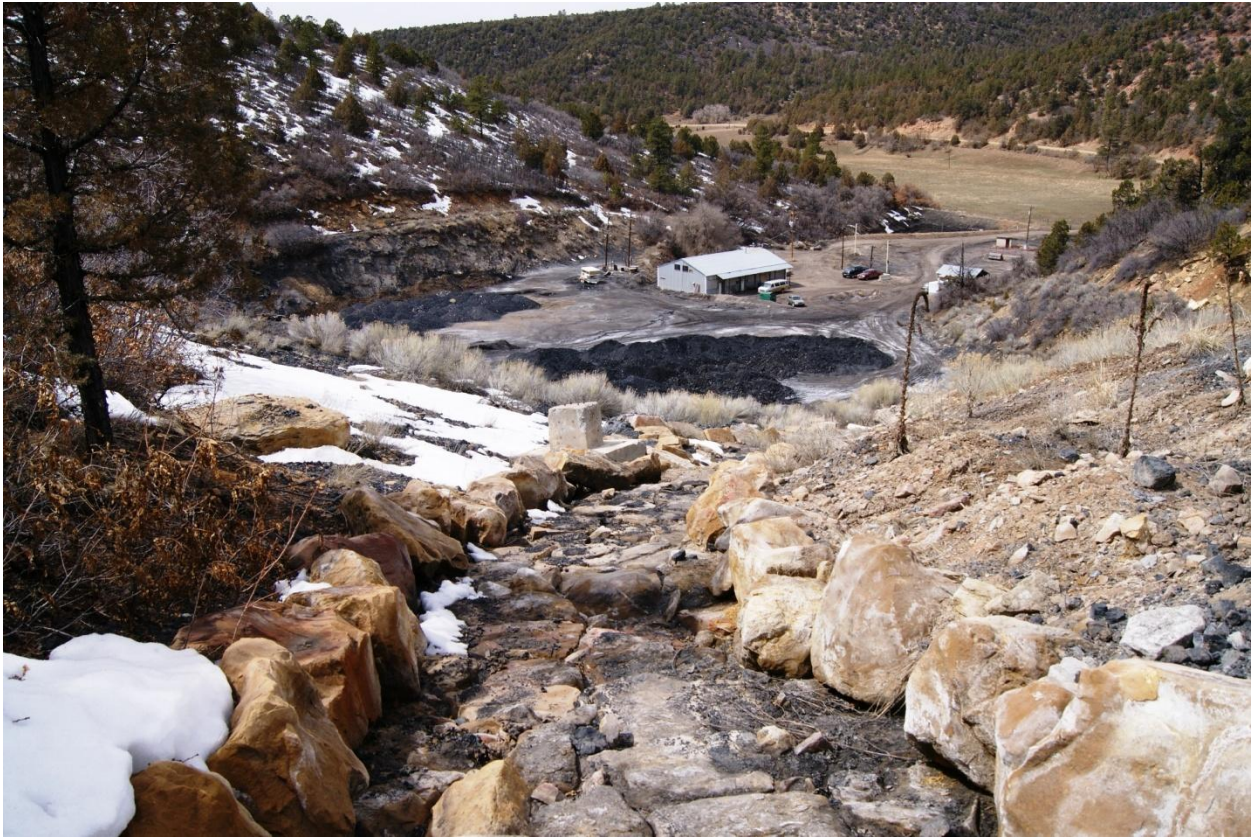
- Coal Mine Waste (development waste) produced at the King II mine is hauled by tandem-axle dump truck to the King I mine for permanent disposal. A valley-fill "waste pile" has been previously approved for this purpose. Details regarding design, construction and reclamation of the Waste Pile are provided in the following portions of the King I permit volumes: Sections 2.05.3 (p. 3) and 2.05.4 (pp. 4-5); Appendices 10(1) and 11(1); and Maps 007, 014 and 015.
- Ground conditions at the King I Waste Pile have improved to the point where placement and compaction of coal mine waste that was end-dumped at the site during the winter (Photo 1) may now be possible. The snow had nearly all melted, and the roadway to the top of the pile was clear and dry.

Photo 1 – Development waste in King I yard area (rock-lined collection ditch in foreground)

- ***The Division is presently conducting a review of the permitted Waste Pile design, to ensure that all requirements of the Coal rules have been properly addressed. We request that no additional coal mine waste be delivered to the top of the pile, pending the results of this review.***

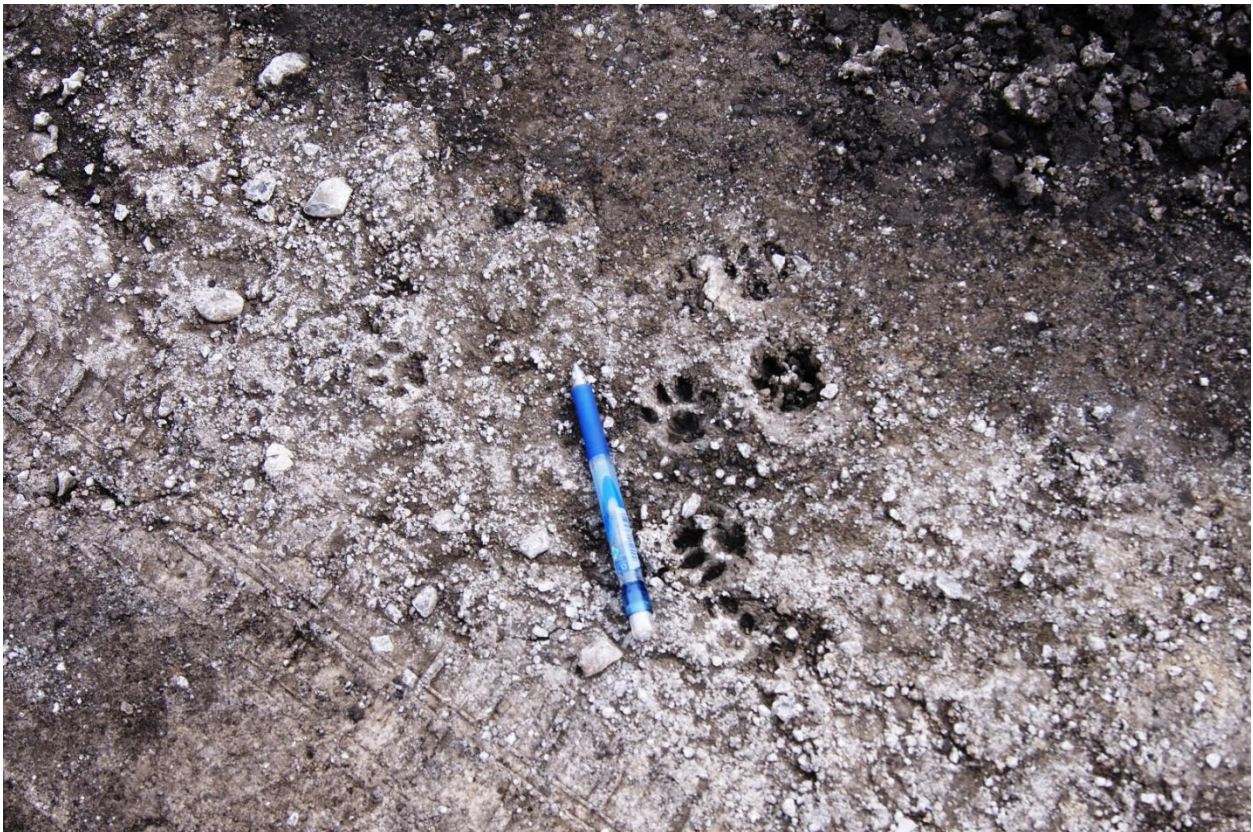
- There were numerous small mammal tracks (Photo 2) in the damp soil near the shop highwall at King I. They appear to have been made by a young coyote or young bobcat.

Photo 2 – Paw prints at King I

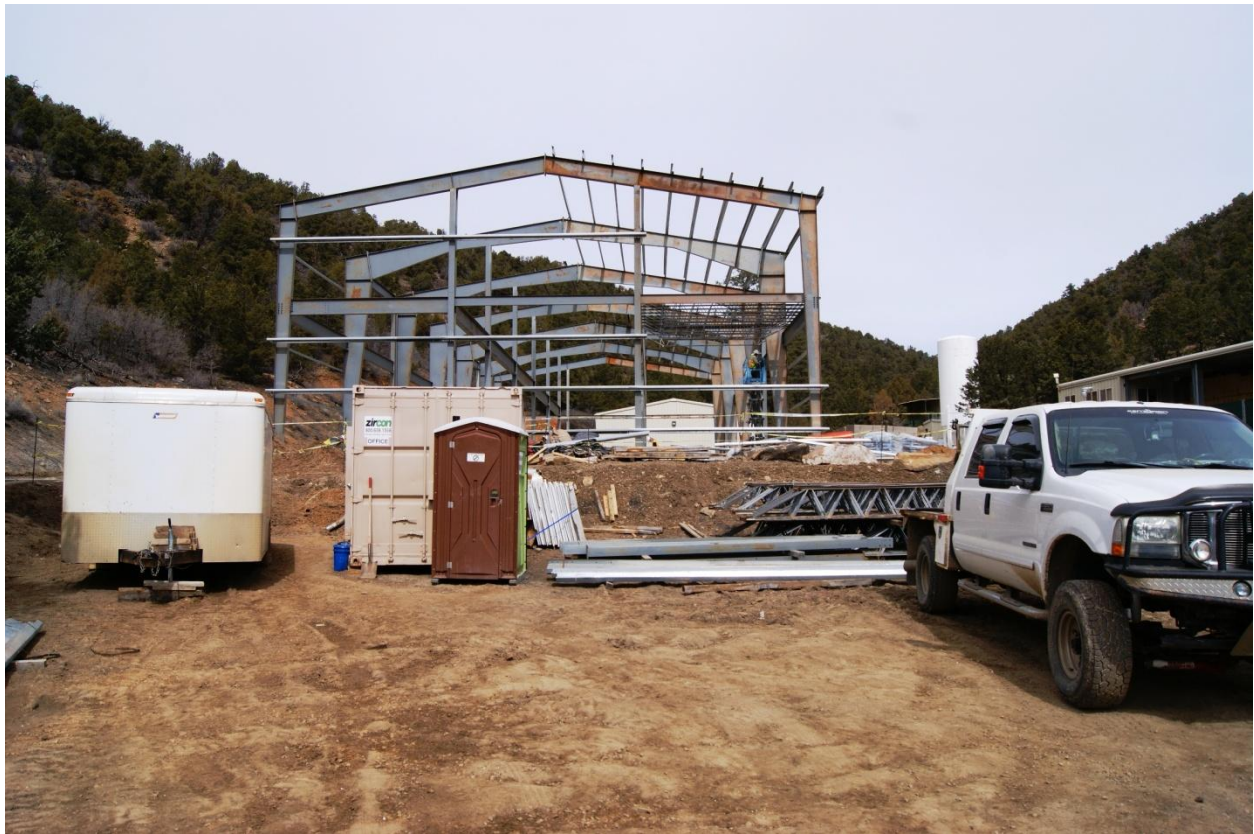
- At King II, a steady stream of highway haul trucks was being loaded with coal for delivery to GCC's customers. The screening tower was running during the inspection, and coal was stockpiled at each of the two stack tubes.
- Work has begun on erecting the steel skeleton for the new office building at King II (Photo 3).
- At the northeast corner of the petroleum storage shed, we observed that a small amount of soil had been contaminated with oil. Mr. Wymore said the soil would be excavated, placed in a container, and removed from the property for disposal at a proper facility (Photo 4).

Photo 3 – Steel frame of new building at King II, looking north

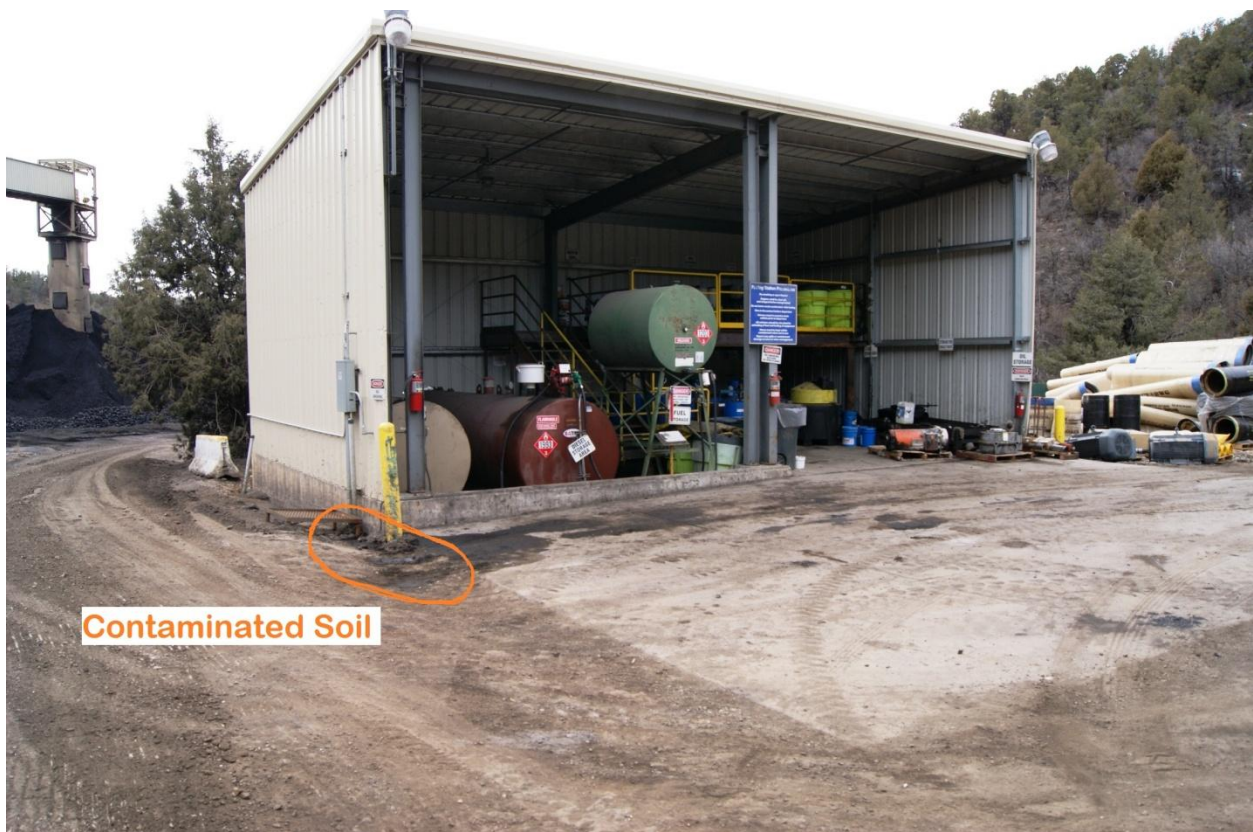
Photo 4 – Petroleum storage shed, contaminated soil
