**COLORADO DIVISION OF RECLAMATION, MINING AND SAFETY  
COAL PROGRAM INSPECTION REPORT**

<b>Permit Number:</b> C-1980-004 <b>Mine Name:</b> McClane Canyon Mine <b>Operator:</b> McClane Canyon Mining, LLC <b>Operator Address:</b> Mr. Gary Isaac P.O. Box 98 Loma, CO 81524	<b>County:</b> Garfield <b>Operation Type:</b> Underground <b>Permit Status:</b> Temporary Cessation <b>Ownership:</b> Federal
	<b>Operator Representative Present:</b>  None
<b>Operator Representative Signature: (Field Issuance Only)</b>

<b>Inspection Start Date:</b> March 26, 2013 <b>Inspection Start Time:</b> 11:00 <b>Inspection End Date:</b> March 26, 2013 <b>Inspection End Time:</b> 13:00	<b>Inspection Type:</b> Coal Partial Inspection <b>Inspection Reason:</b> OSM Oversight Inspection <b>Weather:</b> Clear
<b>Joint Inspection Agency:</b>  None	<b>Joint Inspection Contacts:</b>  
<b>Post Inspection Agency:</b>  None	<b>Post Inspection Contacts:</b>  
<b>Inspector(s):</b>  Michael P. Boulay	<b>Inspector's Signature:</b>  <i>Michael P. Boulay</i>  <b>Signature Date:</b>  4/3/2013

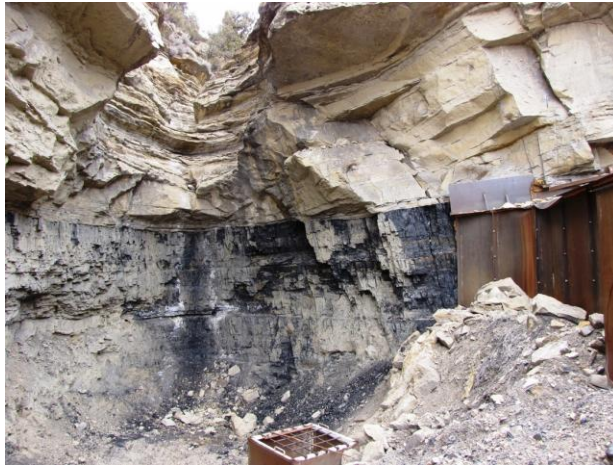
Drainage structures and diversion culverts in the portal area were clear of debris and functional. The diversion structures are very well maintained at the portal facilities area (see attached Photograph No. 1). Ditches and culverts were clear of sediment and debris and functioning properly throughout the site.

Photo No. 1 - Upper drainage diversion.

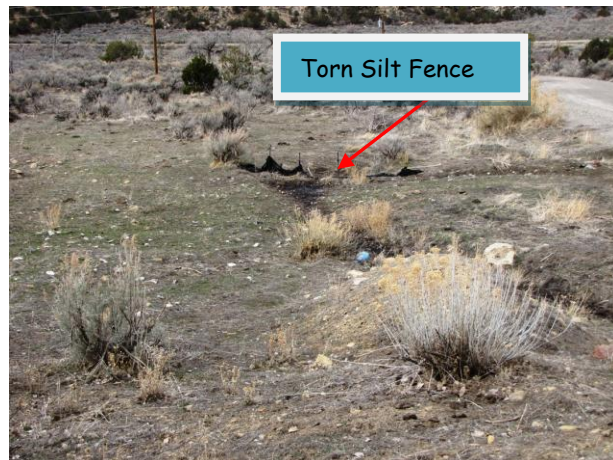
The sediment pond was containing muddy water at approximately 2 feet below the level of the gated principal spillway. The manually operated pond was not being discharged. The silt fence and sump at the east side of the bridge at East Salt Creek crossing were maintained. The silt fences at the entrance to the road accessing the construction material and topsoil pile locations is damaged and needs to be replaced (see Photograph No. 2). All

Photo No. 2 - Damaged silt fence.

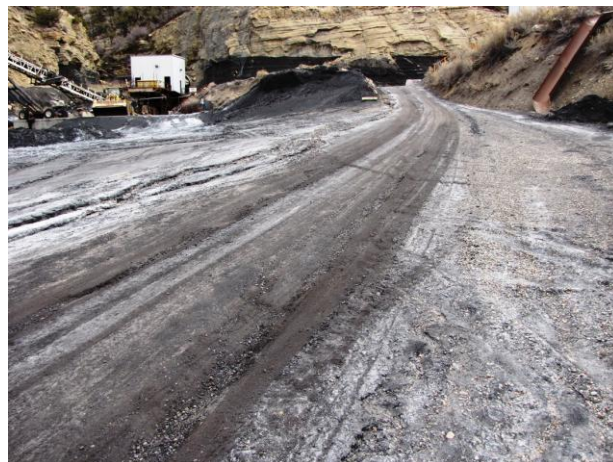
Roads were generally well maintained and in good condition throughout the site. Some minor rills have formed in the coal stockpile area and at the upper end of the haul road adjacent to the stockpile area due to the recent snowmelt and runoff (see Photograph No. 3). Please repair the rills that have formed at the coal stockpile area and grade the upper end of the haul road prior to the next inspection to ensure compliance.

Photo No. 3 – Minor rills at upper end of haul road & stockpile areas.
