**COLORADO DIVISION OF RECLAMATION, MINING AND SAFETY  
COAL PROGRAM INSPECTION REPORT**

<b>Permit Number:</b> C-1992-080 <b>Mine Name:</b> Carbon Junction Mine <b>Operator:</b> Oakridge Energy, Inc. <b>Operator Address:</b> Mr. Michael S. Savage 4610 Haystack Drive Windsor, CO 80550	<b>County:</b> La Plata <b>Operation Type:</b> Surface <b>Permit Status:</b> Inactive <b>Ownership:</b> Private  <b>Operator Representative Present:</b>  None
<b>Operator Representative Signature: (Field Issuance Only)</b>  This report was issued electronically from the Division's Durango Field Office.

<b>Inspection Start Date:</b> March 26, 2013 <b>Inspection Start Time:</b> 14:45 <b>Inspection End Date:</b> March 28, 2013 <b>Inspection End Time:</b> 12:00		<b>Inspection Type:</b> Coal Complete Inspection <b>Inspection Reason:</b> Normal I&E Program <b>Weather:</b> Cloudy	
<b>Joint Inspection Agency:</b>  None		<b>Joint Inspection Contacts:</b>	
<b>Post Inspection Agency:</b>  None		<b>Post Inspection Contacts:</b>	
<b>Inspector(s):</b>  Marcia L. Talvitie, P.E.	<b>Inspector's Signature:</b>

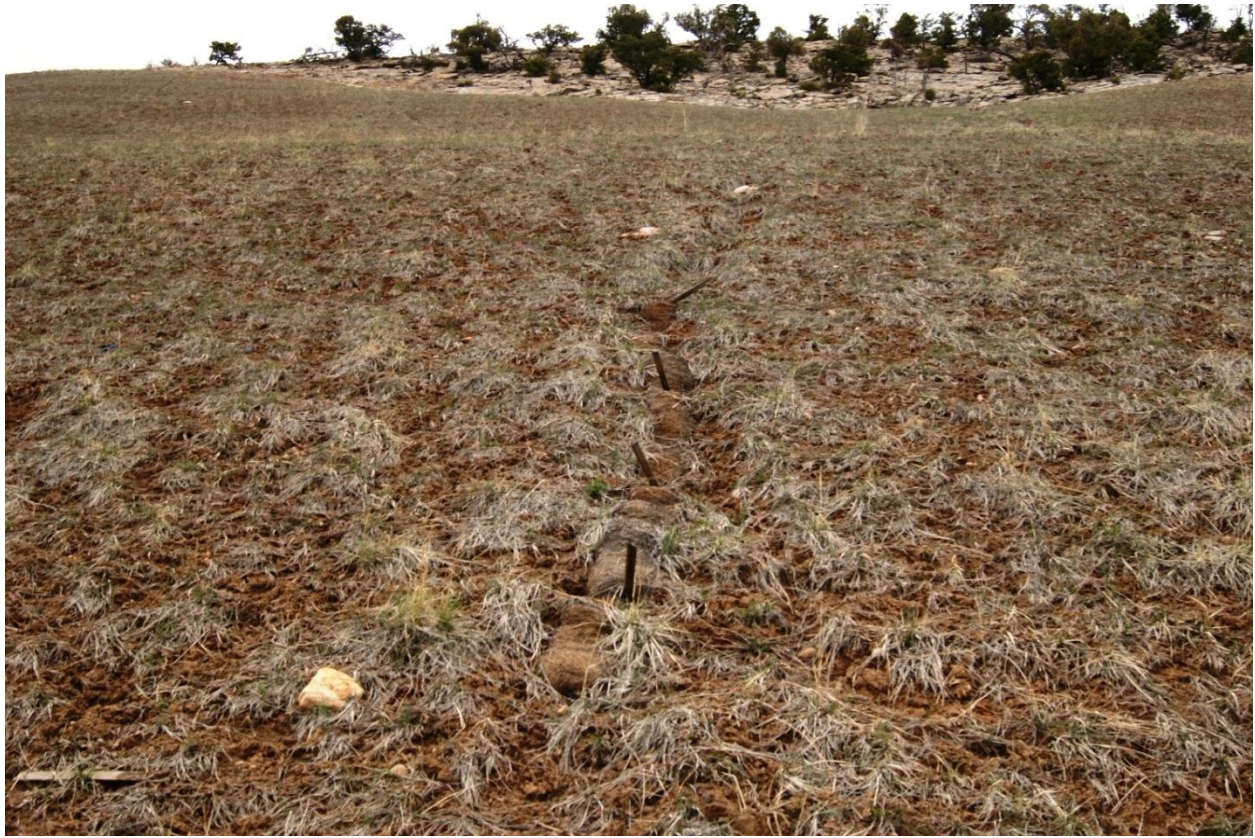
- At the North Pit, zones of concentrated flow identified in a previous inspection report (May 2012) have been stabilized with the insertion of straw wattles (Photo 1). This appears to have been a successful solution; I observed no evidence of continued erosion occurring on the slope.

Photo 1 – Straw wattles stabilizing rill on North Pit slope, above middle bench

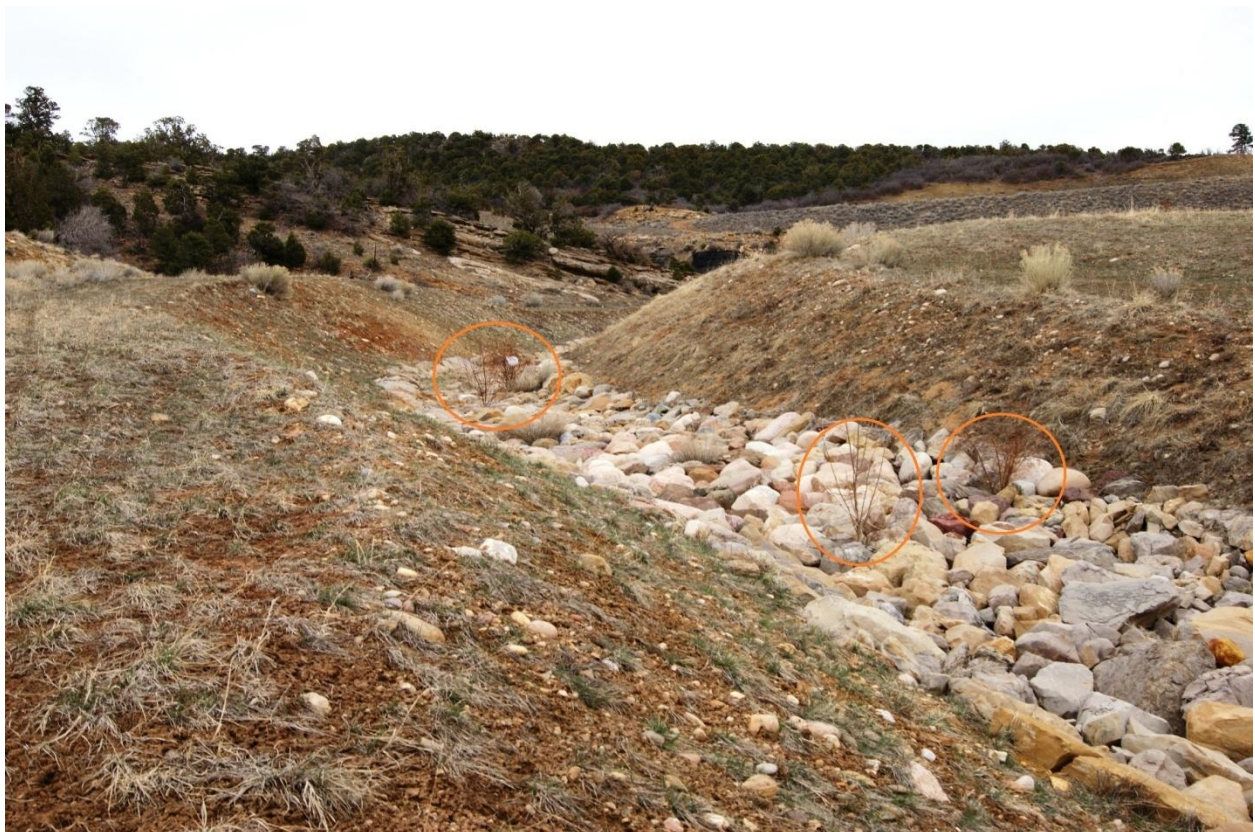
- The riprap-lined portions of the Carbon Junction Canyon permanent diversion appeared to be stable, and the twin culverts crossing the paved haul road were clear. A number of shrubs or small trees have sprouted up within the riprap (Photo 2). ***These must be removed in order to not diminish the flow-carrying capacity of the channel.***

Photo 2 – Vegetation growing in Carbon Junction diversion (circled in orange)

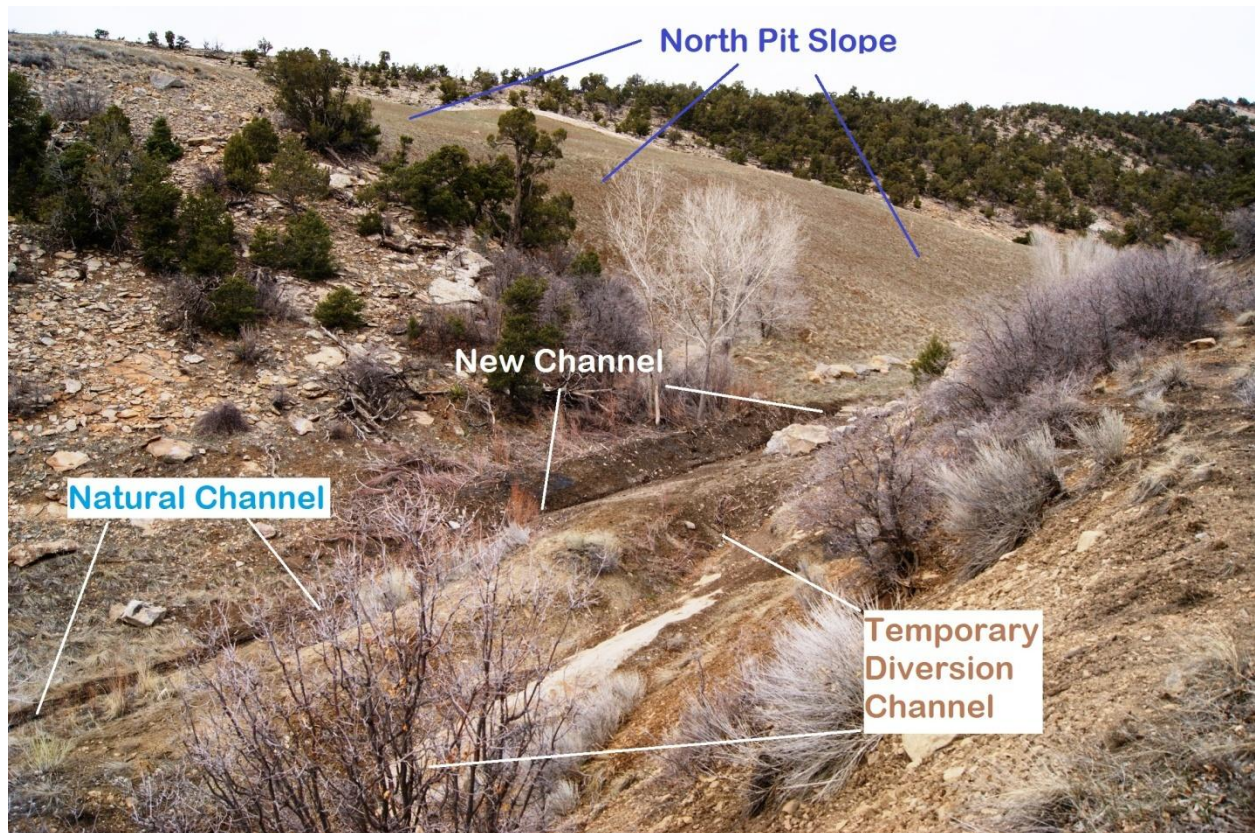
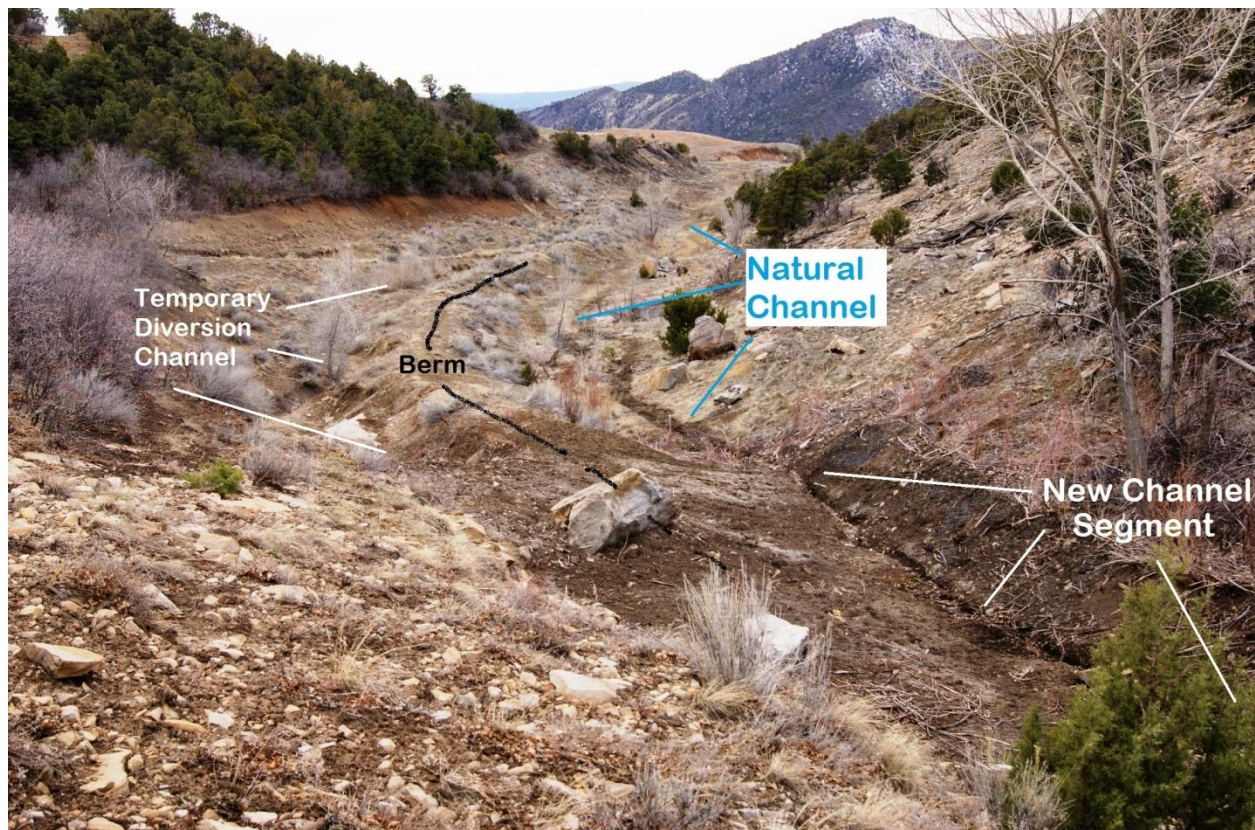
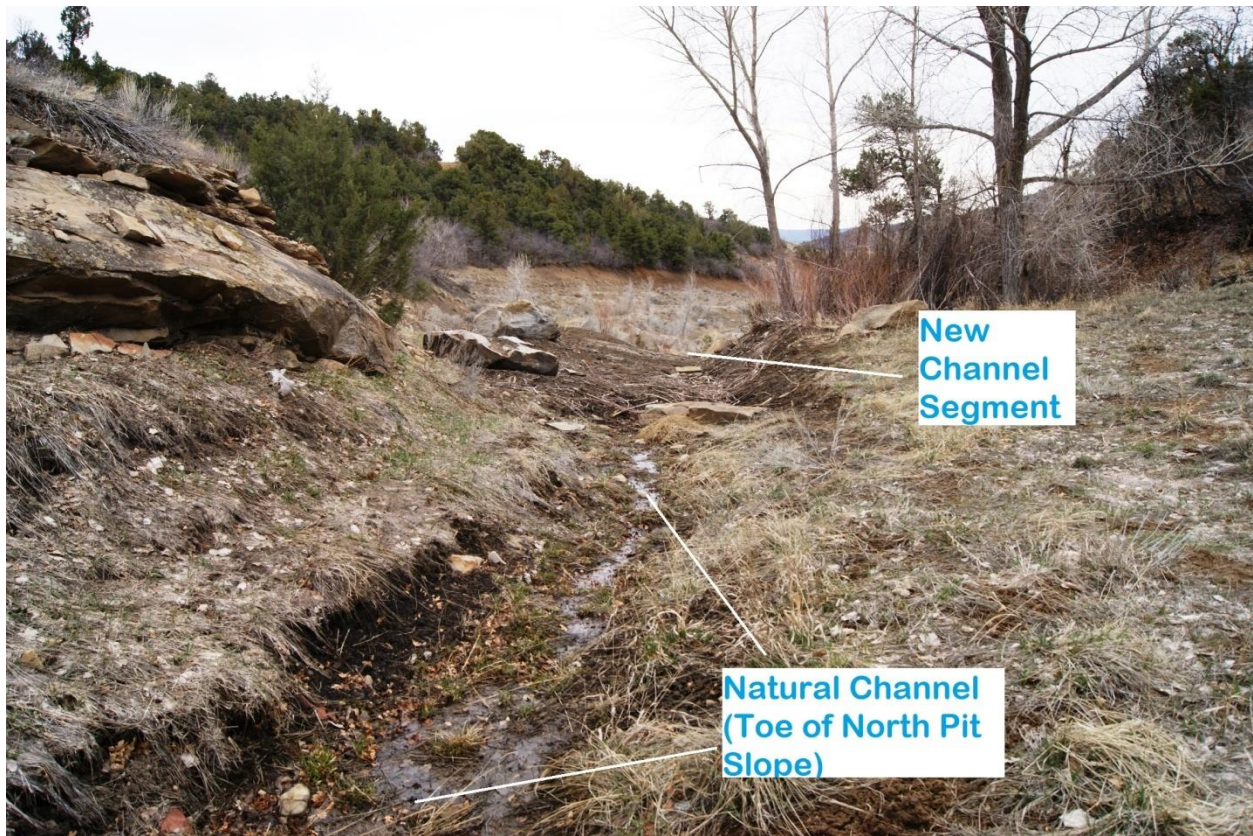
- In the upper segment of Carbon Junction Canyon, an opening (breach) has been created through the segment of berm that previously deflected flow away from the natural channel, and a short stretch of the pre-existing temporary channel has been filled in (Photos 3, 4 and 5). [This hydrologic problem area was identified in 2012, and the need for repairs was discussed with the permittee (Chi Chi Ray and Michael Savage) during the July 2012 inspection.] The Division will continue to monitor this location to ensure that flows are directed into the natural channel and that no noxious weed species become established in the area disturbed by these activities.

Photo 3 – Location of Carbon Junction Canyon improvements, looking NE

Photo 4 – Relative positions of berm, former diversion, natural and new channels, looking W

Photo 5 – Looking downstream at newly graded Carbon Junction Canyon segment

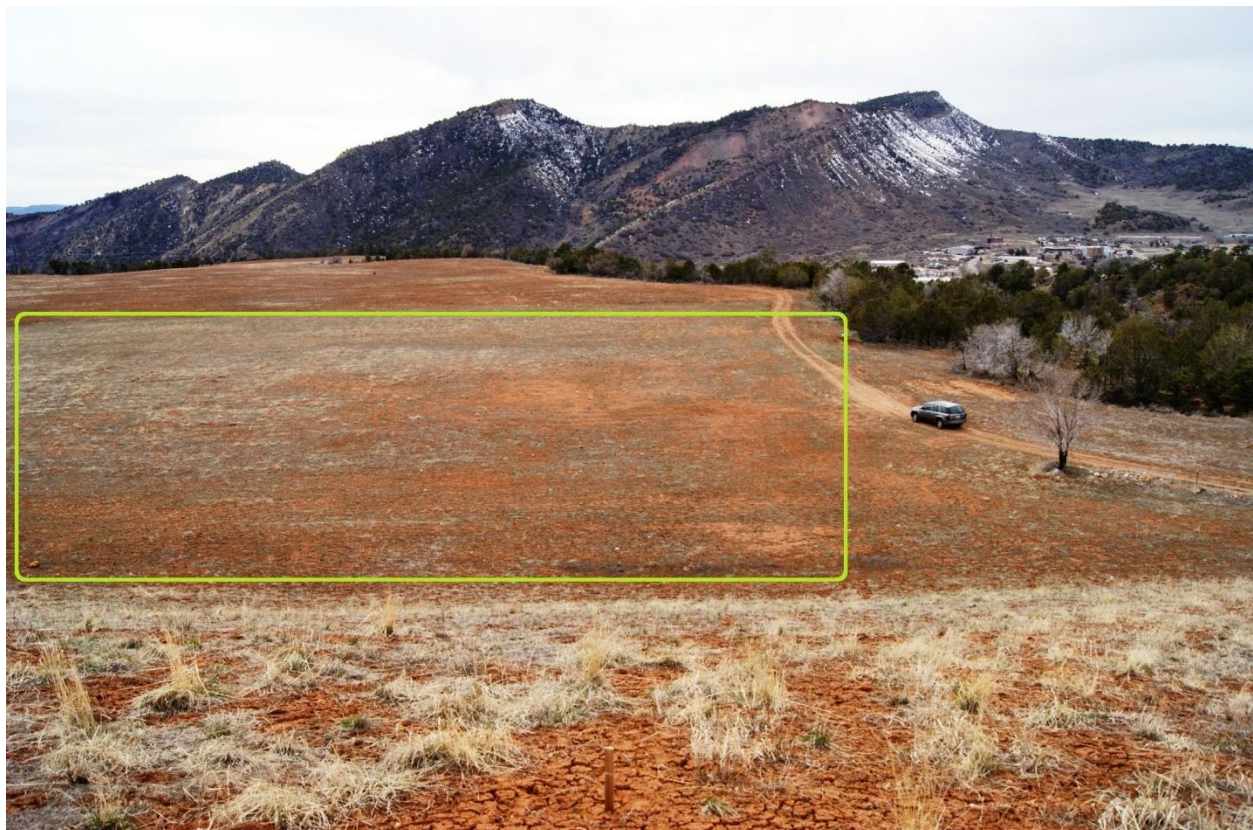
- The reclaimed Sediment Pond #1 area was examined on foot and from atop the remnant Topsoil Stockpile #4 (Photo 6). The reclaimed surface is uniformly smooth, with no signs of erosion occurring. 2009 revegetation efforts appear to be meeting with reasonable success.

Photo 6 – Reclaimed site of former Sediment Pond #1 (approx.)

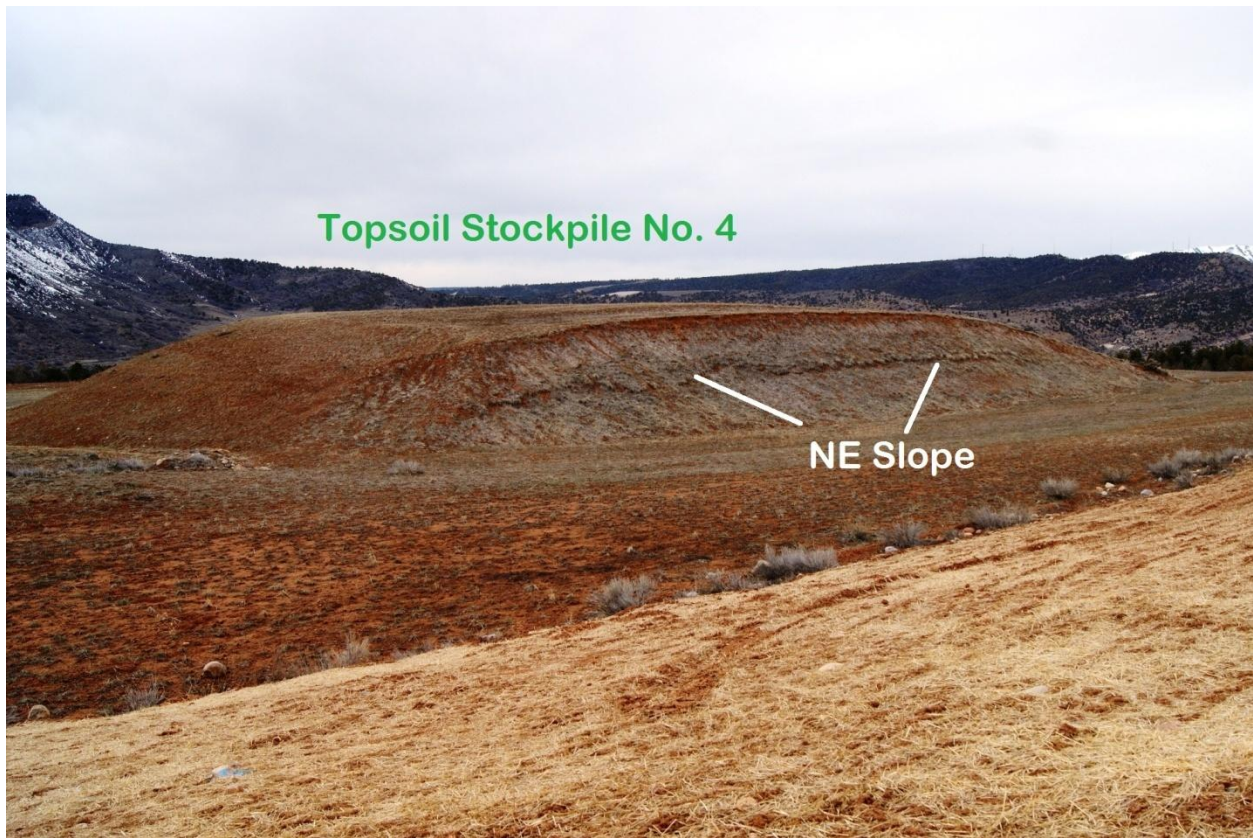
- The side slopes of Topsoil Stockpile No. 4 (Photo 7) appear to be generally stable with respect to erosion. However, there are rills or gullies (possibly the result of vehicle tracks) beginning to appear on the northeastern slope, which is substantially steeper than the remainder of the stockpile (Photo 8).

Photo 7 – Topsoil Stockpile No. 4, looking NW

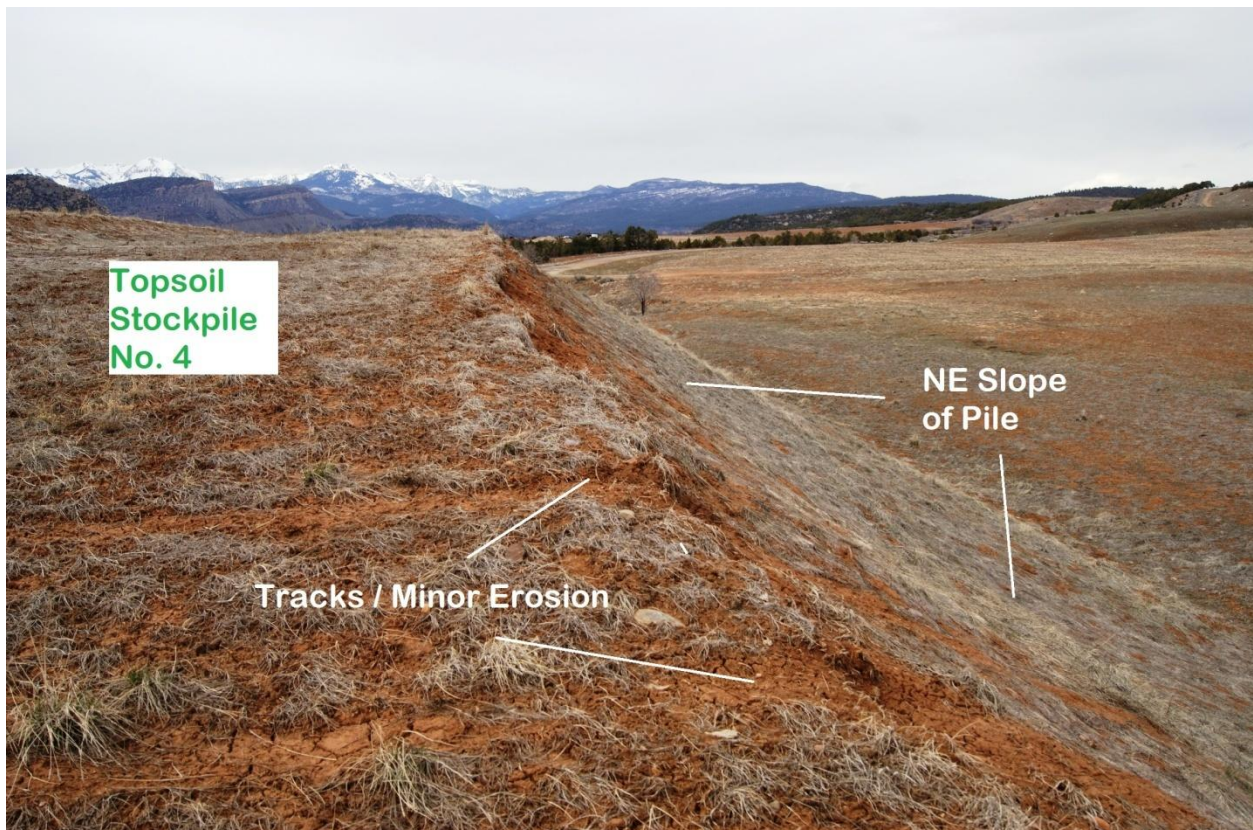
Photo 8 – Slope break and tracks/erosion on northeastern flank of Topsoil Stockpile No. 4
